**Land Drainage Consultancy Ltd.**

## **CHERRY BURTON VILLAGE**

### **Flooding of Village**

**Prepared for Cherry Burton Parish Council  
By Jenny Lambert BSc (Hons) Dip Ag Eng  
November 26<sup>th</sup> 2008 (Version 2)**

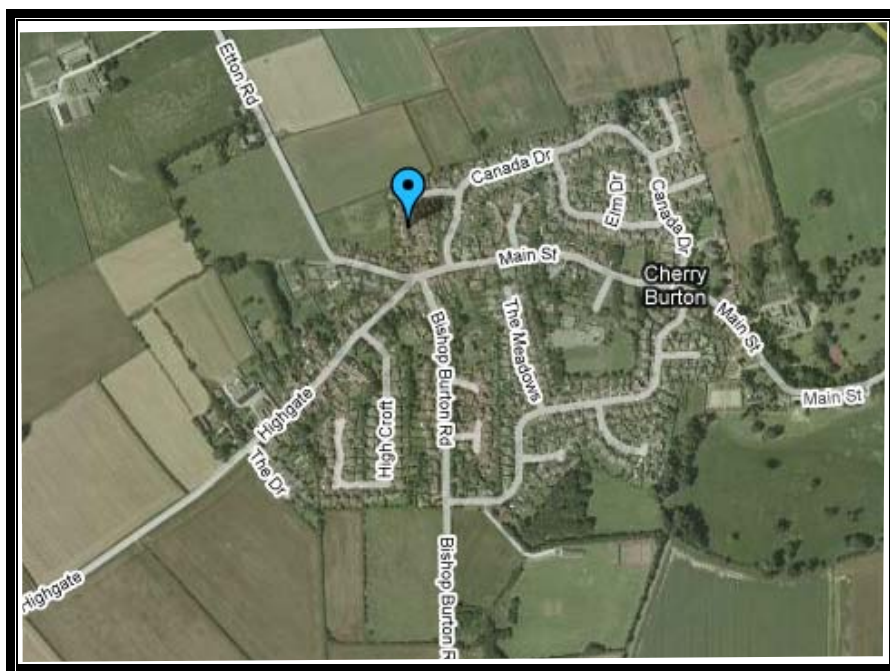
The village of Cherry Burton was severely flooded during the summer of 2007. Two separate areas of the village were affected. The first was along The Meadows which lies to the south of the village and the second was along Canada Drive which lies to the north of the village. Flood water entered many properties. These areas are shown on the aerial photograph below.

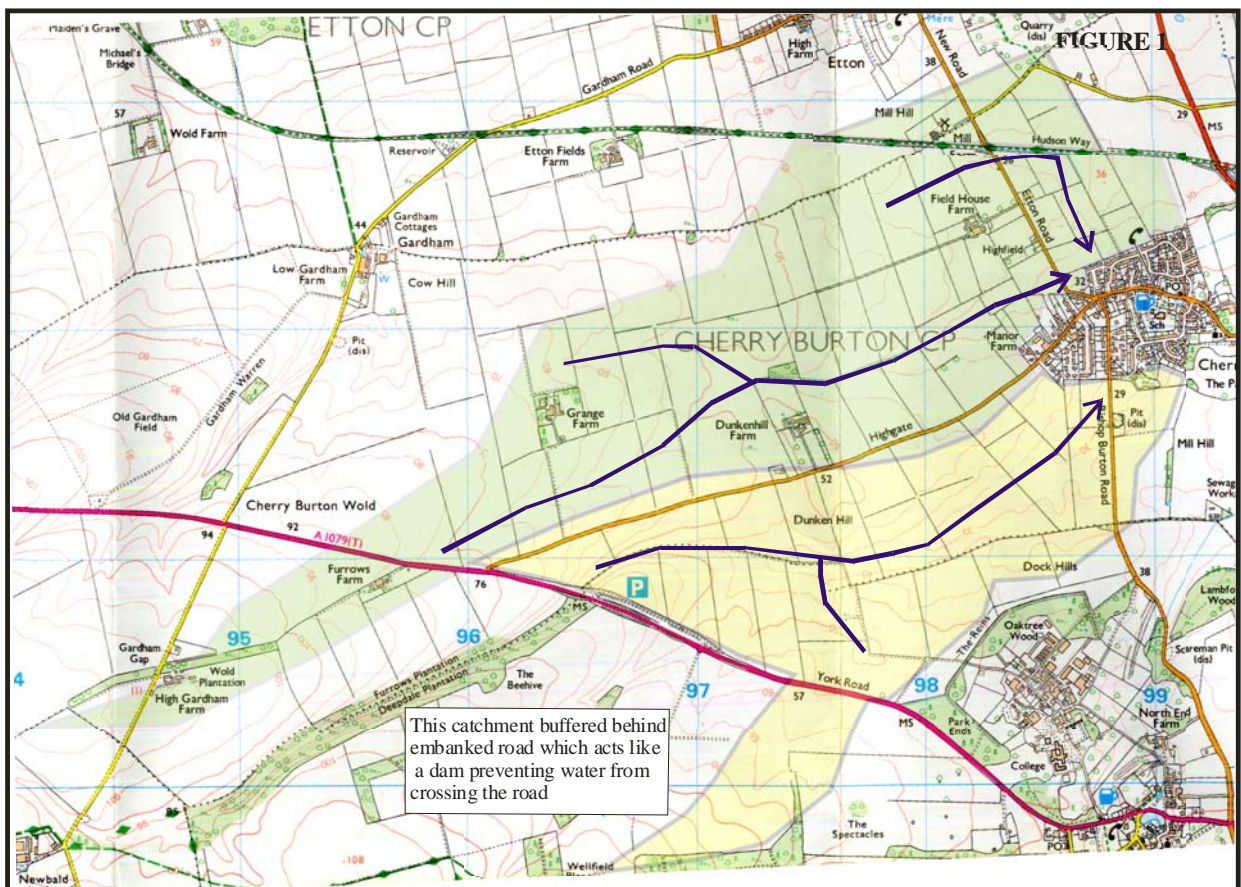
The flood water entered the village from two directions as indicated on the plan at Figure 1 below.

The contributing catchments are shown coloured. Water from the catchment shaded yellow crossed the Bishop Burton Road just south of the village and entered The Meadows. Water from the catchment shaded green crossed Etton Road just north of the village and entered Canada Drive.

There is a surface water drainage system which runs through the village but the quantity of flow emanating from these catchments exceeded the capacity of these drains and consequently overland flow occurred with flood water discharging into properties on the low lying land.

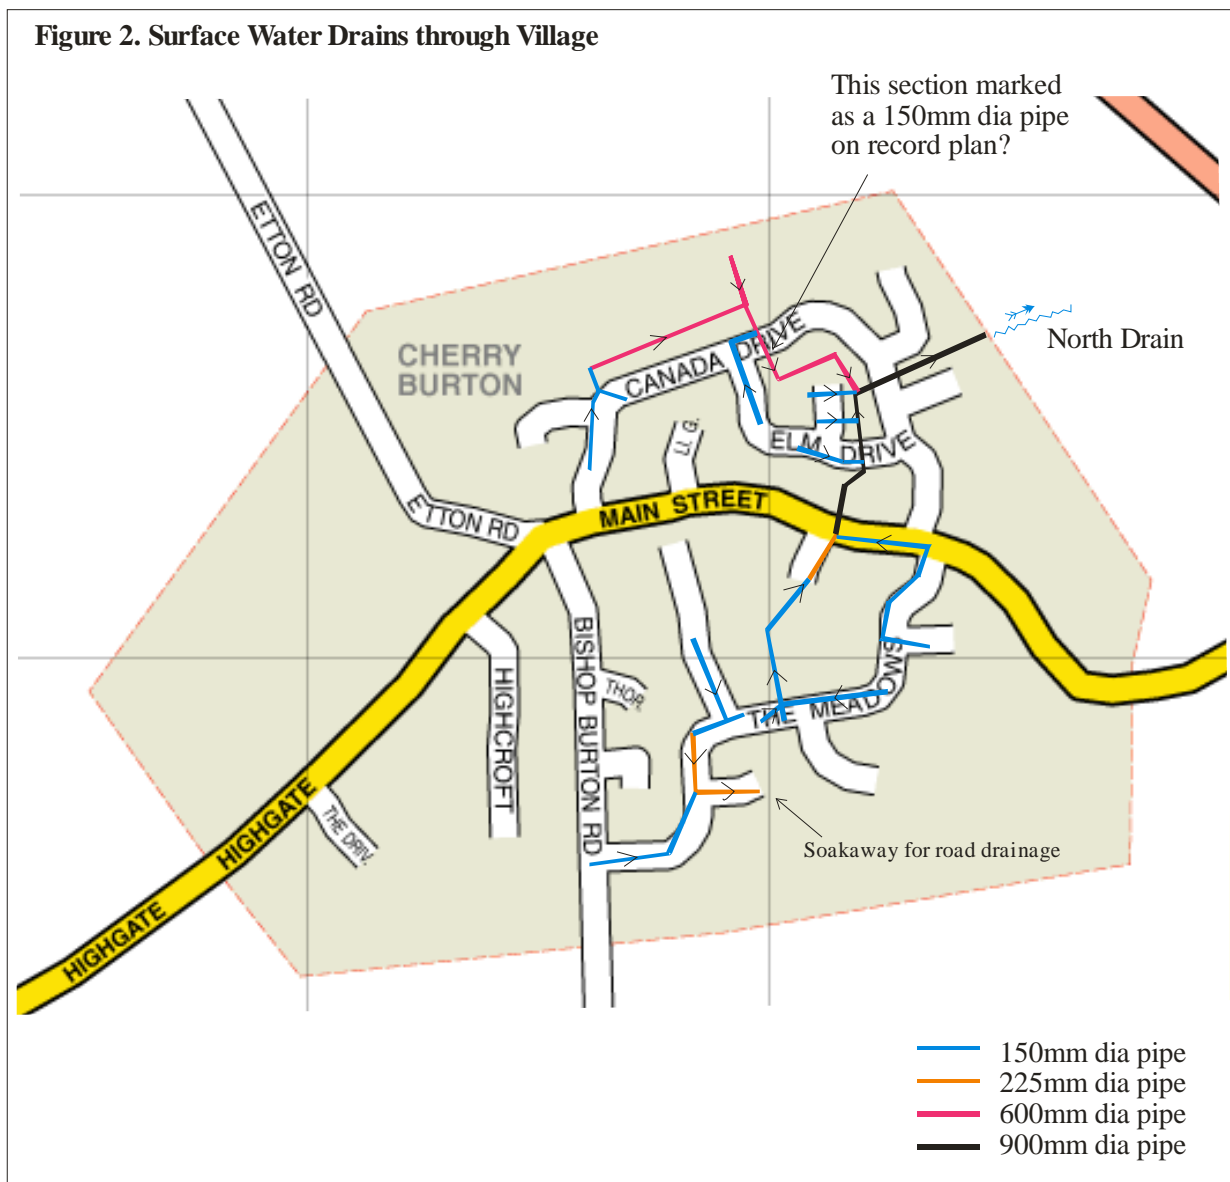
The main surface water drains that are believed to exist through the village are shown on Figure 2 below.

The ‘yellow’ catchment drains towards The Meadows. There is a series of road gullies outfalling into pipes and eventually into a soakaway. When the capacity of the soakaway is exceeded the water flows along The Meadows to be picked up by road gullies which discharge into a 150mm diameter pipe at the side of number 34. This pipe increases in size to 225mm diameter beyond the school and then enters a large 900mm diameter pipe under the road.

The 'green' catchment draining towards Canada Drive has a 600mm diameter pipe as its primary outfall. This eventually enters the same 900mm diameter pipe that takes the water from the 'yellow' catchment and the rest of the village. The 900mm diameter drain tips out into the head of North Drain.

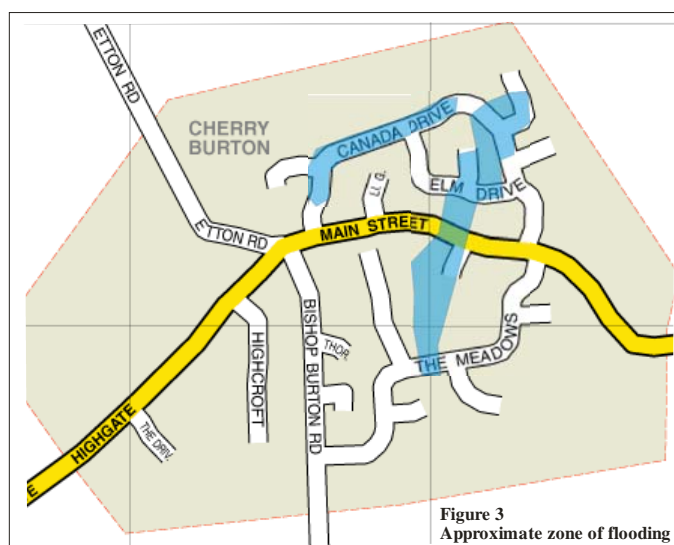
The diagram below shows the approximate extent of the flooding that occurred through the village. It is estimated that more than 60 properties were affected including the village school and shop.

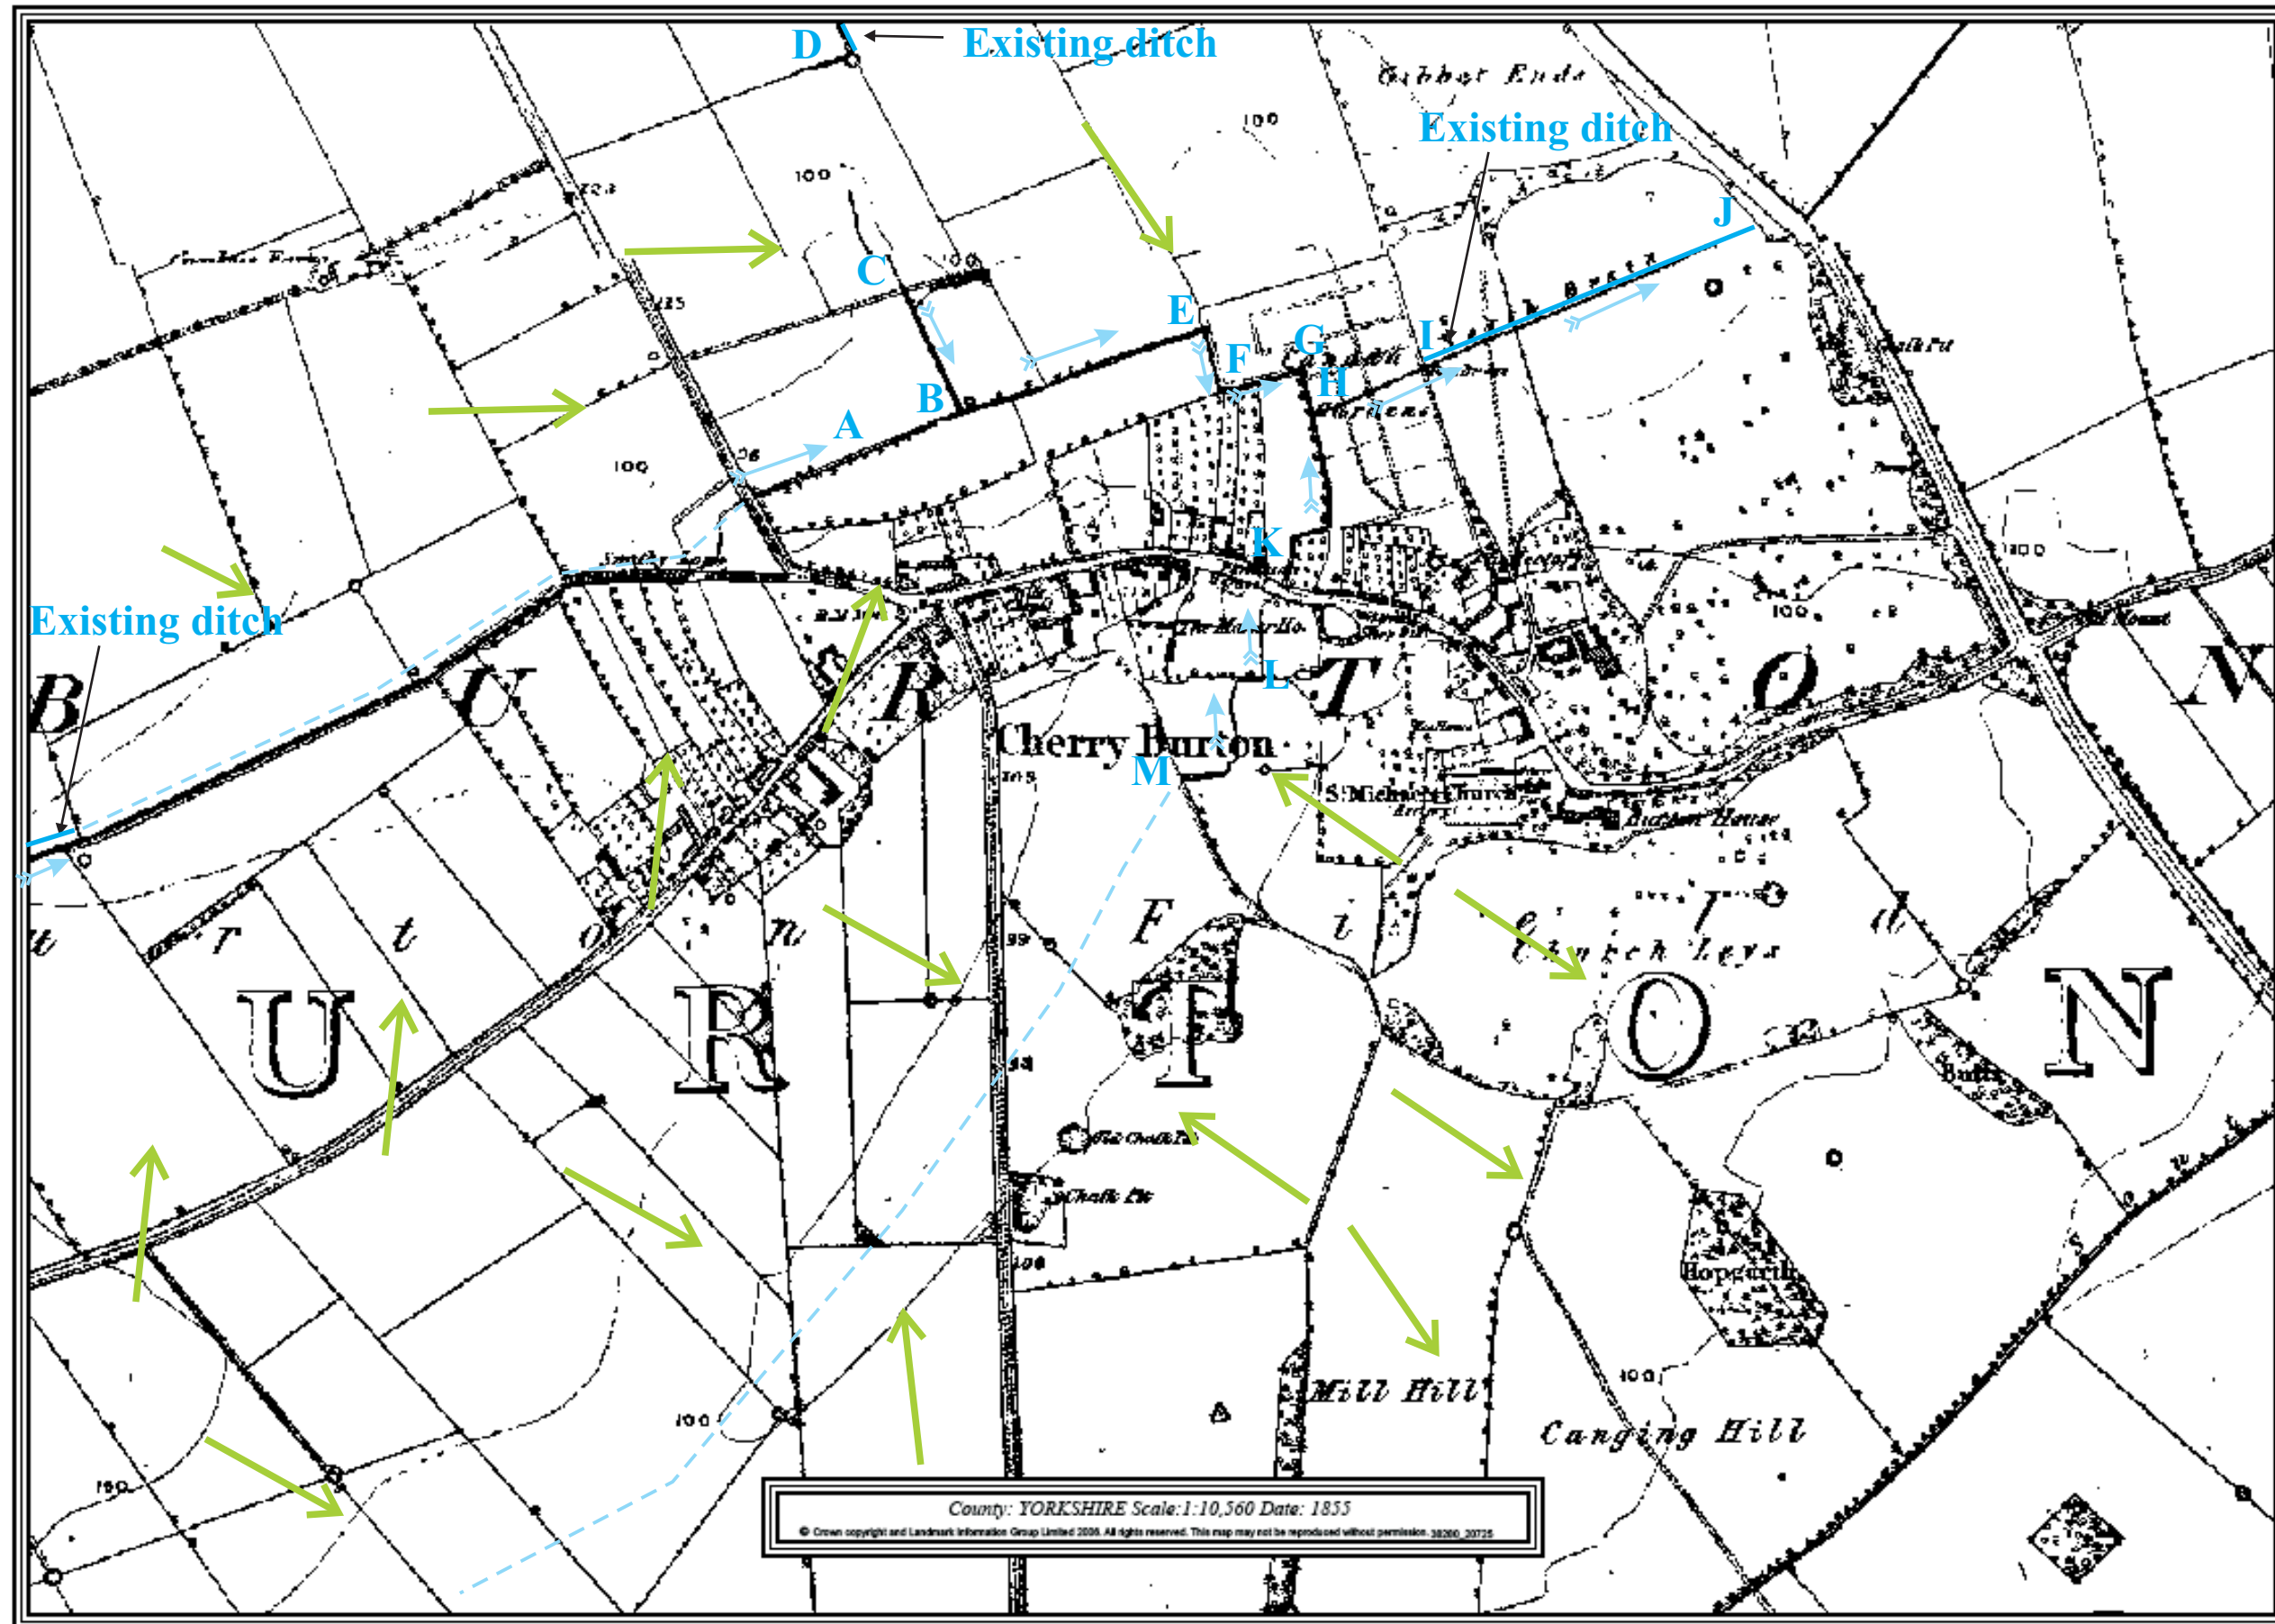
The plan at Appendix 1 shows the drainage through the village prior to the relatively recent housing developments. This plan is dated 1855 and shows quite clearly the existence of several open ditches. Other old maps are attached at Appendix 2. In particular a main ditch appeared to run all the way down the valley feature of the 'green' catchment and then skirted round the north of the village where it picked up a ditch from the railway before dog legging its way southwards towards North Drain. A similar feature is not seen along the valley of the 'yellow' catchment until it approached the village when an open ditch can be seen meandering towards and under the road near the aptly named Shop Dike. This ditch then dog legs northwards to meet North Drain.

It would appear that as the village has developed some of these ditches have been piped such that ditch A-H is the 600mm and K-H is the 900mm diameter surface water drains that exist today. Other ditches have not been maintained and are all but not existent.

Former ditch section A- H has been replaced with a 600mm dia pipe with the exception of a short section from E, through the garden of 122 Canada Drive which is recorded as a 150mm dia pipe.  
 Former ditch section K-I has been replaced with a 900mm dia pipe.  
 Former ditch section K-M has been realigned and replaced with a 150mm di pipe from The Meadows to the school and then a 225mm dia pipe from the school to point K
