No. 2031, Rev. II
ATA Code 25-00

EQUIPMENT/FURNISHINGS - NOTICE OF AVAILABILITY OF SHOULDER HARNESS KITS

Issued: June, 1985

Revised: September, 1990

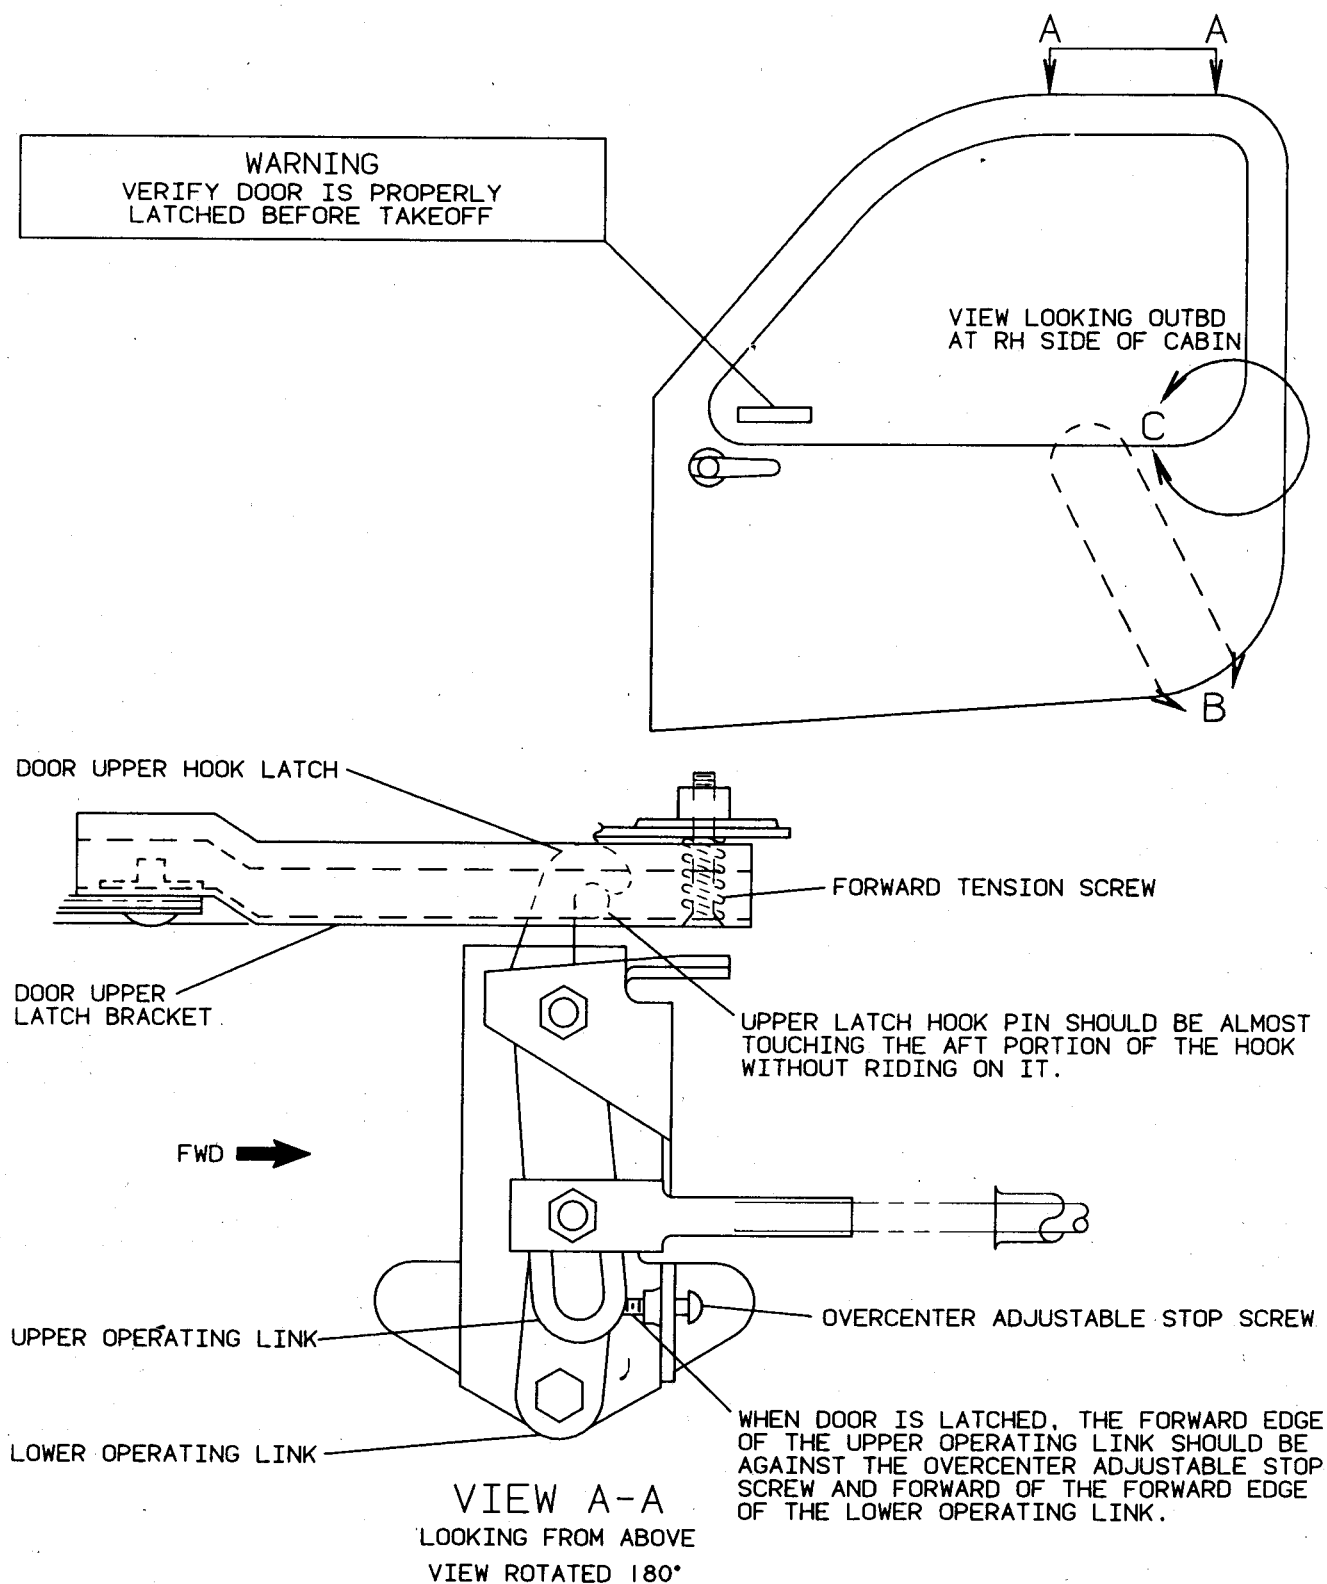
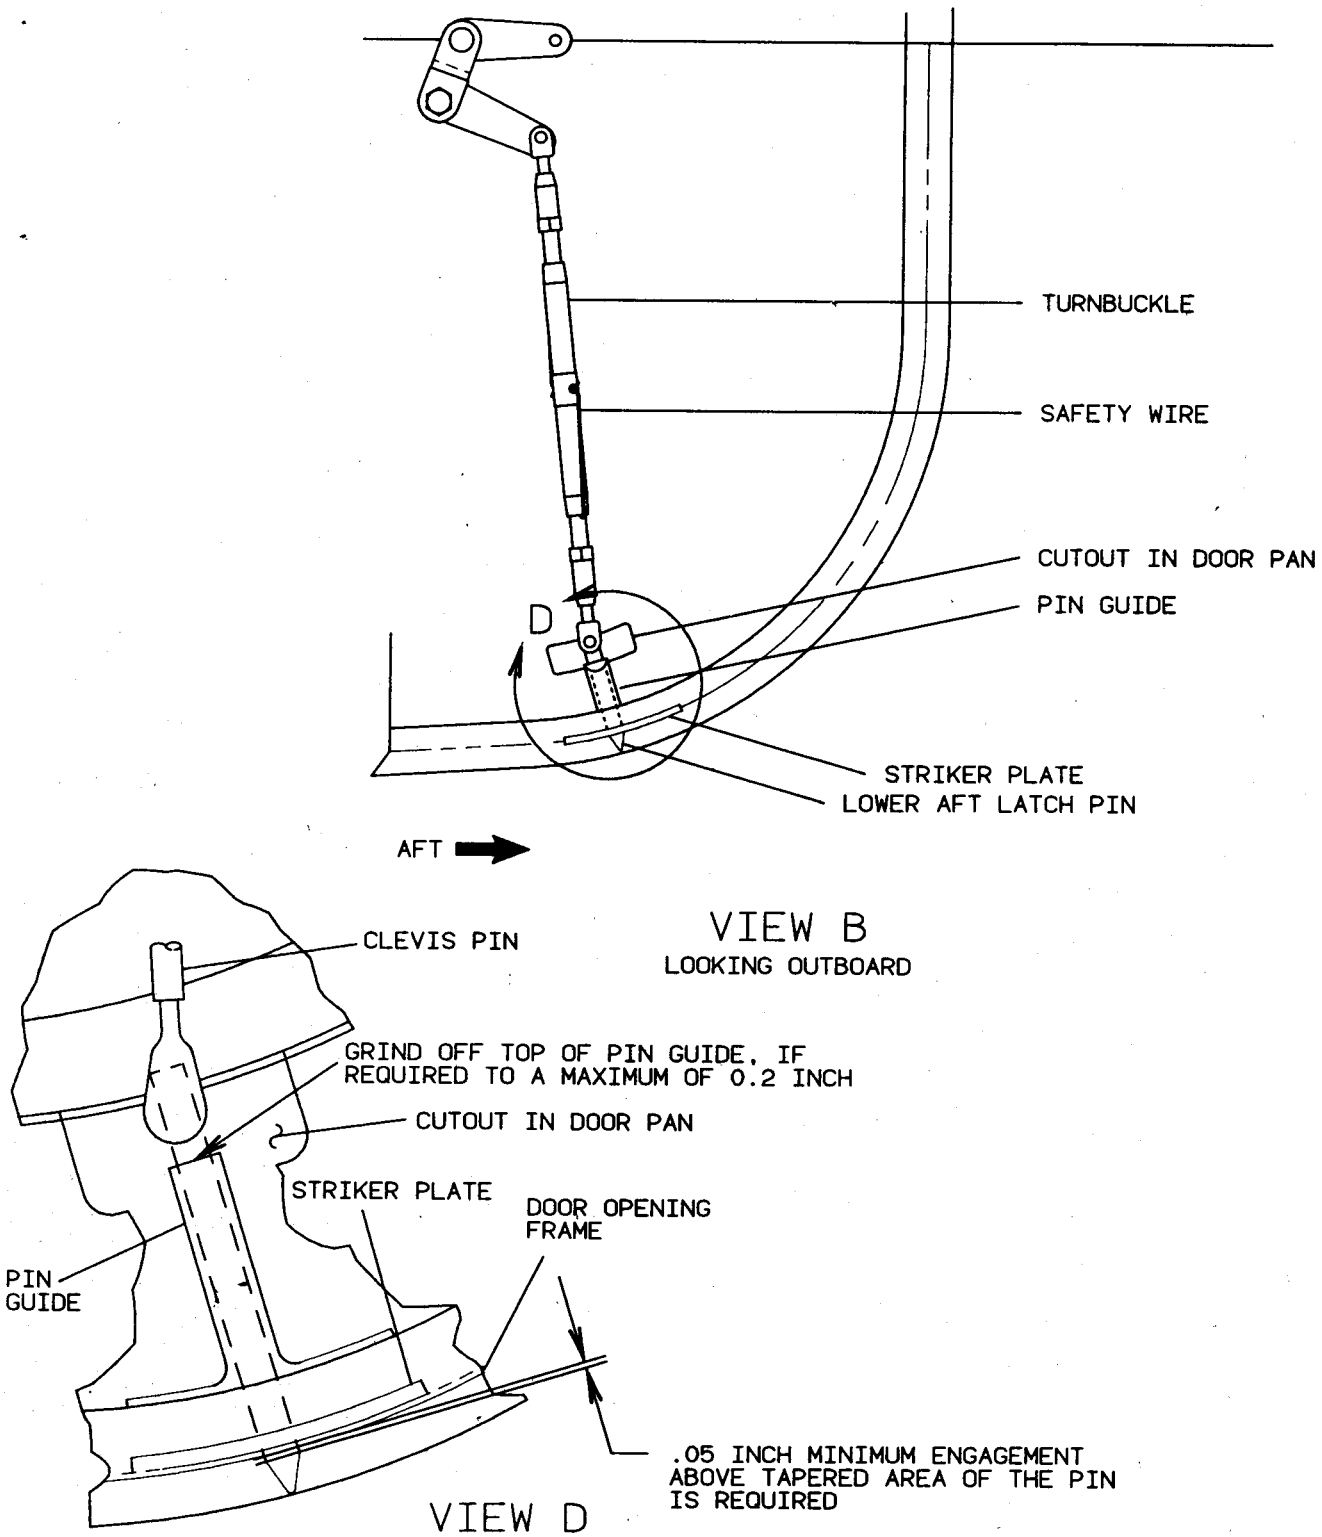
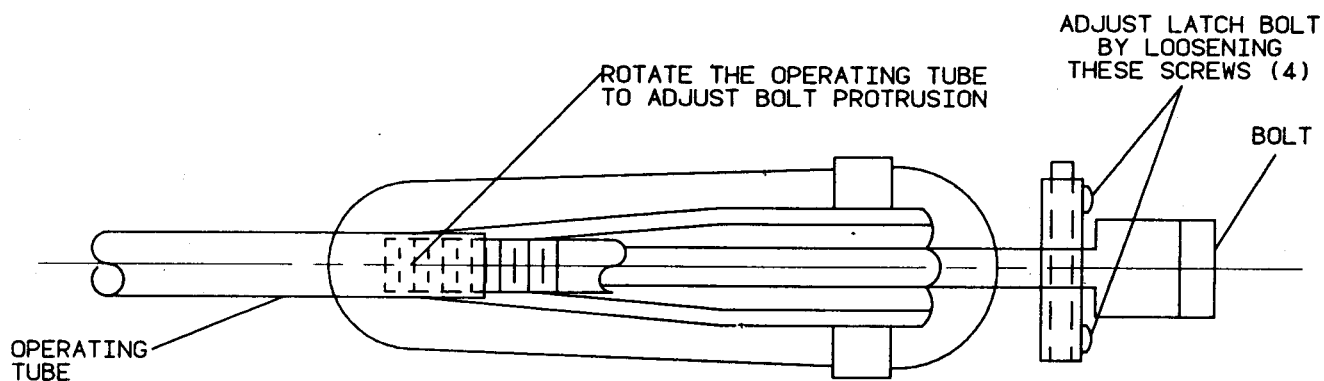
Cabin Door Latch Points
Figure 1

- The door is not airtight or watertight.
- The door is opening in flight.
- The door has recently been removed or repaired.

2. If any of the following conditions have been reported by the owner/pilot, inspect the cabin door for proper latching.

When this is done the outside handle may protrude up to 0.25 inch into the airstream, which is acceptable.

- 4) Reconnect the lower aft latch pin mechanism (if applicable) to the operating tube. Reconnect the operating tube to the inside door handle.

The aft latch bolt can be adjusted inboard or outboard by loosening the four retaining screws on the aft side of the door and moving the bolt inboard or outboard as necessary, and then tightening the four screws.

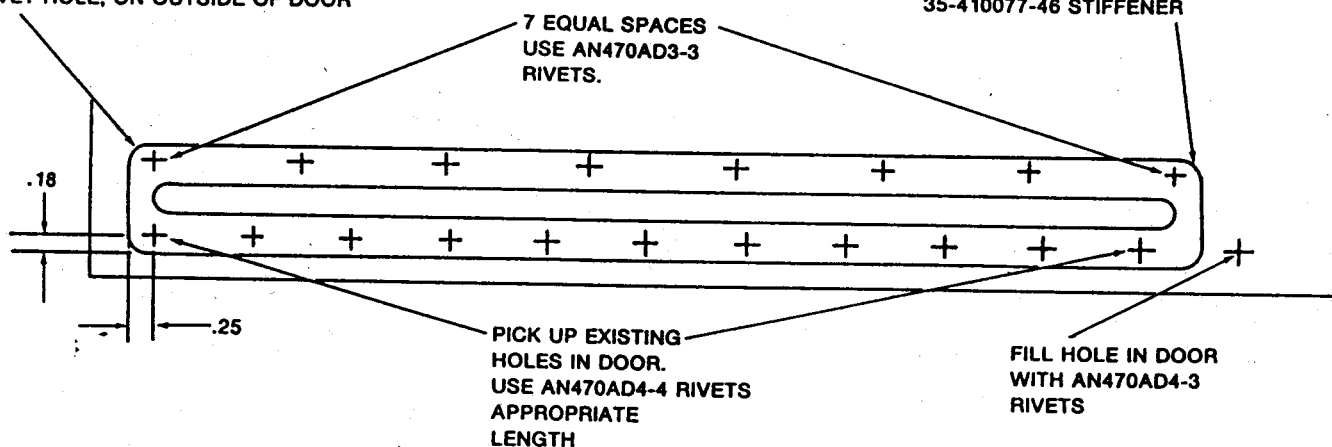
View Looking Inboard From RH side of Door
Figure 1

This Service Bulletin replaces the P/N 95-410031-23 stiffener angle. The stiffener is located at the aft end of the R. H. nose landing gear door, at the lower edge (with the doors open) on the inboard side of the door. The new stiffener, P/N 35-410077-46 will be put on the outboard side of the door.

2. Install a new P/N 35-410077-46 stiffener on the outboard side of the RH landing gear door. Pick up the row of open holes left by removing the P/N 95-410031-23 stiffener. This will be the lower row of rivets on the P/N 35-410077-46 stiffener. Use AN470AD4-4 rivets in the lower row as shown in the illustration.
3. Close the open hole located forward of the stiffener with an AN470AD4-3 rivet as shown in the illustration.
4. Lay out and drill a row of eight .098 -- .101 inch diameter holes for the upper row of rivets as shown in the illustration.
5. Use AN470AD3-3 rivets in this upper row of holes as shown in the illustration.

LOCATE STIFFENER, PER
DIM SHOWN FROM EXISTING
RIVET HOLE, ON OUTSIDE OF DOOR
