No. 2242, Rev. 1
ATA Code 27-30
Recurring Inspection

SUBJECT: FLIGHT CONTROLS - INSPECTION AND/OR REPLACEMENT OF MAGNESIUM ELEVATOR CONTROL FITTINGS

Issued: April, 1988

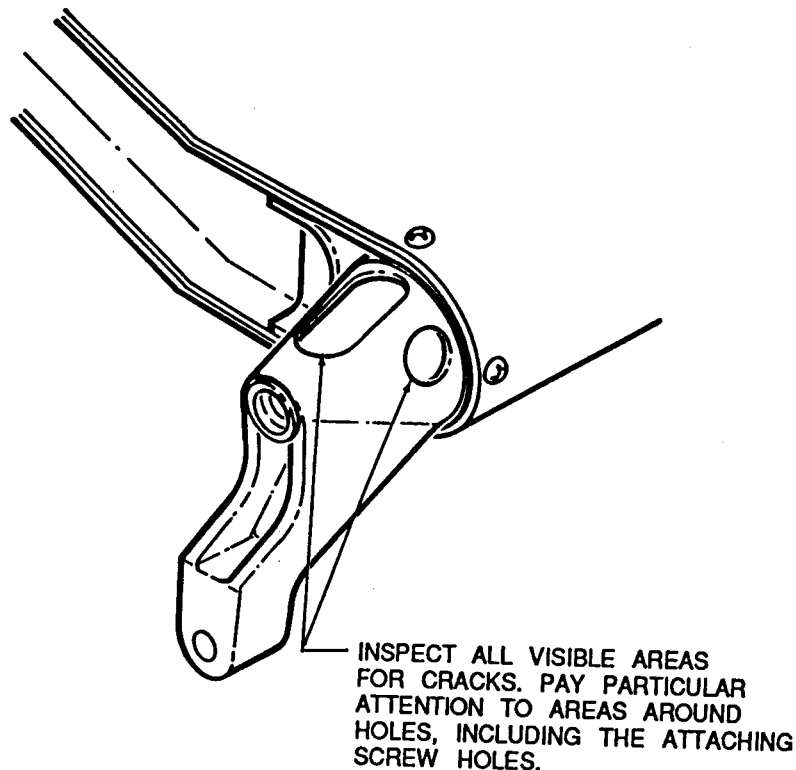
Beech Aircraft Corporation considers this to be a mandatory modification and a visual inspection of both elevator control fittings must be accomplished within 25 service hours after receipt of this Service Bulletin.

If the fittings are of magnesium construction and are not replaced, the visual inspection must be repeated at each 25 hour inspection interval until they are replaced with aluminum fittings.

1. Refer to Figure 1 and inspect both elevator control fittings as shown.

Beech Aircraft Corporation recommends that even if the existing magnesium elevator control fitting is in an acceptable condition, it should be replaced with an aluminum elevator control fitting at this time. Beech Aircraft Corporation supplies only aluminum control fittings.

Upon installing a new elevator control fitting, ensure that the fitting is clocked to the correct degree prior to drilling the holes.

MODEL	CLOCKING POSITION, WITHIN
33 Series Airplanes	90°
Model 45 Series - T34A & T34B	67° 20 minutes
35 through J35	67° 20 minutes
K35 through V35B	71° 20 minutes (LH) 67° 20 minutes (RH)
36 through A36	88°
A36TC (EA-1 through EA-272)	88°
B36TC (EA-273 through EA-328)	83°
B36TC (EA-329 and after)	81°
55 Series Airplanes 56TC, 58	90°
58P, 58TC, T42A, 95 Series Airplanes	90°

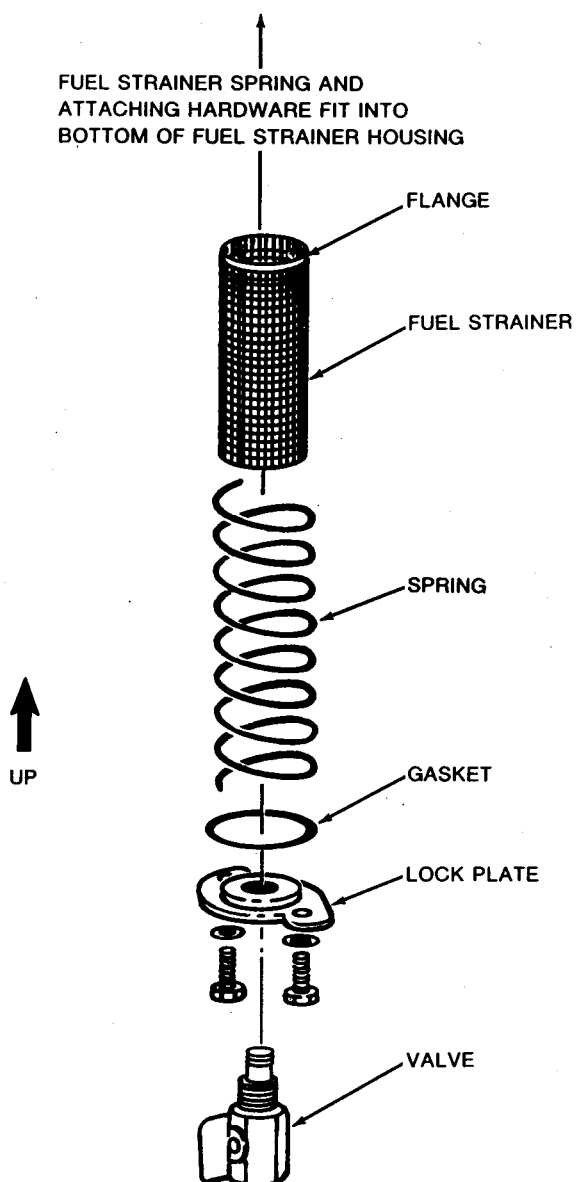
Fuel Strainer Components
Figure 1

This Service Bulletin is being issued to prevent the possibility of the fuel strainer screen being installed upside down, resulting in unfiltered fuel entering the engine, which could cause power interruption. A caution placard is offered for aircraft previously produced by Beech Aircraft Corporation.

IT IS POSSIBLE TO INSTALL THE FUEL STRAINER UPSIDE DOWN. The strainer must have been inserted into the fuel strainer housing prior to insertion of the spring. The strainer has a flange which

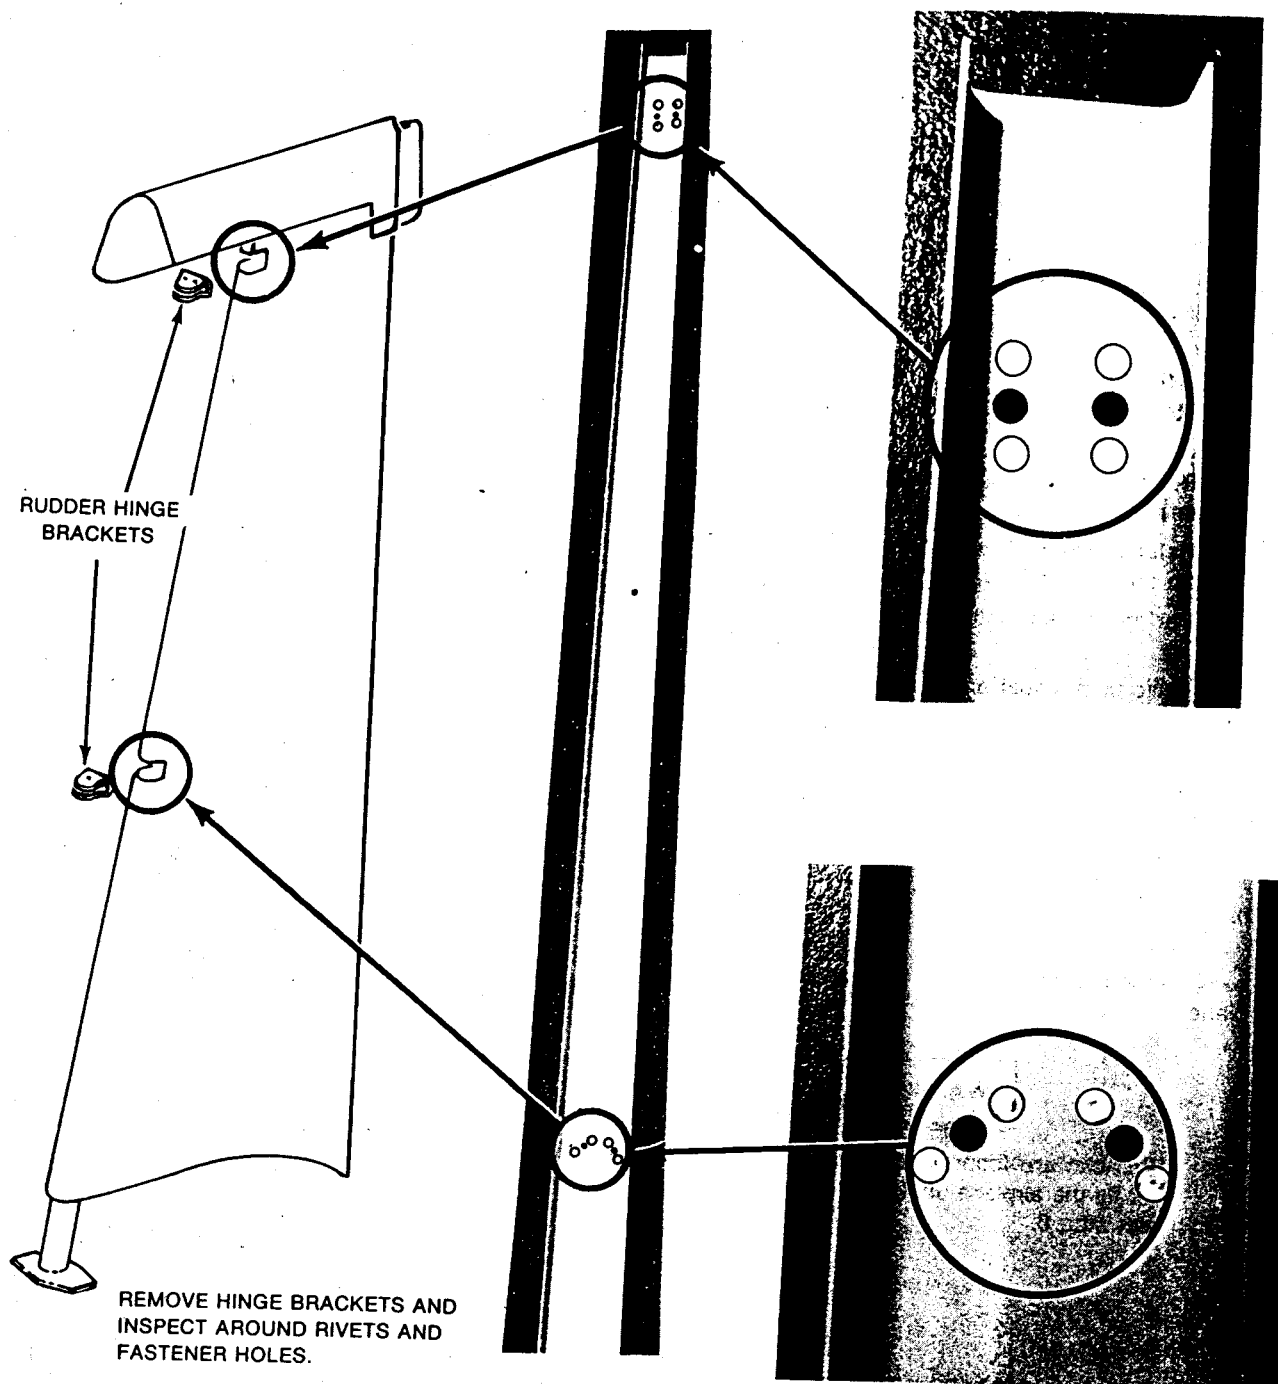
This Service Bulletin is being issued to provide an inspection which will determine if there are any cracks in the rudder forward spar. Cracks in the rudder spar could result in loss of airplane control.

1. Refer to the appropriate shop/maintenance manual and remove the rudder from the airplane.
2. Refer to Figure 1 and remove the two hinge brackets from the rudder forward spar.
3. Perform a visual inspection of the entire rudder and spar.
4. Perform a visual and a dye penetrant inspection, using visible dyes, on the spar, in the areas around the hinge brackets. Pay particular attention to the following areas:
 - a. Areas around rivets which are used to attach the nutplates.
 - b. The holes for the screws which attach the hinge brackets to the spar.
5. If no cracks are found install the hinge brackets back on the rudder and install the rudder back on the airplane.

If cracks are found in the rudder spar, do not fly the airplane until you have complied with step 6.

- a. If cracks are found in any area of the rudder spar, Kit No. 33-6001-1 S must be installed, or a new rudder assembly installed. Refer to the MATERIAL Section for the part number of a new rudder assembly.

- b. When inspecting the rudder, open the inspection covers adjacent to the upper and center hinges. Inspect ribs, spar, hinges, and all rudder components in the areas of the hinges for attachment security, cracks, and general condition using a flashlight and mirror.

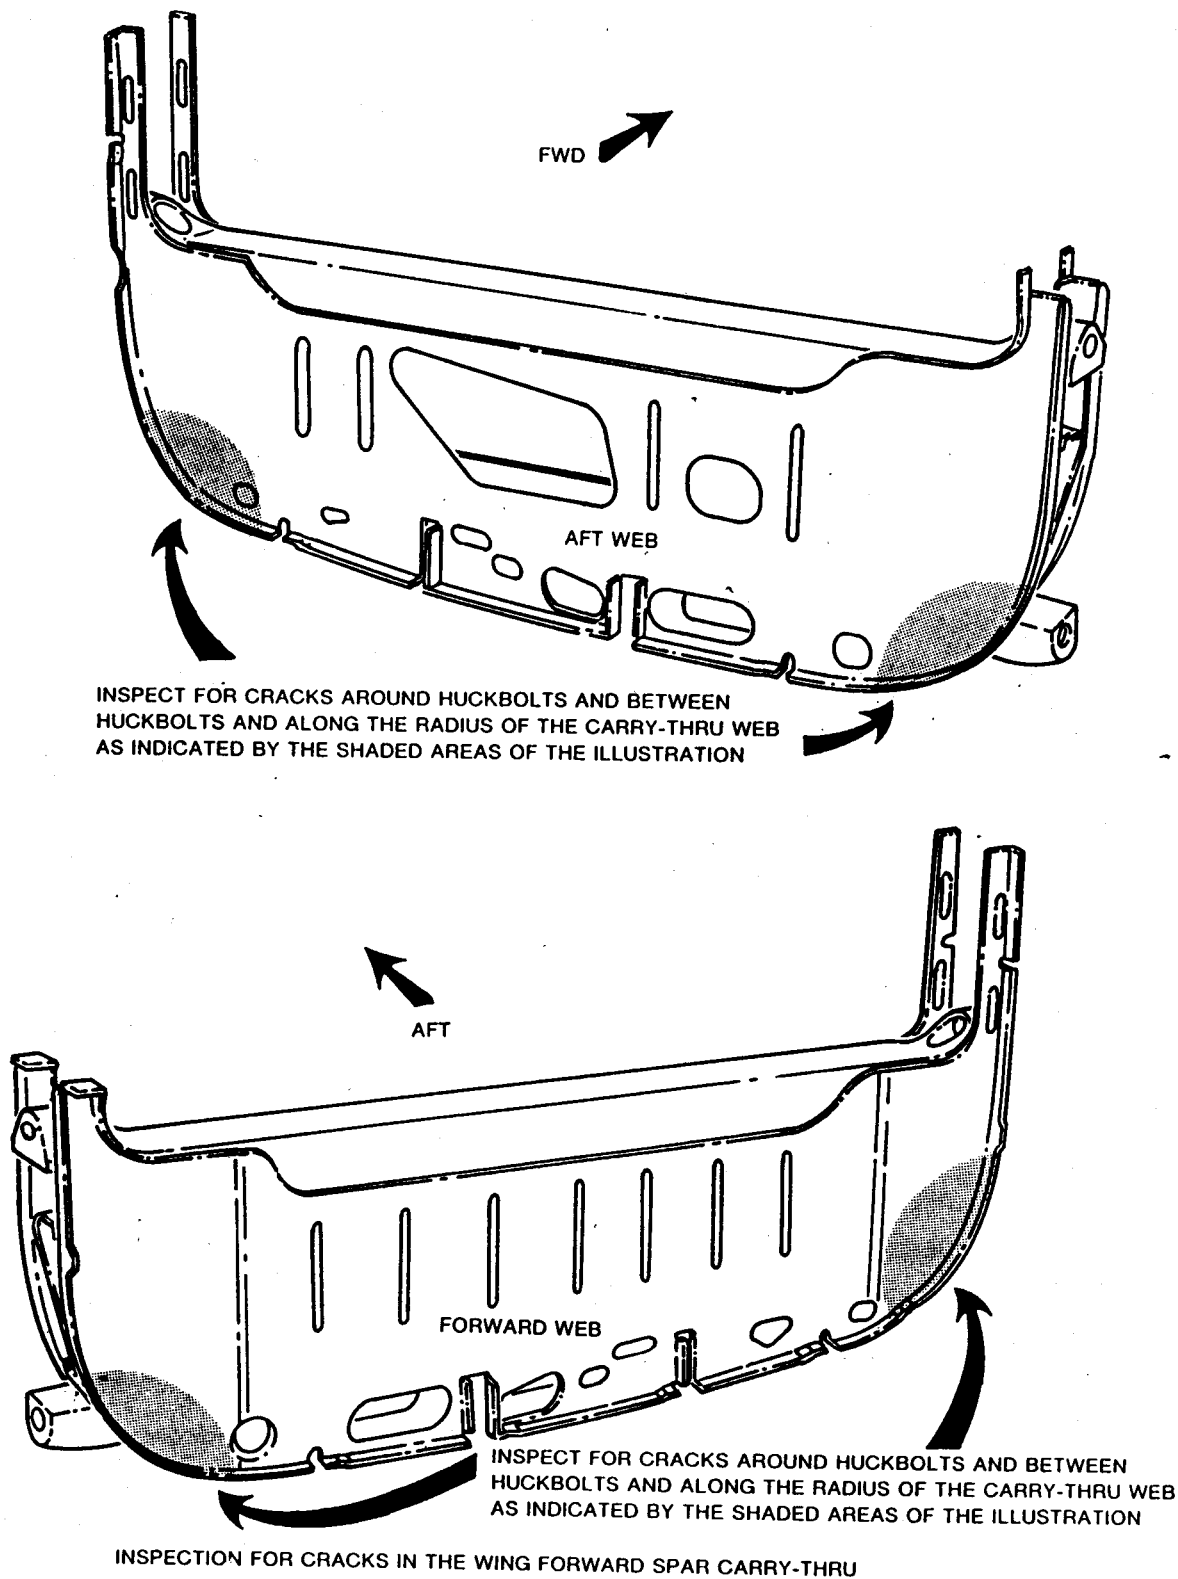
Inspection for Cracks in the Wing Forward Spar Carry-Thru
Figure 1

REASON: This Service Bulletin is being issued to provide inspection and repair information relating to forward wing spar carry-thru structure forward and aft frames. Reports of frame (web) cracking have been received on in-service airplanes. If these cracks are detected at any time, the repairs described in this Service Bulletin should be applied.

1. Remove the pilot's and copilot's seats and the carry-thru cover to obtain access to the front spar carry-thru structure.
2. Thoroughly clean the forward and aft frames (webs) of the front spar carry-thru structure in the areas shown in Figure 1.
3. Perform a visual inspection of the area cleaned in step 2 for evidence of cracks.
4. Perform a dye penetrant inspection, using visible dyes, of the area cleaned in step 2 for evidence of cracks.

Areas shown in Figure 1 that have cracks that fall within allowable limits and that have not been modified by a doubler must be inspected or repaired as indicated in this Service Bulletin on an individual basis.

- 1) A crack up to 2.25 inches in length must be stop drilled #30 at crack ends and inspected for progression at each annual inspection or every 200 hours, whichever occurs first. One stop drilled crack per left side and one stop drilled crack per right side of the wing forward spar carry-thru structure bend radius are permissible, if neither one exceeds 2.25 inches.

- 2) A crack between 2.25 inches and 4.0 inches in length shall be stop drilled #30 at crack ends. The area is to be repaired per the applicable P/N 36-4004 Kit within the next 100 flight hours.

- 3) A crack exceeding 4.0 inches in length shall be repaired prior to further flight per the applicable P/N 36-4004 Kit.

- 1) A crack less than 1.0 inch in length or one crack between two fasteners does not require immediate repair, but shall be inspected for progression at each annual inspection or every 200 hours, whichever occurs first. A crack emanating from one fastener in two directions is considered to be one crack. **Do not stop drill, due to the possibility of damaging structure behind web face.** One crack per left side and one crack per right side of the wing forward spar carry-thru structure web face are allowed, if neither one exceeds 1.0 inch.

- 2) A crack more than 1.0 inch in length shall be repaired per the applicable P/N 36-4004 kit, within the next 25 flight hours.

- 3) A crack passing through two fasteners and extending beyond for more than 0.5 inch on either end shall be repaired prior to further flight, per the applicable P/N 36-4004 kit.

6. Repair all cracks per the appropriate P/N 36-4004 Kit if the limitations in Steps "5a", "5b", or "5c" are exceeded.

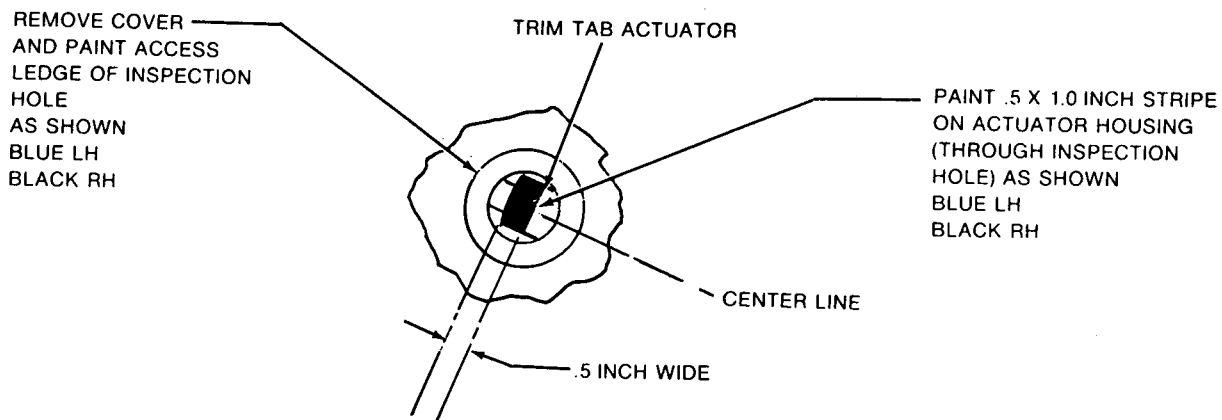
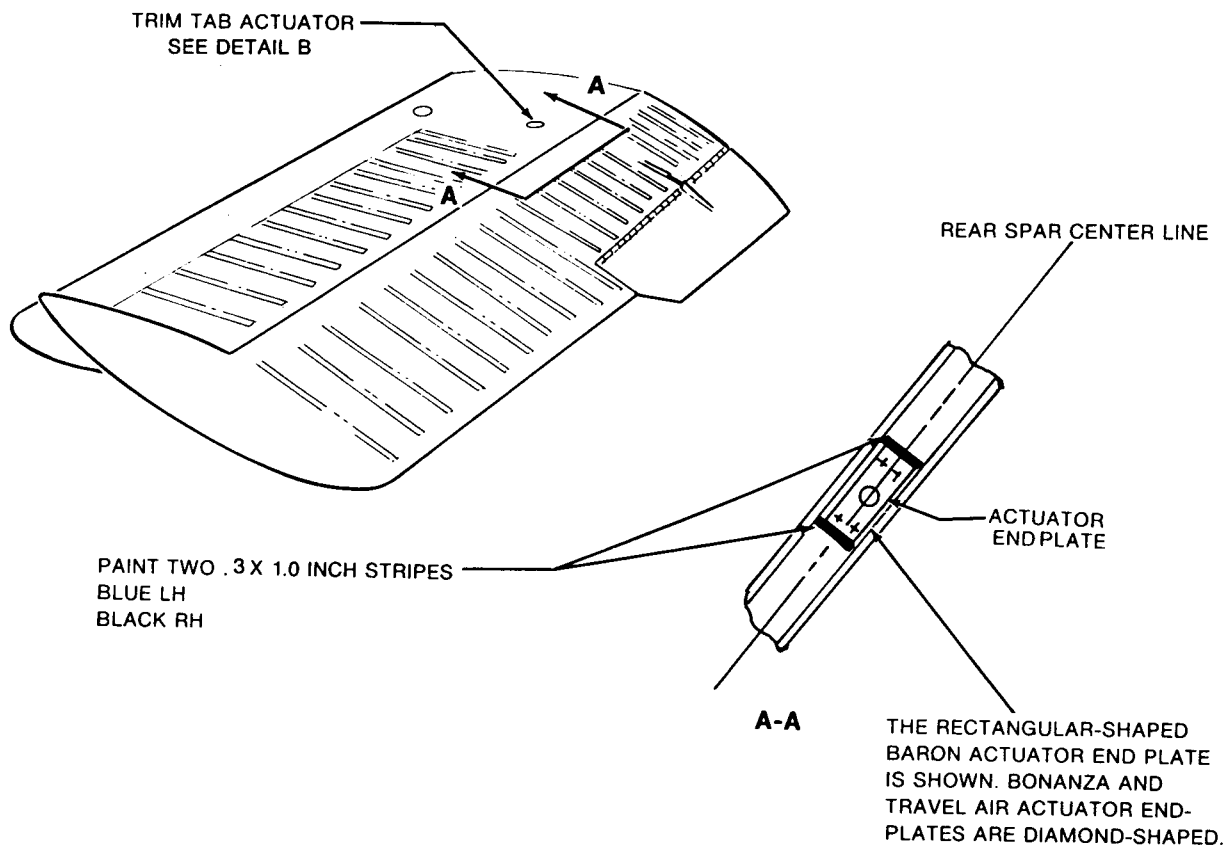
**Areas to be Color Coded
Figure 1**

REASON: This Service Bulletin is being issued to reduce the probability of elevator tab actuators being installed incorrectly. The factory-installed elevator trim tab actuators must not be interchanged between the right and left horizontal stabilizers when they are reinstalled after removal for any reason. Reversing the actuators reverses the direction of tab deflection and, in turn, airplane longitudinal trim direction. In this situation a pilot's intention to induce airplane nose-up trim would actually result in an inadvertent nose-down trim condition that could result in an uncontrollable airplane attitude. The instructions for actuator identification contained in this Service Bulletin are intended to reduce the probability of unintentionally switching the actuators upon installation.

1. Paint two blue stripes approximately 0.3 inch wide by 1.0 inch long at right angles to the stabilizer spar cen-

terline next to each end of the LH elevator trim tab actuator endplate, as shown in Figure 1.
