All Commercial BEECHCRAFT Models

No. 2405
ATA Code 11-00
Recurring Inspection

SUBJECT: PLACARDS AND MARKINGS - INSPECTION TO VERIFY INSTALLATION AND CONDITION OF ALL INTERIOR AND EXTERIOR PLACARDS AND MARKINGS.

SUBJECT: FLIGHT CONTROLS - INSPECTION OF FLAP DRIVE CABLE/FLAP DRIVE MOTOR COUPLING CONNECTION

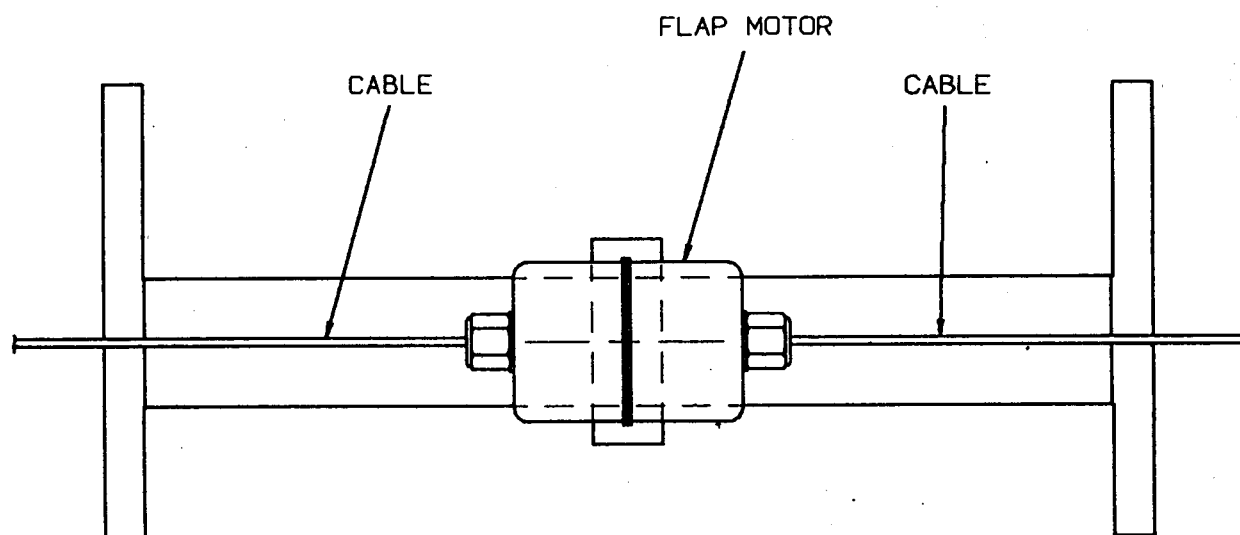
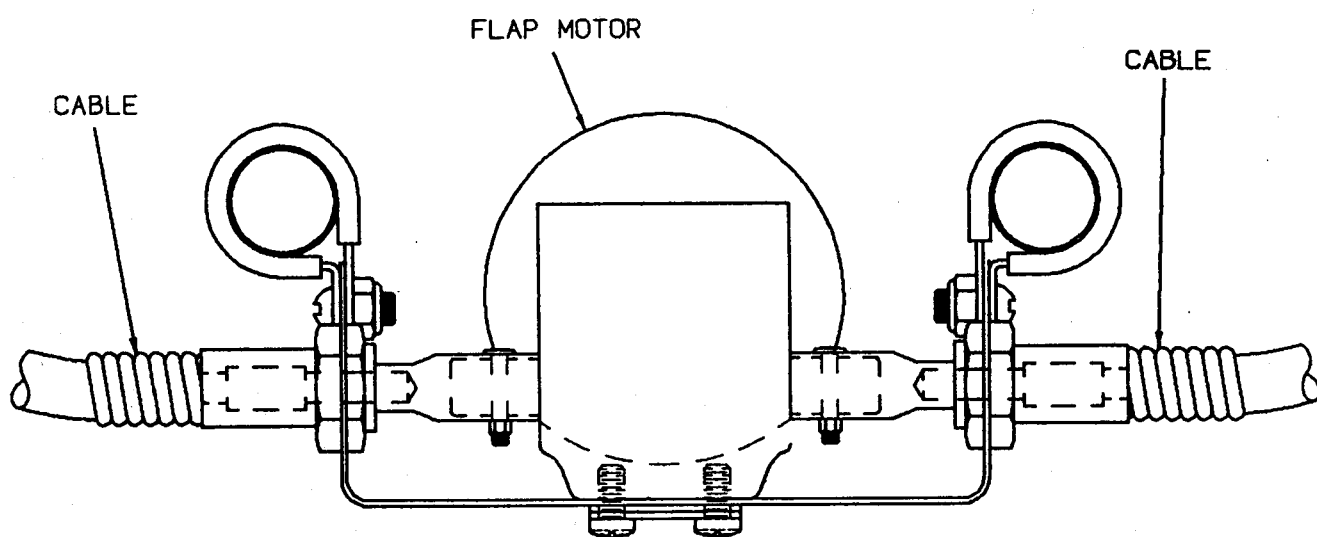
**Flap Drive Cable/Flap Drive Motor Coupling Connection
Figure 1**

- a. The flap drive cable configurations shown in Figure 1 are not affected by this Service Bulletin. If the airplane is configured as shown in View A or View B of Figure 1, proceed as follows:

AIRPLANES WITH EITHER OF THESE
CONFIGURATIONS ARE NOT AFFECTED
BY THIS SERVICE BULLETIN.

- 1) Replace all seats and equipment that were removed to gain access to the flap drive motor.
 - 2) Restore electrical power to the airplane and ensure that the flap system operates properly.

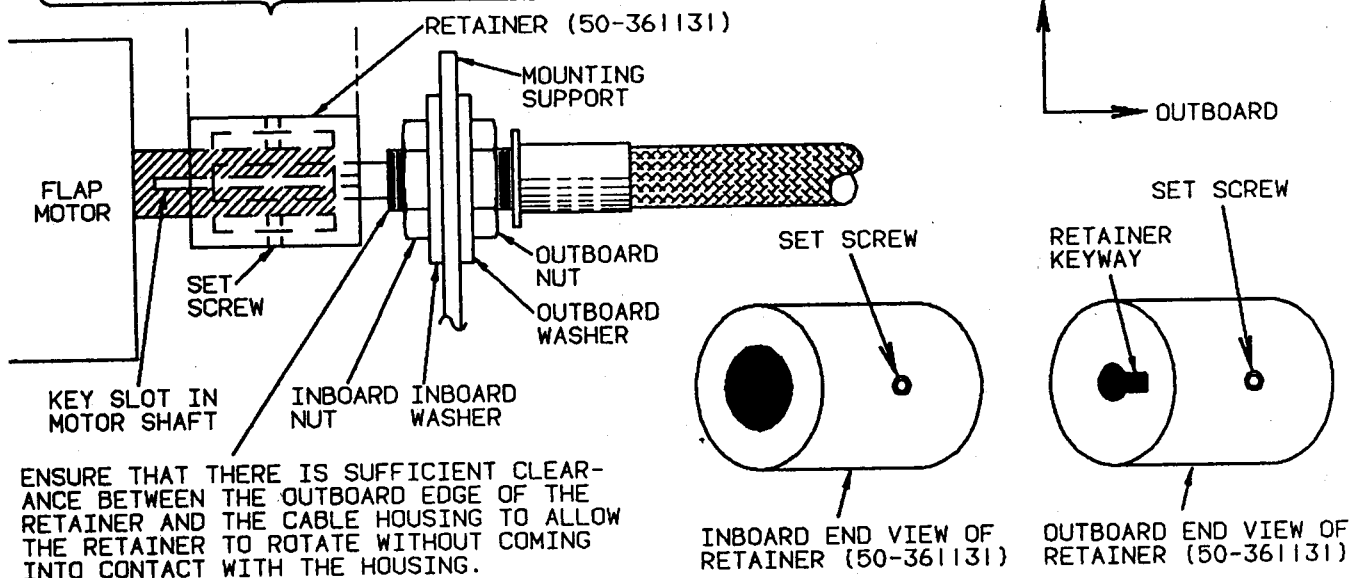
Flap Drive Cable/Flap Drive Motor Coupling Connection
Figure 2

REASON: This Service Bulletin is being issued to provide an inspection and instructions for proper attachment of the flap drive cable to the flap motor drive shaft. Improper attachment may result in a split flap condition.

- b. If the airplane is configured as shown in Figure 2, proceed to Step 5.
5. Verify that retainers are installed and cable housings and hardware are arranged as shown in Figure 2. Ensure that the keyway slot is rotated 90° relative to the slot in the motor drive shaft. Clearance must exist between the outboard end of the retainer and the inboard

MODEL 60 AIRPLANES ARE EQUIPPED WITH A SPRING IN THIS LOCATION. ENSURE THAT THE SPRING IS INSTALLED.

AIRPLANES WITH THIS CONFIGURATION ARE AFFECTED BY THIS SERVICE BULLETIN.

end of the flap cable housing. If retainers are not installed and/or if flap cable housings need to be repositioned, proceed in accordance with the FLAP DRIVE CABLE CONNECTION instructions in this Service Bulletin. Refer to the applicable Shop/Maintenance Manual for instructions to disconnect the flap cables from the flap motor drive shaft.

1. Connect the LH and RH flap drive cables to the flap drive motor as follows, using Figure 2 for component locations:
 - a. Install the outboard nut and washer as far as it will go on the threaded portion of the flap cable.

- b. Insert the retainer through the mount support and onto the motor shaft as far as it will go. Align the retainer keyway with the key slot in the flap motor drive shaft and tighten one set screw temporarily.

- c. While inserting the flap cable through the mount support, install the inboard washer and nut. Fully install the cable through the retainer and into the motor drive shaft until the keyway is just past the key slot in the retainer.

- d. Loosen the set screw that was tightened in Step b. Ensure that the retainer is still installed on the motor shaft as far as it will go and rotate the retainer 90°.

- e. Keep inboard pressure on the retainer and tighten both retainer set screws.
 - f. Secure the flap drive cable to the mount support by tightening the nuts. Tighten the inboard nut and ensure that there is sufficient clearance between the c

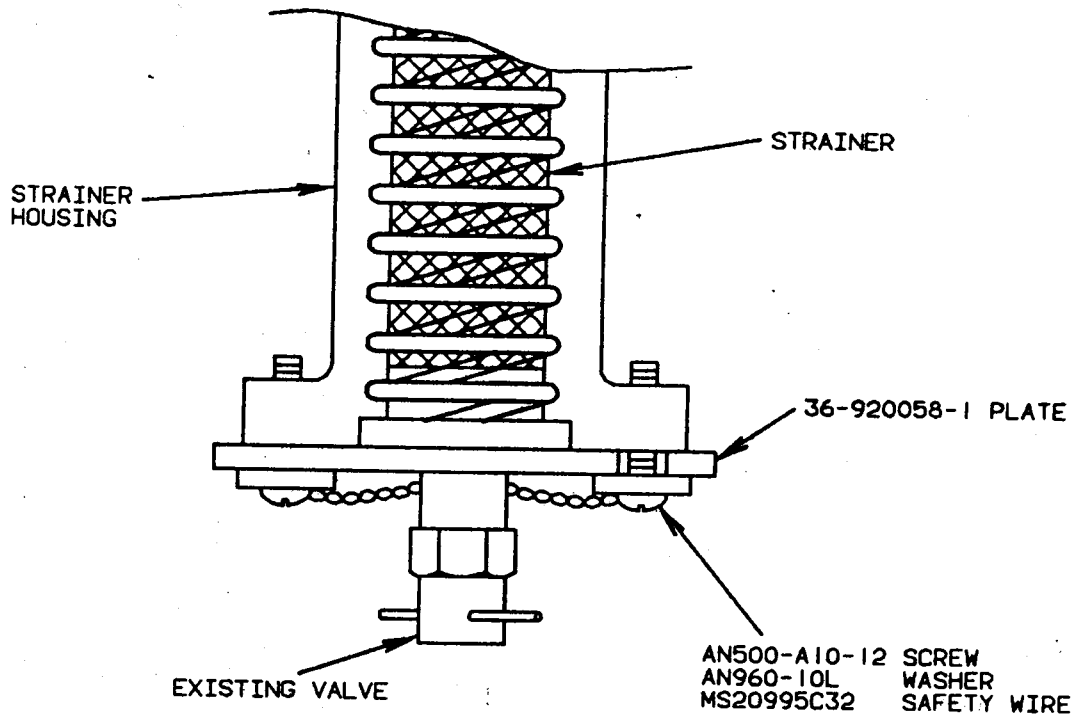
Figure 1

This Service Bulletin is being issued to replace the fuel strainer spring and housing plate with an improved housing plate. The new plate and spring come as one assembly and will prevent the strainer screen from being installed incorrectly. An incorrectly installed strainer screen may allow unfiltered fuel to enter the fuel system. Unfiltered fuel may contaminate the engine fuel system and cause engine power interruptions.

the spring (attached to the new plate) and attach the plate to the strainer housing using the two screws and washers which were removed in Step 3. Safety the two screws with P/N MS20995C32 safety wire (obtain locally).

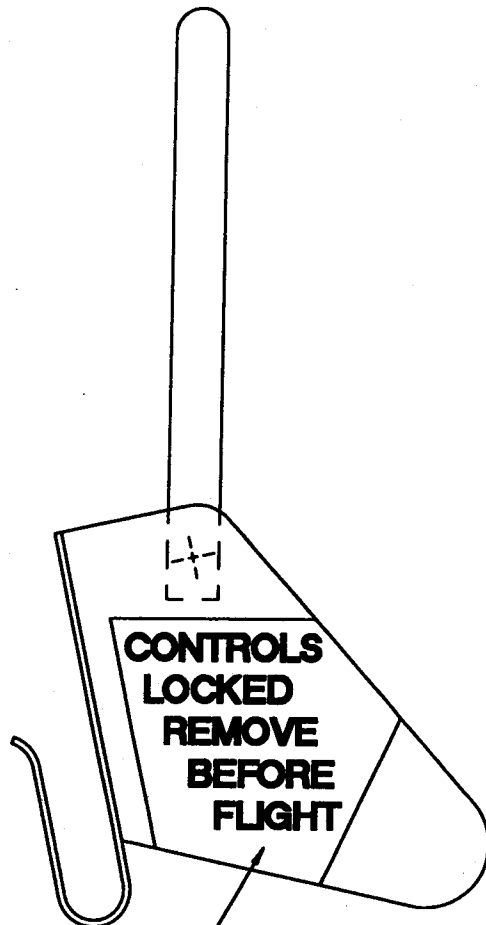
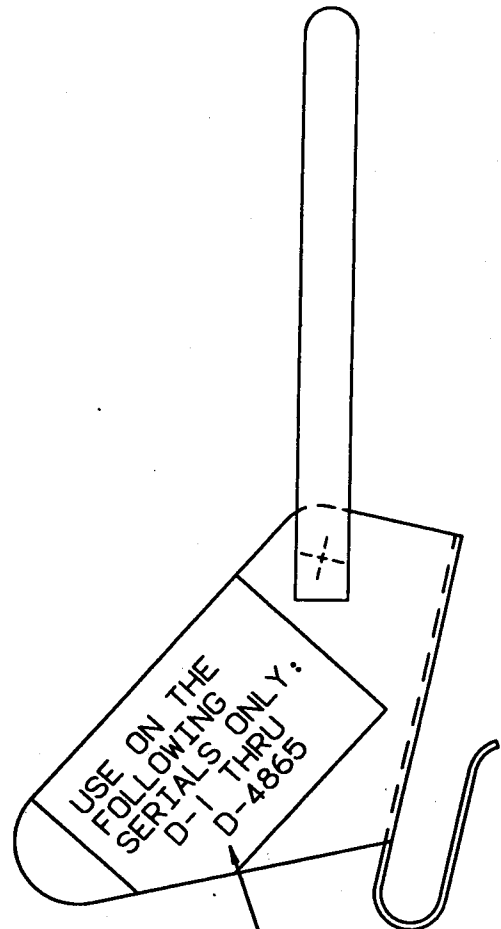
Control Gust Lock Modification/Replacement
Figure 1

REASON: This Service Bulletin is being issued to modify an existing control gust lock and to announce the availability of two improved control gust locks. Precautionary placards that identify applicable airplane serial numbers and remind pilots to remove control gust locks before flight are being added to existing control gust locks that correspond to Bonanza 35 series airplane serials D-1 through D-4865. Two improved control gust locks that prevent throttle movement out of idle and include the precautionary placards mentioned previously have been developed to replace the existing control gust locks on the remaining Bonanza series airplane serials affected by this Service Bulletin. Beech Aircraft Corporation is taking this action because of continuing reports of incidents and accidents, involving Bonanza airplanes, in which the pilot attempted take-off with the control gust lock installed.

35-524190 CONTROL GUST LOCK
(ORIGINAL PART - PLACARDS MUST BE ORDERED SEPARATELY)
35-524190-3 CONTROL GUST LOCK (REPLACEMENT PART - PLACARDS INCLUDED)

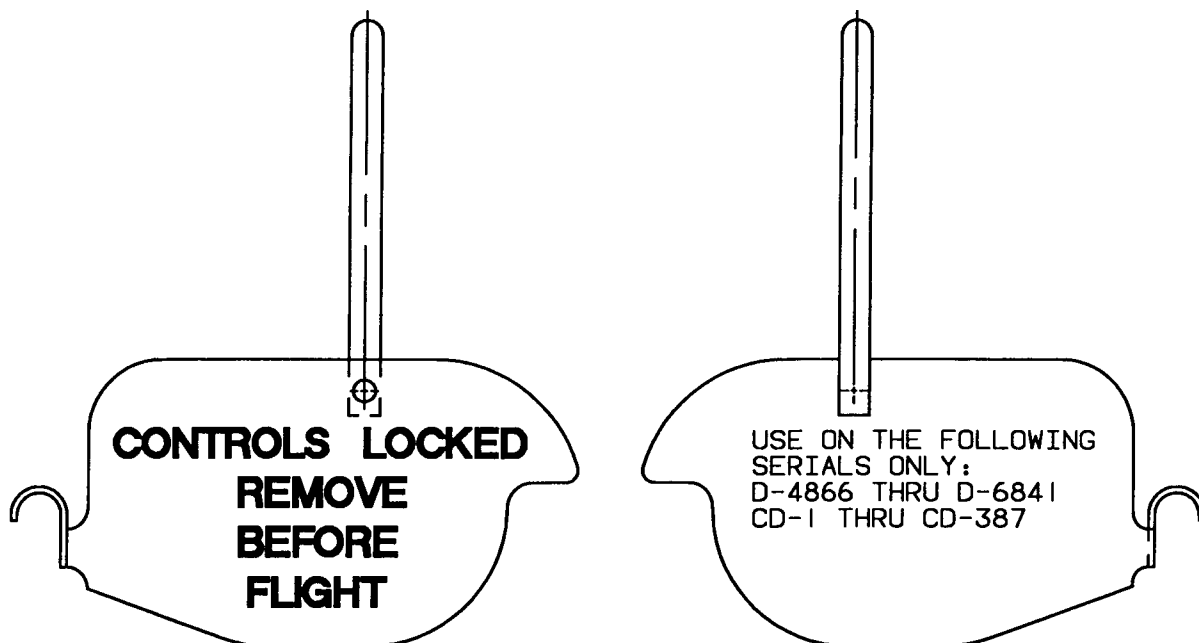
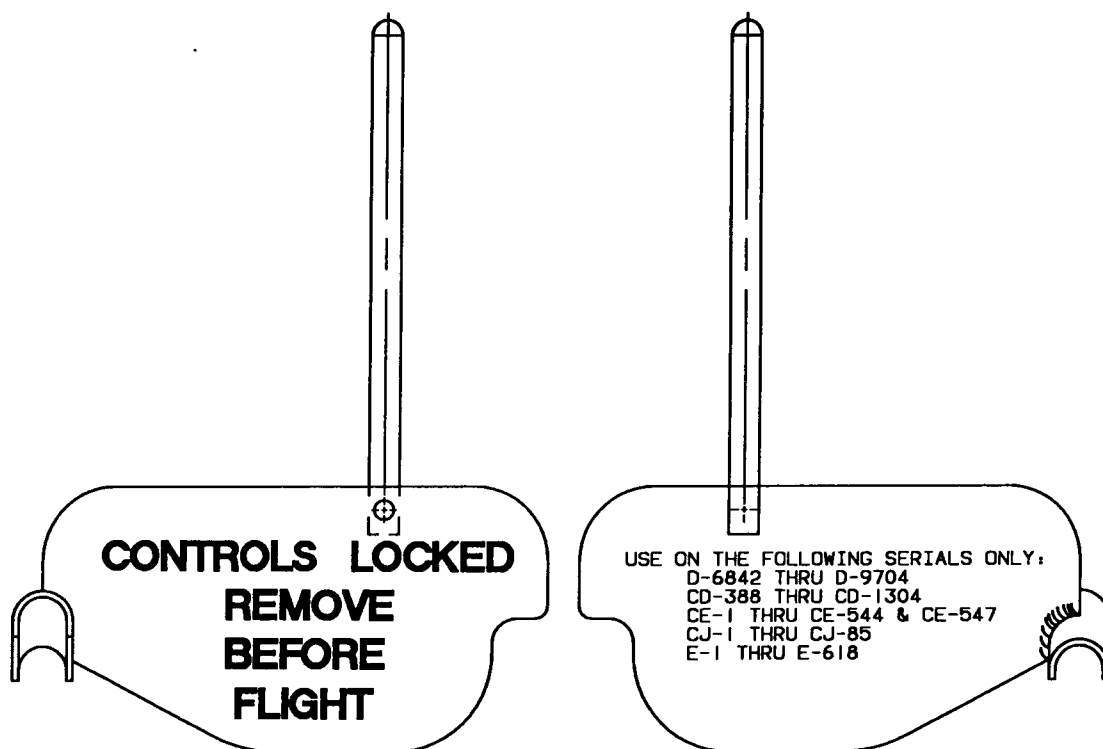
**Control Gust Lock Replacement
Figure 2**

35-590127-1 CONTROL GUST LOCK
(REPLACES 35-590081 CONTROL GUST LOCK)

35-590128-1 CONTROL GUST LOCK
(REPLACES 35-590103 CONTROL GUST LOCK)

Refer to Figure 2 and install the P/N 35-590127-1 or P/N 35-590128-1 control gust lock as applicable.

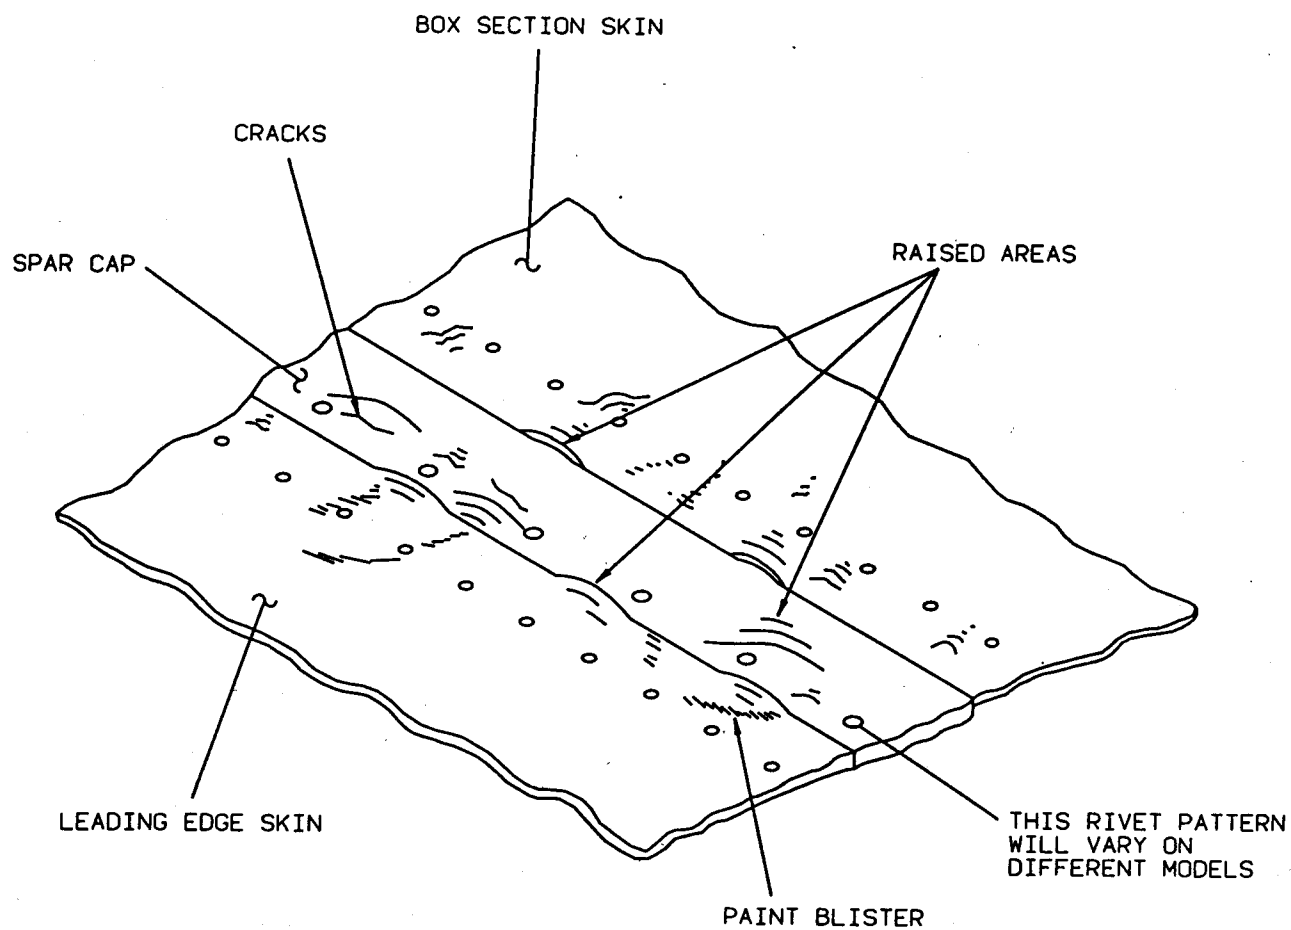
Typical Section of the Spar Cap to be Inspected
Figure 1

1. Wash all exposed areas of the upper and lower spar caps using normal cleaning procedures.
2. Visually inspect all exposed areas of the upper and lower spar caps for paint blisters, raised areas and/or unevenness and cracks in the metal. Paint blisters could be caused by corrosion, therefore, if blisters are detected during the visual inspection, the area of the blister should be examined closely for unevenness and/or raised areas and cracks in the metal. The exposed areas of the spar caps are extruded flat, therefore, areas of unevenness and/or raised areas on the spar caps could indicate corrosion and should be considered suspect areas. See Figure 1.

THIS ILLUSTRATION REPRESENTS A TYPICAL SECTION OF THE SPAR CAP TO BE INSPECTED FOR INDICATORS OF POSSIBLE CORROSION. ALL INDICATORS ARE SHOWN IN ONE AREA AND ARE EXAGGERATED FOR CLARITY. ANY ONE OR ANY COMBINATION OF THE INDICATORS ARE CAUSE FOR FURTHER INVESTIGATION.

3. If during visual inspection, any build up of a whitish, salt-like, non-metallic substance is detected, the area should be examined carefully, as this is indicative of corrosion. However, wax or paint that may be trapped between the edge of the skin and the exposed section of the spar cap should not be interpreted as corrosion.
4. If corrosion is detected:

Contact Beech Aircraft Corporation Customer Support Department for disposition, at TELFAX No. (316) 676-8027, International TELEX No. 203603, (Wichita, Kansas 67201), and report the location and extent of the corrosion. Beech Customer Support will then advise how to proceed.
