SERVICE BULLETIN

Beech**ATA CODE 11-30****TITLE: PLACARDS AND MARKINGS - INSTALLATION OF FUEL SELECTOR PLACARD****SYNOPSIS OF CHANGE**

This Service Bulletin is being issued to add placards to the fuel selector because Raytheon Aircraft Company has received reports of incidents and accidents involving Beech piston airplanes in which engine stoppage may have been caused by incorrectly positioning the fuel selector between tank detents.

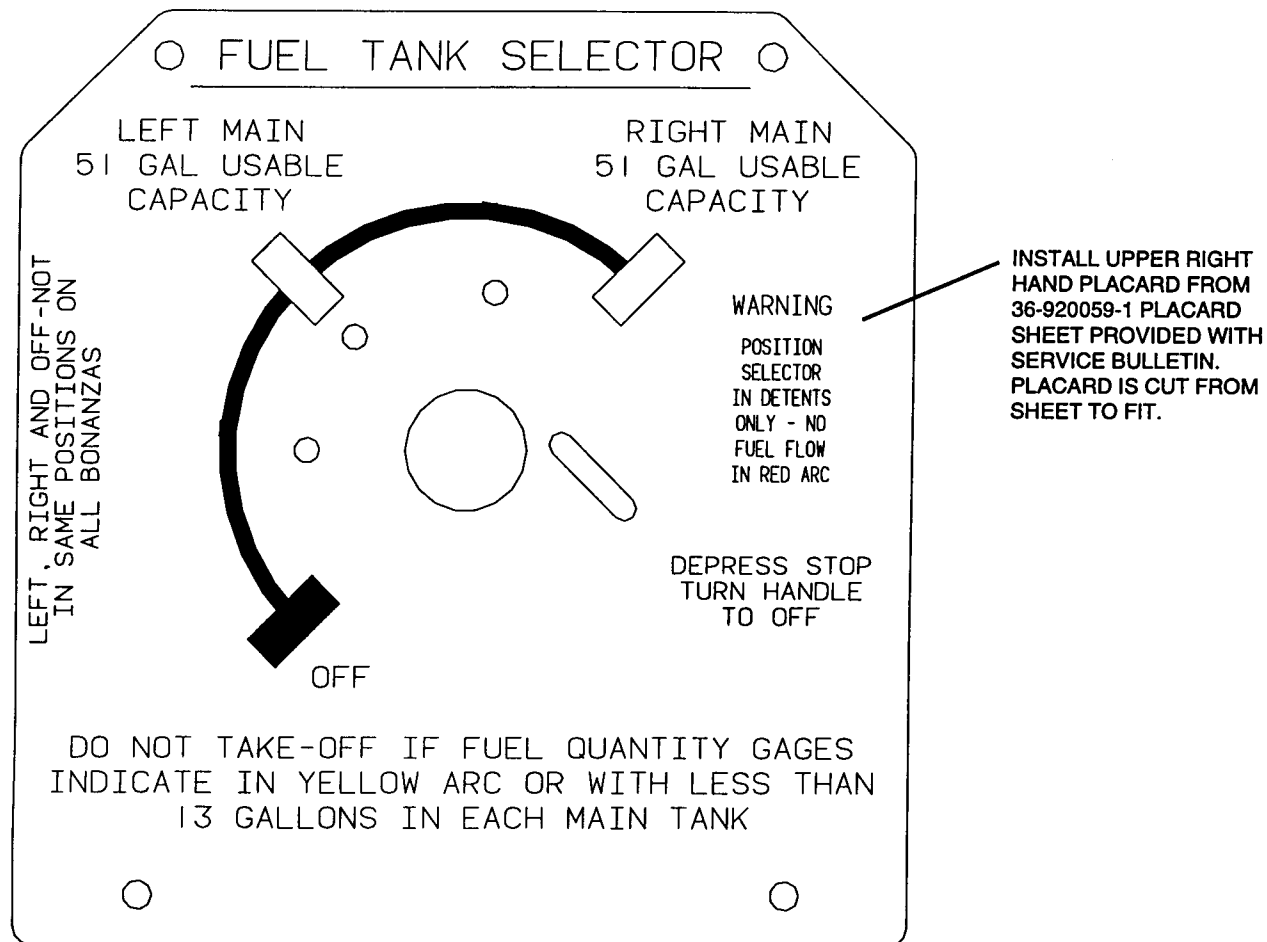
Figure 1

FUEL SELECTOR VALVE
(B36TC SHOWN, A36TC SIMILAR)

EFF: A36TC SERIAL EA-1 THRU EA-241 AND EA-243 THRU
EA-272 WITH BEECH KIT NO. 36-9008-1 INSTALLED,
KIT SERIAL NUMBERS 101 THRU 389 ONLY. B36TC
SERIALS EA-242 AND EA-273 THRU EA-591.

- (1) Figures 1 and 2 (and matching placards attached) are to be used primarily for the serials shown but may be used as an example of suitable configurations for typical Beech single-engine and twin-engine Beech airplanes. The no-flow sectors include the areas between tank detents and any "OFF" selection. Ensure that the placard does not cover any existing words or markings.

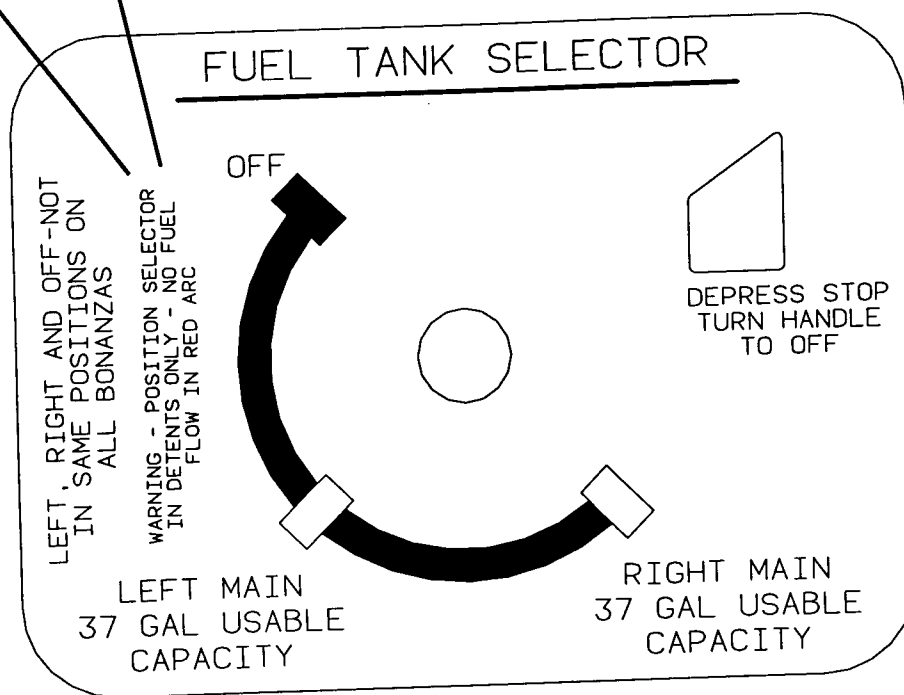
Figure 2

PLACARD IS
CUT FROM
SHEET TO FIT

INSTALL UPPER LEFT HAND
PLACARD FROM 36-920059-1
PLACARD SHEET PROVIDED
WITH SERVICE BULLETIN

FUEL TANK SELECTOR COVER

EFF: F33A - CE-1014 THRU CE-1791
F33C - CJ-156 THRU CJ-179
A36 - E-2062 THRU E-3046
