**ENGINEERING
FAILURE
ANALYSIS**

Failure of locked coil wire rope of coal handling system

P. Parameswaran^{a,*}, V.S. Raghunathan^a, S.C. Hiremath^b, K.R. Paknikar^c

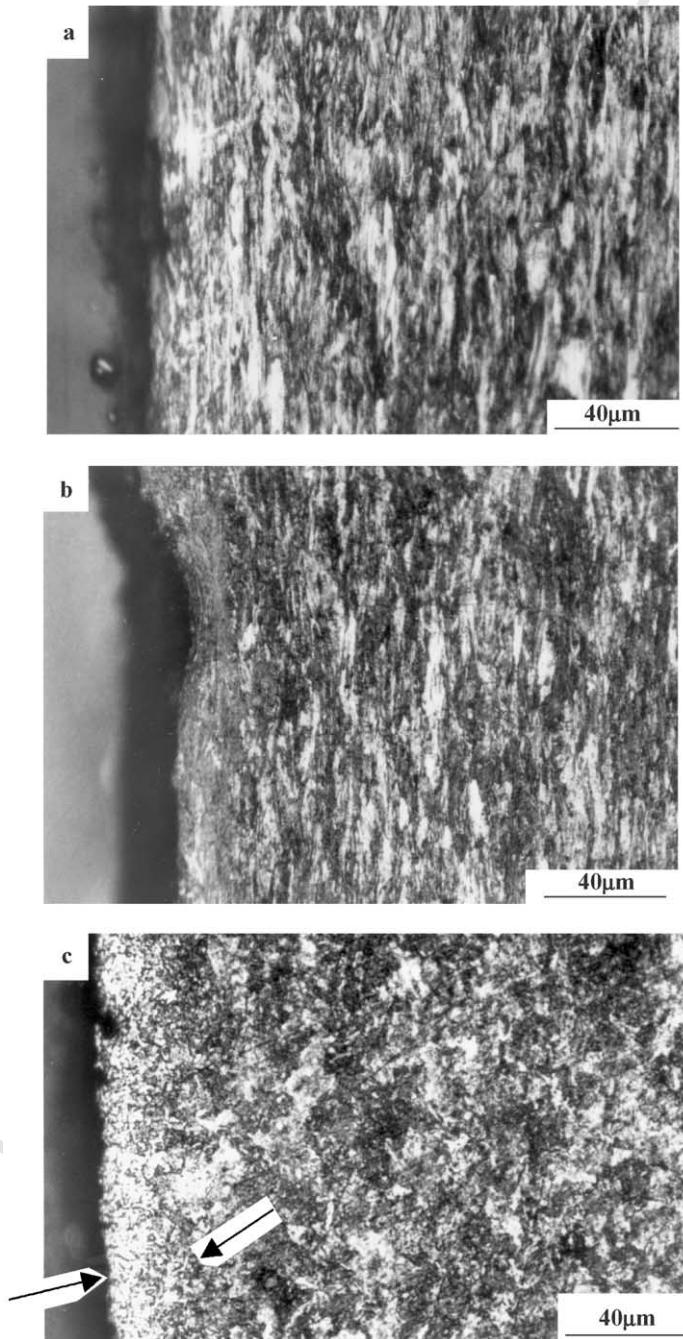
Optical microscopic investigation of the transverse and longitudinal sections of the samples indicates that the general microstructure is drawn pearlitic in nature (Fig. 3). However, careful examination of the sample of the wire that served a shorter life (PS2) indicated that the microstructure along the surface changes to ferrite, indicating the possibility of a decarburised layer. Hence the microhardness of the cross section of the samples was measured. Fig. 4 presents the hardness values as a profile for all the different sections of WS2 and PS2 samples. The microhardness of WS2 remained almost constant around the surface layers in all three sections. In contrast, the surface layers of the rib section of sample PS2 exhibited a hardness of 250 VHN. This is in contrast to the core hardness, which is around 330–350 VHN. On examining several locations near the surface of the rib section, the hardness was found to be around 190–250 VHN. This confirms that a decarburised layer of 40 μm exists around the surface of PS2.

Fig. 3. Optical micrographs of the transverse section of samples (a) WS1, (b) WS2, (c) PS2. In all the samples, generally the structure is drawn pearlitic in nature. Arrows in (c) refer to the decarburised layer.

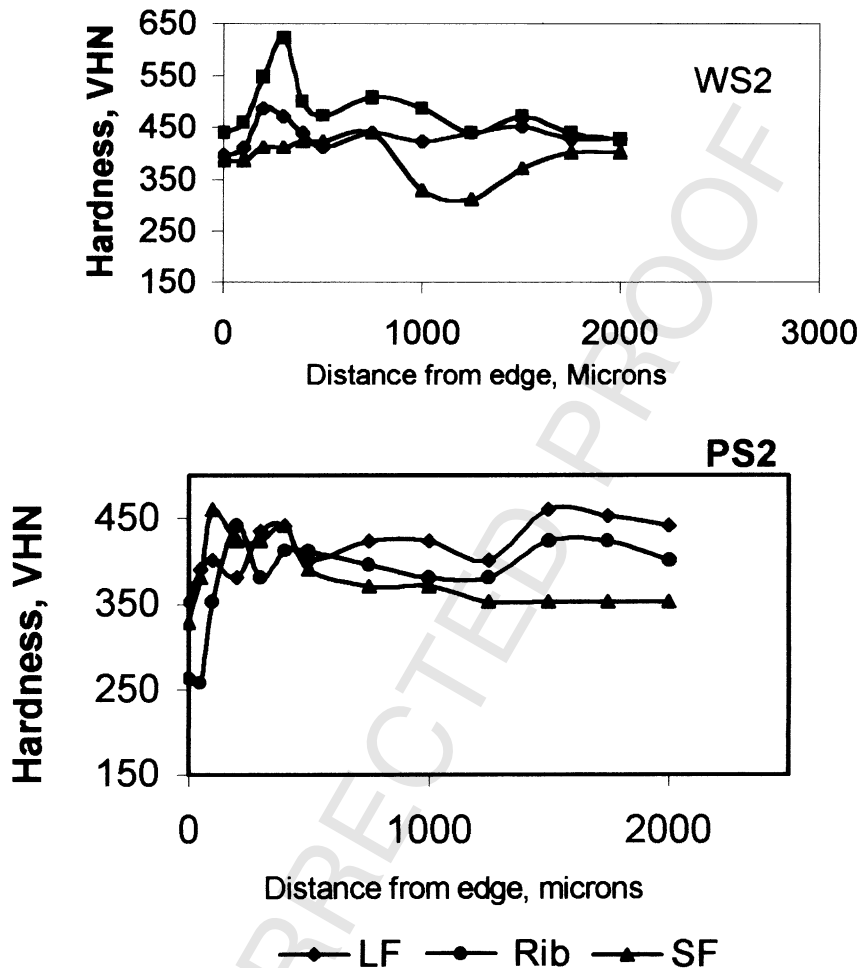
Fig. 4. Microhardness profile of the samples WS2 and PS2 samples for different regions of the cross sections of the wire. Note the sample PS2 shows a low surface hardness in the rib region.

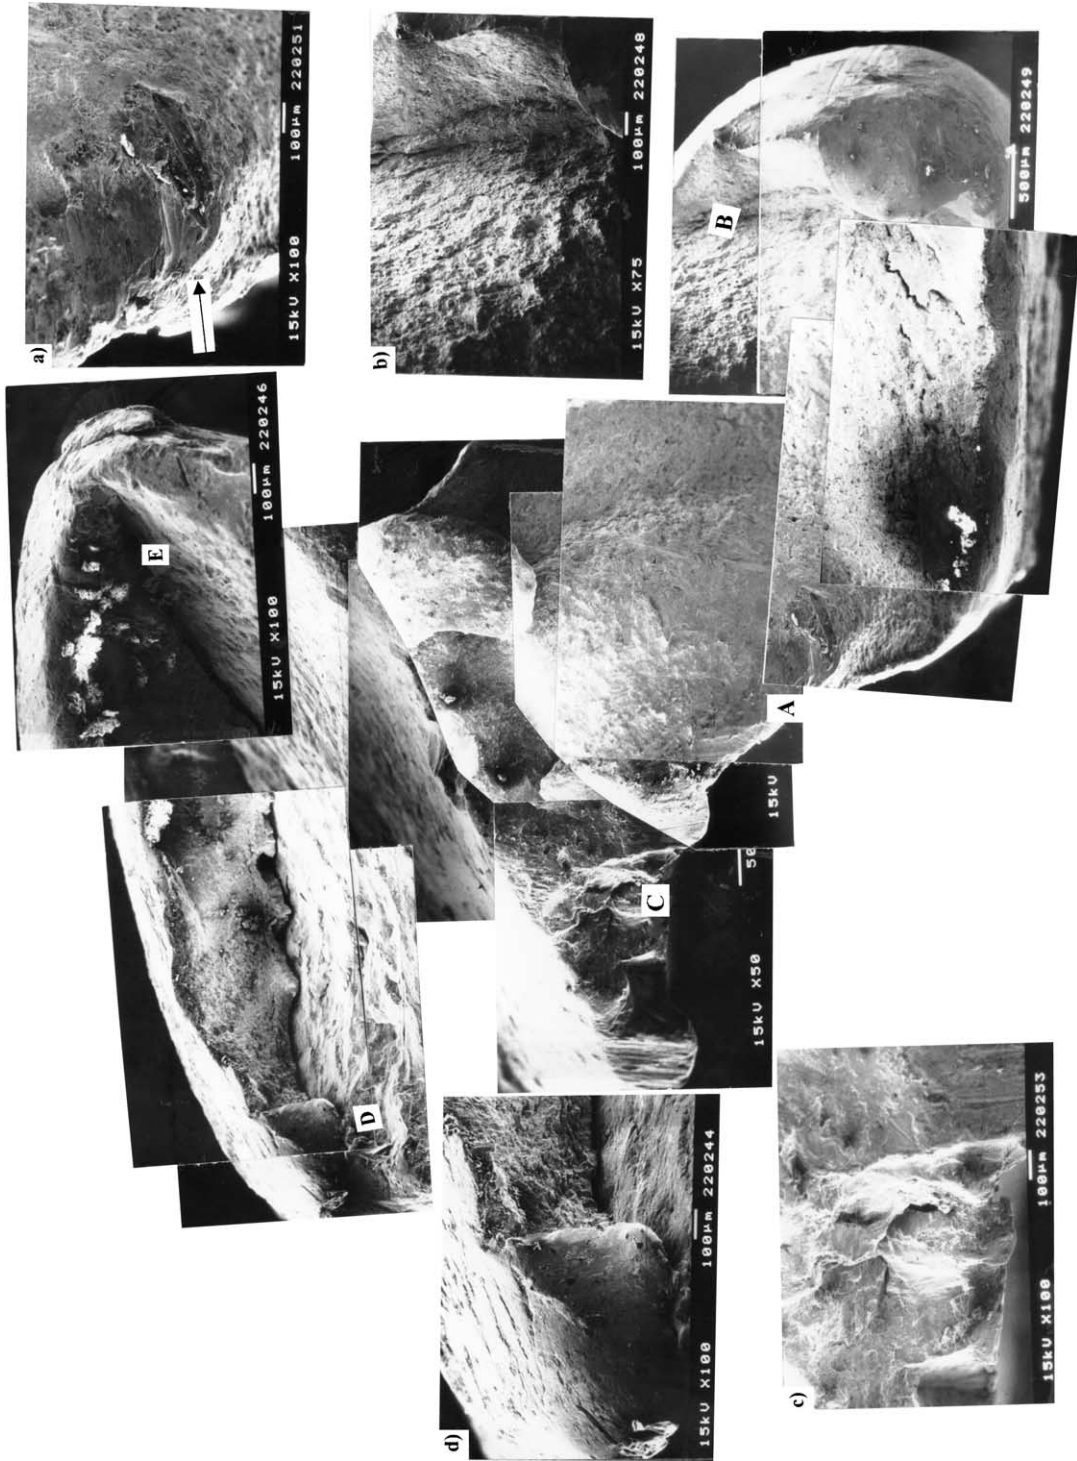
The failed surface of sample PS1 exhibited a crack origin (A) on the edge in the rib location of the cross section (Fig. 5). A higher magnification view (a) of the area A shows clearly round crack fronts (arrow) with fine voids. The crack origin shows shear lips emanating out from the surface edges. This means there is a region of severe plastic yielding around this area. Our earlier finding that a decarburised zone exists around the edges is in line with the present observation. This is a typical case of fatigue failure, developed at the soft surface layers and propagated slowly.

The circular crack front, which emerged from the location A is observed to go into the small flange area in the form of circular lines with cavities. Further secondary cracks (B) generated therein and overload fracture appeared (C). Consequently, on the other end, which is at the large flange, a crack opened up with very flat fractured area (E). In order to confirm the role of the decarburised layer, cross-sectional micro-

Fig. 5. SEM fractograph as a montage showing details of fracture of sample PSI. Regions A, B, C, D in the montage are shown in a detailed view in (a), (b), (c) and (d). Region A is origin. B refers to secondary cracks. Arrowhead shows the crack front developing as circular lines from the origin A.

Thus, the fracture surface details clearly indicate fatigue-loading signatures like concentric lines developing from the origin in the case of sample PS1, along with ductile dimples. This could happen in case of constant tension loading superimposed with an impact load.

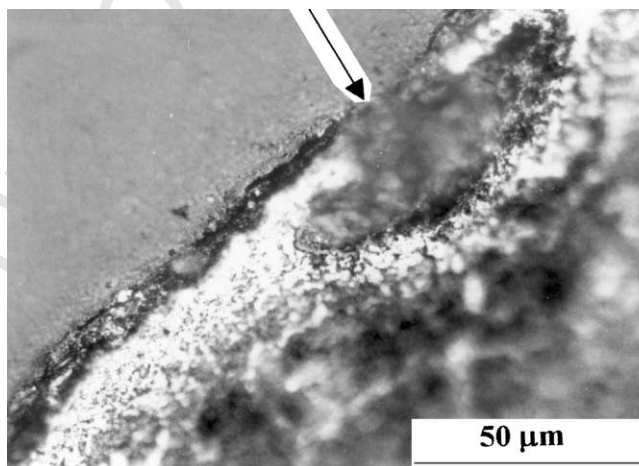
scopy of the same sample was carried out. Fig. 6 shows the optical microscopy of the rib region of the wire. It can be easily observed from the figure that the crack has originated in the decarburised zone.

Fig. 6. Optical micrograph of the cross section of the failed wire showing the Rib section. Note the crack at the decarburised layer.

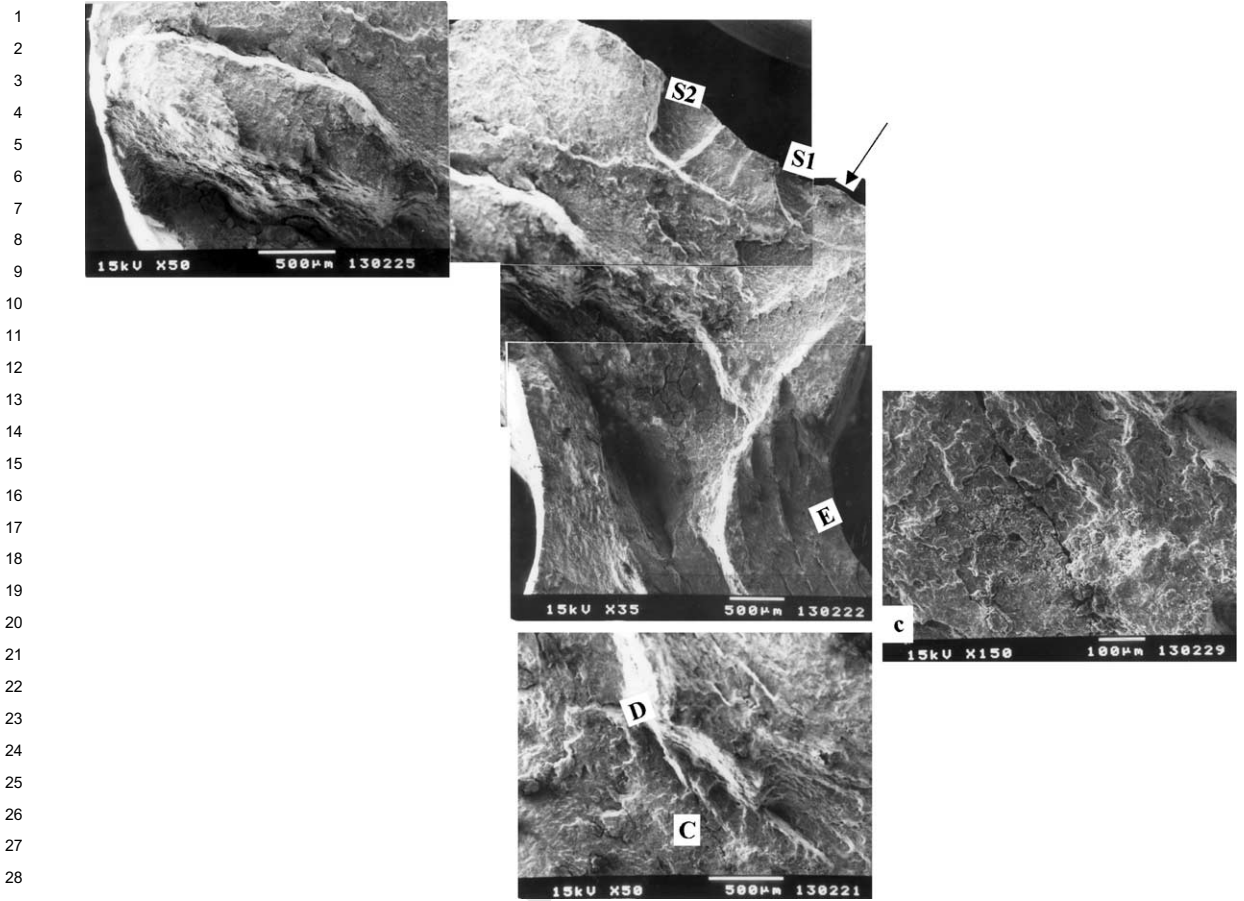
Fig. 7 shows the fractographic details of sample WS1. The origin of the crack begins at the edge of the large flange (see arrow). Then a crack front develops with steps (S1, S2). There are also ductile fibres (D) which seem to go into the rib. However, the rib contains oriented grains leading to secondary cracking [see fine parallel lines (E)]. The load bearing area being less, overload fracture occurred (located at the centre with a deep cavity evident there).

The fracture surface of wire sample WS1 indicated the failure originated from the surface with its development continuing with steps. These are again signatures of fatigue. However, the wire seems to have been subjected to large ductile deformation, as indicated by ductile fibres in the rib section. This is due to the strengthening effect of the oriented grains.

Fig. 7. SEM fractograph as a montage showing details of fracture of sample WS1. Note the arrowhead pointing to the origin; see the steps S1, S2, the ductile fibres (D) and the fine lines (E) of the secondary cracks due to oriented grains in the rib region. Region C is shown again in higher magnification.

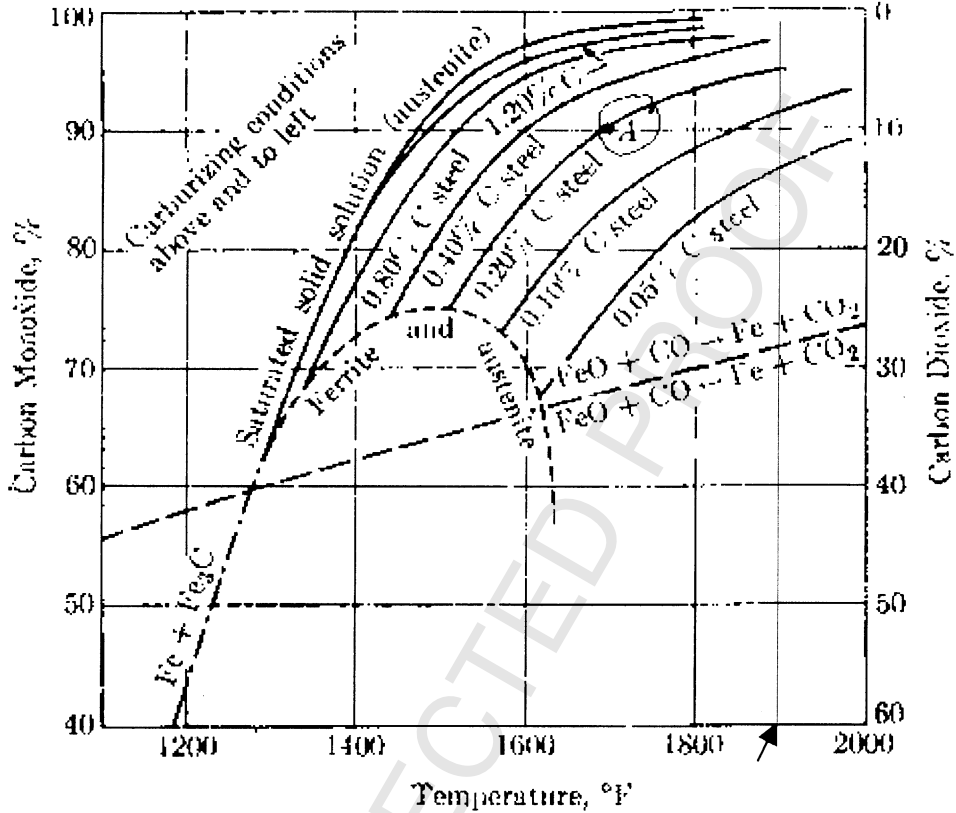
The furnace atmosphere in these furnaces is a combination of CO_2 and CO . The consequence of this atmosphere is governed by the curves shown in Fig. 8. Two reactions are important in this figure namely, the oxidation of iron by CO_2 occurring for gas compositions and temperatures above and to the left of the curve labelled with the composition in question. For 0.8%C, the furnace atmosphere has to be high in CO content, say of the order of 98% or so, for an annealing temperature of 1020 °C.

If the atmosphere has less than the prescribed proportion of CO , then it will be decarburising [3]. Hence it becomes necessary to control the relative amounts of the two gases to avoid decarburisation. Alternatively, for a given furnace atmosphere, the annealing temperature can be lowered to avoid decarburising.

Fig. 8. Curves showing the equilibrium between CO-CO₂ gas mixtures and steels of various carbon contents at heat treating temperatures [3]. Note the arrow indicates the temperature of annealing. It can be read that the corresponding amount of CO should be around 98%.

4. To avoid decarburisation, it is necessary to have a close control of the furnace atmosphere by checking the relative partial pressures of CO_2 and CO . Alternatively given a furnace atmosphere, decarburisation can be avoided by lowering the annealing temperature.

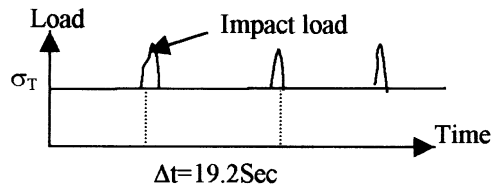
Fig. 9. Schematic of a mechanical test involving a constant tensile load with an impact load at a frequency of bucket movement.

test to impose a constant tensile load with an impact load on a standard pre-determined length of the rope could be most beneficial. Fig. 9 depicts the schematic of such a test. The frequency of the impact load is approximately the 0.02 Hz ($\sim 10^6/\text{year}$). This test is recommended to be added in the specification.
