TECHNICAL BULLETIN INDEX
Sorted by Bulletin Number

All the 2000 Mods You Wanted — But Were Afraid to Ask For

Tandy 2000 Orphans

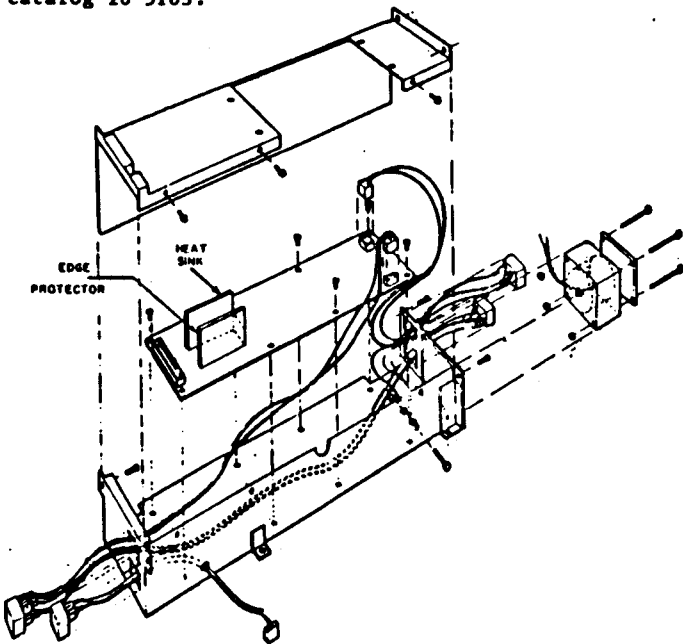
Due to the close fit of the power and reset switch wiring harness to the large heat sink on the power supply, it is possible the heat sink could rub against the wires causing a short. To prevent this, an insulating edge protector should be installed on the right side of the heat sink.

The edge protector is available from National Parts under part number AHC-3100 and catalog 26-5103.

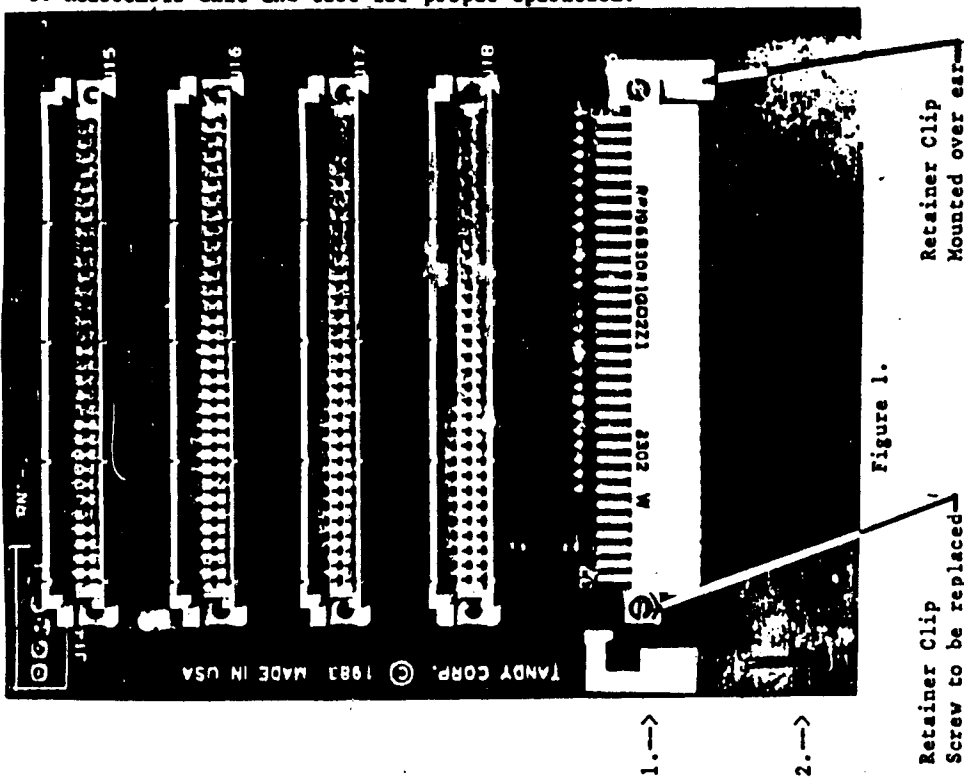
DISCUSSION: Due to improper seating of the mother board to the main logic board, intermittent bootup, video, or power problems may occur. The four screws which hold the main logic board and pan to the plastic case often times become stripped and create a bad connection to the motherboard. To insure proper connection is made between the main logic and motherboard, a Retainer Kit is to be installed on the motherboard.

3. (Refer to figure 1.) Remove screws and nuts holding (P6)(96-pin connector) to the motherboard. Replace the original screws with the #4 x 1/4" screws and the #6 lock washers. These are used to hold the retainer clips tightly in place.

5. Reattach the main logic board to the pan. Reinstall the mother board and insert the two screws into standoff's from bottom side. Thread the two screws into the retainer clips, pulling the two boards together for a tight fit. **WARNING: Do not over tighten the screws or you will strip out the retainers.**

1. Retainer clip is inserted over (P6) connector mounting ears.

2. Insert screw through bottom of main logic board pan standoff's under the (J5) connector on main logic board.

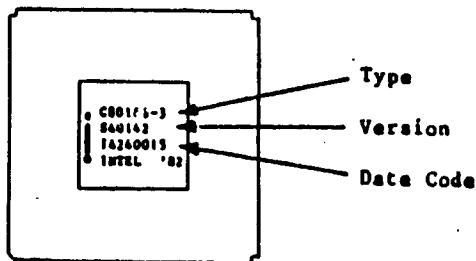
Several versions of the 80'86 CPU have been used in the Tandy 2000. Some of these may have missing command functions. Some are 6 MHz speed chips instead of the required 8 MHz. These CPU chips may not exhibit any problems, or only have problems with certain application programs such as a CAD package. Proper identification, and replacement if necessary, is required to insure proper operation.

There are two items to check, clock speed and version number. If either one, or both of these numbers are incorrect the chip must be replaced. Figure 1 shows a typical 80186 CPU chip.

Note the type number may be prefixed with either a "C" or an "R". Either of these is correct. This prefix is Intel's chip package code.

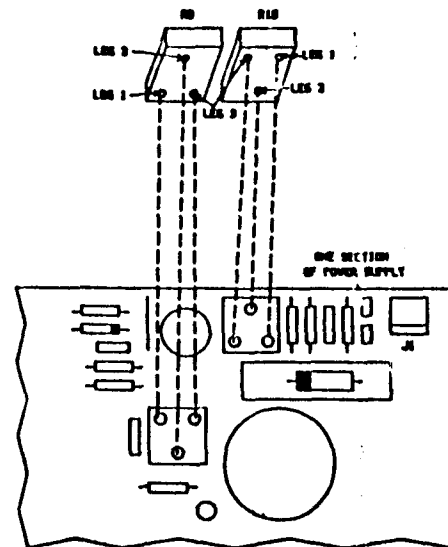
The power supply for the Tandy 2000 has two potentiometers. One to adjust the +5 volts (R10) and another to adjust the +12 volts (R8). During operation it has been found that these potentiometers will change value. This could cause the voltage to increase which in turn causes the power supply to go into current limiting mode; shutting itself down and rebooting the computer.

To eliminate this voltage fluctuation, the potentiometers must be replaced with fixed resistors. Two items must be noted here. First, the required resistance may not be a standard value resistor which will indicate that a series and/or parallel resistor combination must be used. Secondly, the +5 volt potentiometer will require two resistors (or combinations) where as the +12 volt will only require one resistor (or combination). This is because the +12 volt potentiometer's slide arm is connected to one of its fixed legs.

5. Install the first fixed resistor between the holes on the power supply PCB vacated by Leg 1 and Leg 2. Install the second fixed resistor between the holes vacated by Leg 3 and Leg 2. This completes the replacement of the +5 volt potentiometer.

7. Install the fixed resistor between the holes on the power supply PCB vacated by Leg 1 and Leg 2. This completes the replacement of the +12 volt potentiometer.
