SERVICE BULLETIN ML 0020

Date : 28 November, 2000
Game : Slam'N'Jam
Subject : Gate Motor Overload

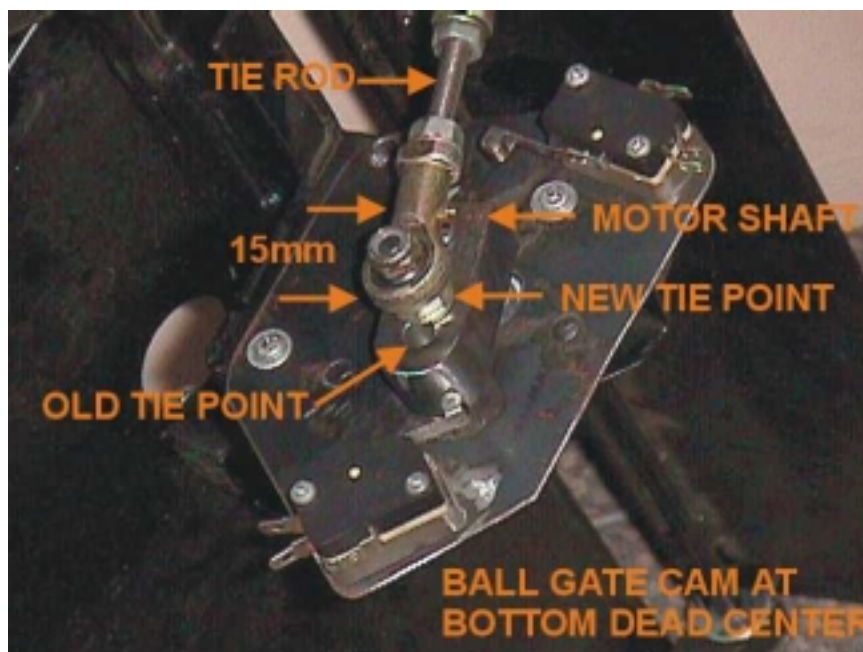
Problem : Overload on Slam'N'Jam Ball Gate Motor due to balls gripping onto ball gate and damaging gear box.

Solution : Lower Ball Gate to prevent gate catching on balls when ball gate closes at start of game

Instructions : Remove the Motor Cam and drill a new Tie Rod mounting point 15mm from the motor shaft hole (the current distance is 25mm). This will reduced the overall stroke length from 50mm to 30mm. Then shortened the Tie Rod, you will need to cut 5mm of the threaded rod. Adjust the gate down to the stoppers when the motor cam is at bottom dead center.

Note : A new Ball Gate Motor Cam (Part No. SP-HA1612) is available for those who are unable to modify the existing cam.
