BULLETIN NO.: 97-T-06
ISSUE DATE: March, 1997
GROUP/SEQ. NO.: Transaxle-02
CORPORATION NO.: 787201

TECHNICAL INFORMATION BULLETIN

SUBJECT: Intermittent Hop Out of 5th Gear or No 5th Gear or Stuck in 5th Gear (Replace Missing/Damaged 5th/Reverse Actuator Retainer Clip or 5th Shift Fork Retainer Clip)

AFFECTED: 1996-1997 Saturns equipped with MP2/MP3 manual transaxles

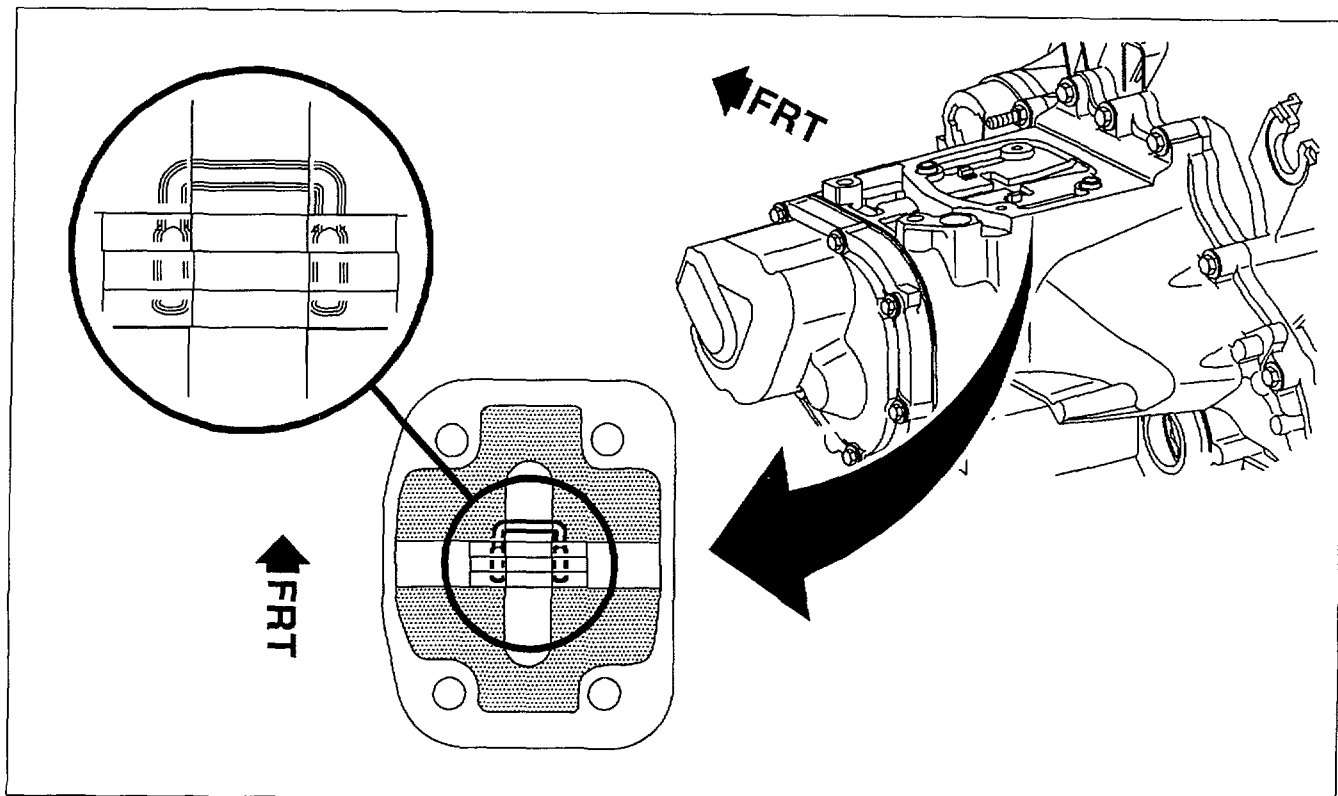
SBPMT68404AB1

CAUSE: These conditions may be caused by a 5th/Reverse actuator retainer clip or 5th shift fork retainer clip that has been damaged or has become disconnected from the shift shaft.

Remove the shift control housing according to procedures in the appropriate year "Manual Transaxle & Clutch Service Manual" and inspect for proper installation of the 5th/Reverse actuator retaining clip.

- If the 5th/Reverse actuator retainer clip is properly secured to the shift fork shaft, re-install the shift control housing according to procedures in the appropriate year "Manual Transaxle & Clutch Service Manual," and proceed to "5th Shift Fork Retainer Clip" procedure in this bulletin.

- If the 5th/Reverse actuator retainer clip is off location (not properly secured to shift fork shaft):
 - a. Remove the transaxle according to procedures in the appropriate year "Manual Transaxle & Clutch Service Manual," and remove the manual transaxle case.
 - b. Remove the 5th/Reverse actuator retainer clip and replace with a new 5th/Reverse actuator retainer clip.
 - c. Re-install manual transaxle case and transaxle according to procedures in the appropriate year "Manual Transaxle & Clutch Service Manual."
- If the 5th/Reverse actuator retainer clip is missing, it must be retrieved to prevent possible damage to other transaxle components.
 - a. Remove the transaxle according to procedures in the appropriate year "Manual Transaxle & Clutch Service Manual."
 - b. Retrieve the 5th/Reverse actuator retainer clip.

- c. Inspect transaxle components for damage from the 5th/Reverse actuator retainer clip and replace any damaged components as necessary.
- d. Replace 5th/Reverse actuator retainer clip.
- e. Re-install the transaxle according to procedures in the appropriate year "Manual Transaxle & Clutch Service Manual."
