# HYUNDAI Technical Service Bulletin

Group	TRANSAXLE
Number	05-40-006
Date	JUNE, 2005
Model	1999- SONATA, 2001- ELANTRA, SANTA FE & XG, 2003- TIBURON, 2005- TUCSON

Subject  
**ATA SOLENOID DIAGNOSTIC CODES P0740, P0741, P0742, P0743, P0746, P0748, P0750, P0755, P0760, P0765, P0770**

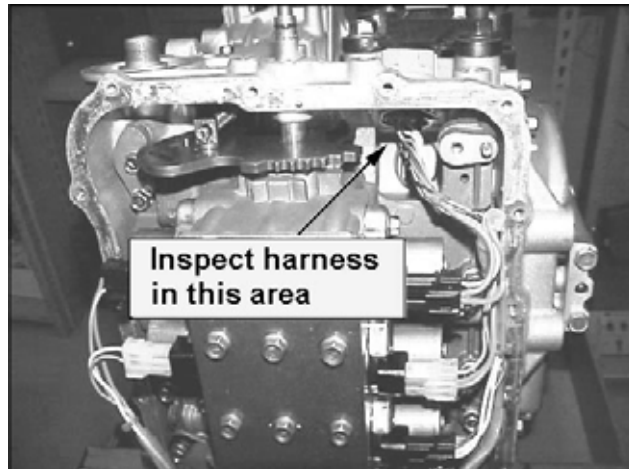
- If Step 2 shows an inoperative solenoid, visually check the wiring harness between the TCM and transaxle for a damaged wire or a short circuit to ground. Disconnect the connectors to the solenoids at the transaxle and the PCM/TCM and check for a bent pin or a pin not fully inserted into the connector. If so, repair or replace the ECM control harness, P/N 914XX-XXXXX.
- Check the harness inside the transaxle oil pan for a short circuit to ground. Replace the harness if damage is found or if **three or more** solenoid DTCs are found in Step 1. (Refer to TSB# 04-40-015 for instructions).

MODEL	Harness P/N
2001~ Elantra, Santa Fe, 2003 Tiburon, Tucson, 1999~2005 Sonata	46307-39050
2006~ Sonata	46308-3A550
XG300/350	46308-39550
