BAD VIBRATIONS

The First Part of One Chevy Fan's Quest for Smoothness

Finally...the End of One Chevy Fan's Quest for Smoothness

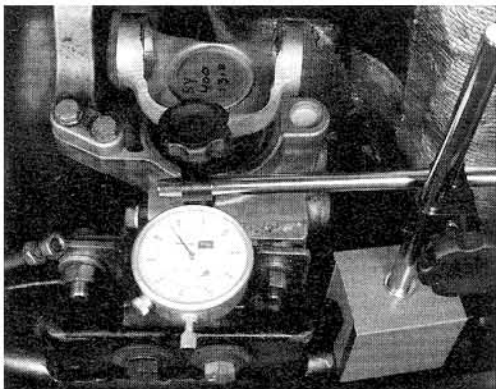
Here's the setup for measuring yoke free-play. Limited space around the tailhousing is a challenge when setting up a solid mounting for a dial indicator. We used a magnetic base on the car's center crossmember.

In an under-car inspection of anything that moves, my friend, Gary, noticed the front yoke was loose on the transmission output shaft splines. I set up my dial indicator, and sure

enough, free-play measured .008 inch. I pulled the driveshaft and temporarily installed a new yoke from Clippinger Chevrolet in Covina, California. It moved only .0015 inch.

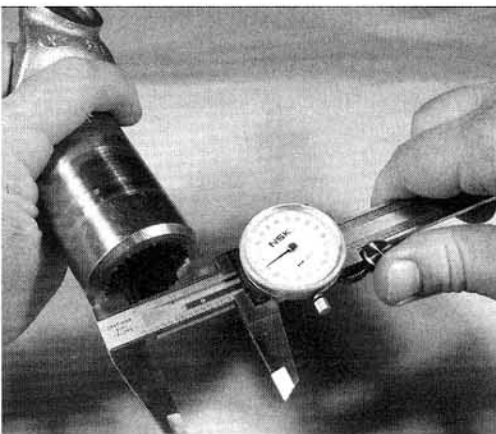
A dial caliper demonstrates the problem with the first yoke. Splines are measured two ways: major diameter, between tops of the splines on the shaft, and minor diameter, between the bottom of the splines on the shaft. The nearly .020-inch difference between the major diameters is why the first yoke was loose.

Measurement of the two yokes showed their spines had the same minor diameter, 1.310 inches, but different major diameters, 1.395 for the bad yoke and 1.376 for new unit. We learned the .019-inch difference is a common, but sometimes undetected, problem for those using transmissions with the 32-spline output, such as Turbo Hydramatic 400s, 4L80-Es, later Muncie four-speeds, the ZF S6-40, and some aftermarket manual transmissions. That much free-play will cause a driveline vibration, and I thought we might be on to the problem. Unfortunately, we'll never know for sure, because we couldn't test the original driveshaft with the tight yoke.

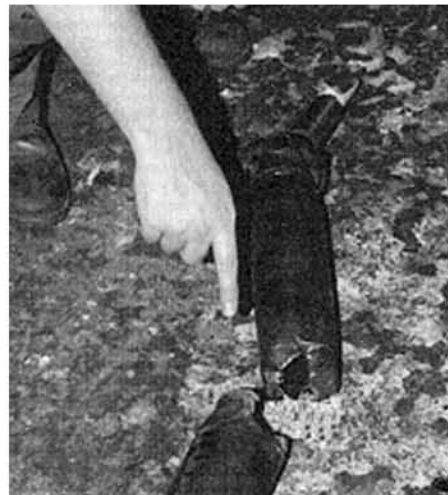
Anything made of elastic material—and metals are elastic—has a resonant bending frequency. When a rotating shaft's speed approaches its resonant frequency, the shaft begins to vibrate as if it were unbalanced. If allowed to spin for very long in that speed range, known as "critical speed," the shaft will fail catastrophically. Don't be in the car when that happens.

Inland Driveline's Jeff Gilroy offers the results of driveshaft failure due to operation at critical speed.

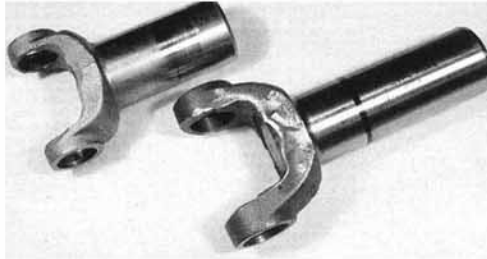
Here are the old yoke (left) and the "tight" TH400 yoke. It's easy to see the difference in size of the required U-joint. We did a little deburring work, then marked it for Inland Driveline service to cut.

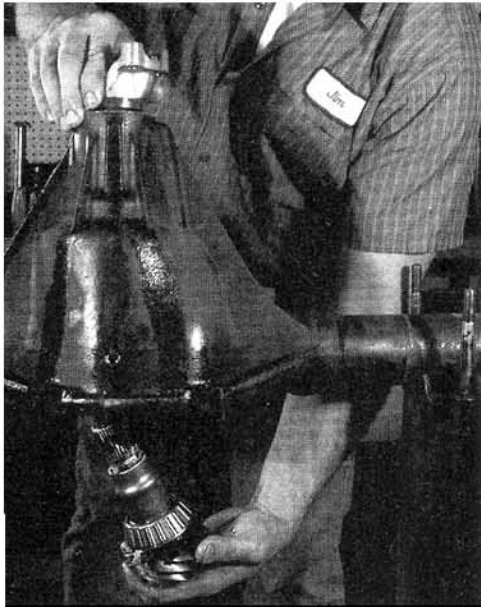
Jim Cook at Performance Differentials in Ontario, California, tore down the axle. As I suspected, the rear pinion bearing was damaged due to either incorrect preload or improper installation of the bearing race. Worse yet, Cook found my axle housing was bent by .125 inch, which could cause a vibration.

Many rear axle service shops recommend Timkin roller bearings, and that's what Jim Cook installed in our Malibu's 12-bolt, along with the new pinion yoke.

Cook straightened the housing and installed new pinion bearings and the new pinion yoke. We put the rear back in the car, filled it with Red Line Heavy Shockproof Gear Lubricant, installed the new driveshaft, and went for a road test. I didn't get very far when, crossing a railroad track, I heard a knock on the floor.

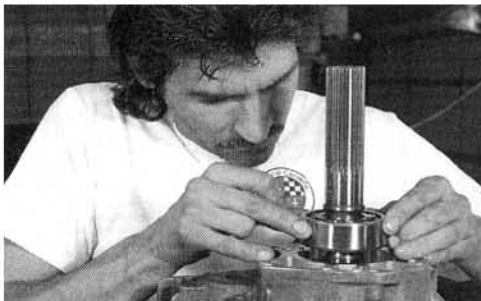
Boudreau pushes a Rockland Gear rear mainshaft bearing into our ZF six-speed. The rear mainshaft bearing experiences the highest load of any in the transmission. It was worn slightly more than the other four, but nowhere near where it would cause a vibration.

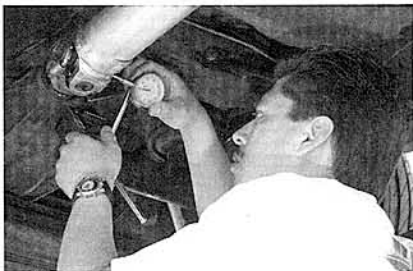
Powertrain Industries' Brian Arvizo measures pinion yoke runout. Mount the dial indicator securely. You must index as close to the center of each U-joint cap as possible and make sure the plane of the U-joint cap is 90 degrees to the dial indicator pintle when the reading is taken.

Brian took dial indicator measurements of the rear U-joint caps which showed the pinion yoke was machined such that the centerlines of the pinion shaft bore and the universal joint were not concentric. This would cause runout at the rear of the driveshaft and could be a reason why a shaft that balanced perfectly off the car would vibrate on the car.

Brian decided to rebalance the driveshaft with the rear yoke attached so the balancing process would compensate for the runout. We hadn't done this before because, up until we took the car to Powertrain Industries, the capability wasn't available.

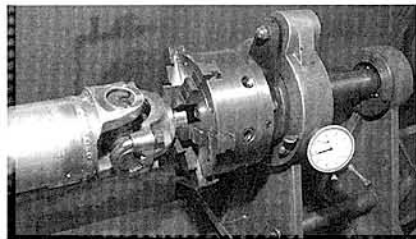
Not all driveshaft services can balance a shaft with a pinion yoke attached. However, if your pinion yoke has run out, that method may be your only solution.

Flores spun the shaft with the rear yoke in place. There was an obvious imbalance, which he fixed with slightly more weight. We slipped the yoke back on the pinion, tightened the nut until the marks lined up, popped the shaft back in the car, and went out for another road test.

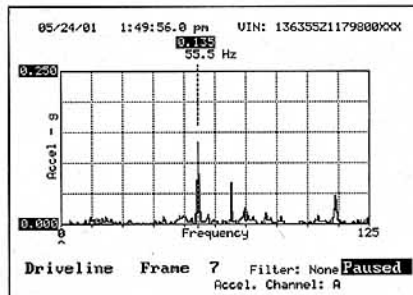
Here's the MTS 4100 data recorded during our first road test. The tall spike at 55.5 Hz below the dotted-line cursor indicates a first-order driveshaft vibration at about 70 mph. (Image Vetronix Corp.)

me, and I quickly glanced at the screen. It showed a vibration spike at 55.5 Hz, the frequency of a first-order vibration at 3,330-rpm driveshaft speed or 69.21-mph vehicle speed.

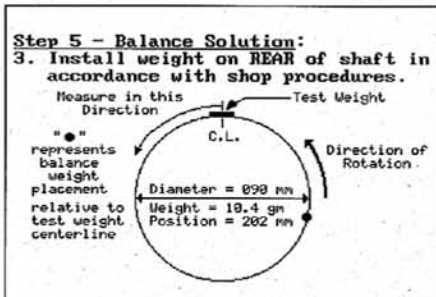
The key to making on-car driveshaft balancing practical in the field is a secure, durable method of affixing weight to a driveshaft without welding. The method Vetronix has developed and is testing (using our Malibu and a number of other vehicles) is small lead weight(s) held to the shaft with a stainless steel and epoxy adhesive. A special tool is used to tighten, then lock the band.

attaching the weight to the shaft with an epoxy adhesive. A stainless steel band, similar to that used to retain CV-joint boots on front-wheel drive cars, was put around the shaft and over the weight. In four spots, the inside of the band was epoxied to the shaft.

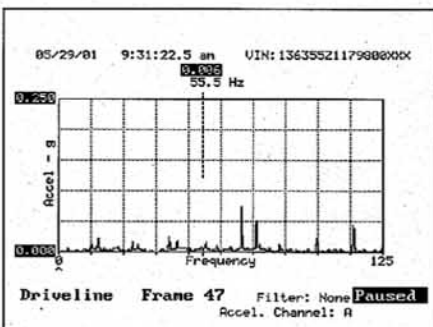
With the driveshaft rebalanced, we went back out for another test drive. At 60, 70, then 80, and even 90 mph, the vibration was finally—gone. I was just about speechless. I'd been working for a year and spent several-thousand dollars trying to solve this vibration with, at best, only partial success. Gehris had completely eliminated the problem in a single, two-hour session using the MTS 4100, a little over a third of an ounce of lead, and a couple of steel bands.

Here is the 4100's graphical display during a final road test with the rebalanced driveshaft. There's little sign of the 55.5Hz vibration.
