**USGA GREEN SECTION  
TURF ADVISORY SERVICE VISIT REPORT**

**LAKE WILDWOOD GOLF CLUB**

**Penn Valley, California**

**August 7, 2008**

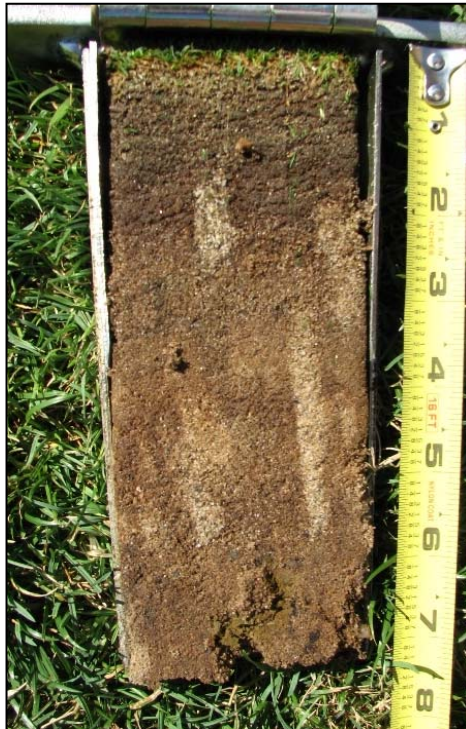
**2. Soil profile challenges** – It was noted that the greens provide acceptable conditions from an aboveground and from a golfer’s perspective; however, the condition of the greens below ground, revealed an entirely different story. Soil profile samples collected from nearly every green on the golf course revealed turfgrass roots ranging from less than 0.5-in. to approximately 4.5-in. in depth. On average, rooting depth extended to approximately 2-in.

*No. 5 profile shows nearly 3-in. of thatch and organic matter directly above soil that does not appear to fall within USGA specifications. Note the light-colored sand channels where aerification holes have been filled with quality topdressing sand.*

Organic matter control – In all likelihood, it appears a greens reconstruction project is at least several years away, thus additional efforts will be necessary during the coming year to control the dense layer of organic matter at the surface of the greens. Current programs for core aeration and sand topdressing have not provided the necessary intensity of organic matter removal to achieve the desired results. You may wish to consider a program that involves modifying a quadra-tine adapter to accept ½-in. diameter hollow tines. The ½-in. diameter holes on a closer spacing removes more organic matter per square foot without increasing the time necessary for turf recovery.

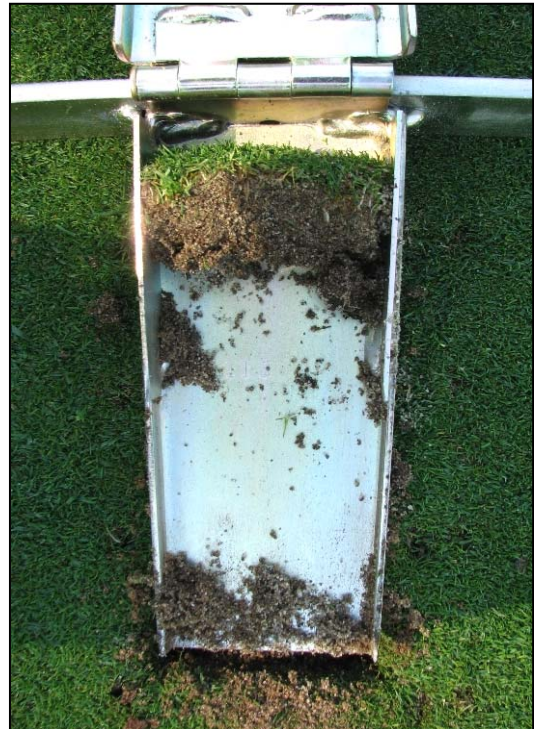
*No. 3 profile shows a rooting depth of approximately 0.5-in. This green lacks sufficient sunlight and air movement.*

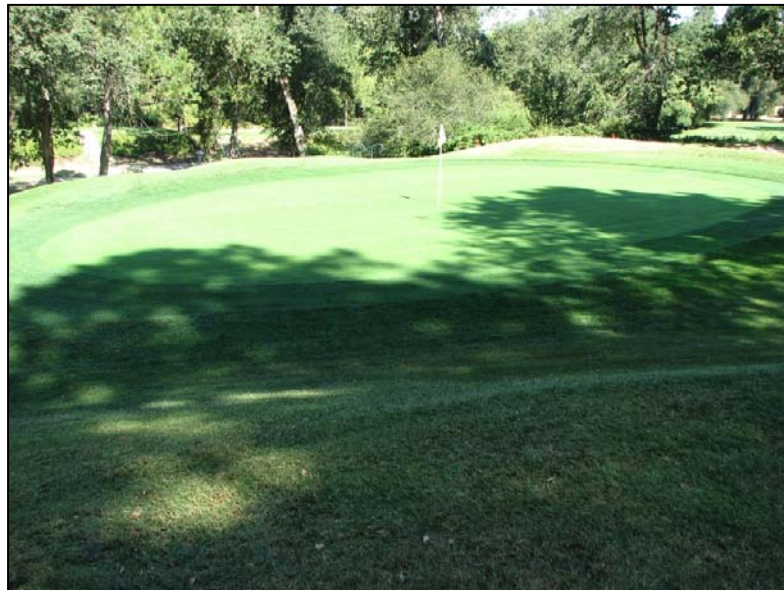
**5. Microclimate** – Several greens on the golf course are situated in microclimates that are by no means ideal for growing quality turfgrass. The microclimate surrounding No. 3 green exhibits poor air movement and produces significant amounts of shade throughout the day. As such, this green has a very shallow root system and is typically the most challenging of all the greens on the golf course when attempting to provide quality turfgrass conditions. The microclimate in which greens Nos. 2 and 3 are situated should be addressed prior to a greens reconstruction project.

*No. 3 green consists of a challenging microclimate in which to grow quality turfgrass. Poor air movement and extended shade periods do not provide an environment that is typically considered ideal growing conditions.*
