Applies To: **See VEHICLES AFFECTED**
**May 28, 2004**

## Rattle From the A-Pillar Trim or the Dashboard Corner

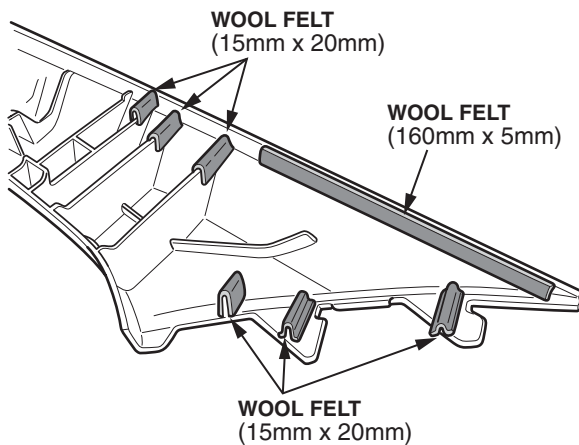
Passenger's side shown:

Too much clearance between the A-pillar trim and the dashboard.

2. Remove the A-pillar trim by releasing the two clips.
3. Cut six 15 mm x 20 mm pieces of the wool felt, remove the adhesive backing, and install the felt onto the A-pillar trim ribs in the areas shown.
