Applies To: **2001 Civic 2-door** – From VIN 1HGEM....1L000001 thru 1HGEM....1L005377
2001 Civic 4-door – From VIN 1HGES....1L000001 thru 1HGES....1L068821

October 23, 2001

Windshield Is Cracked at the Lower Corners

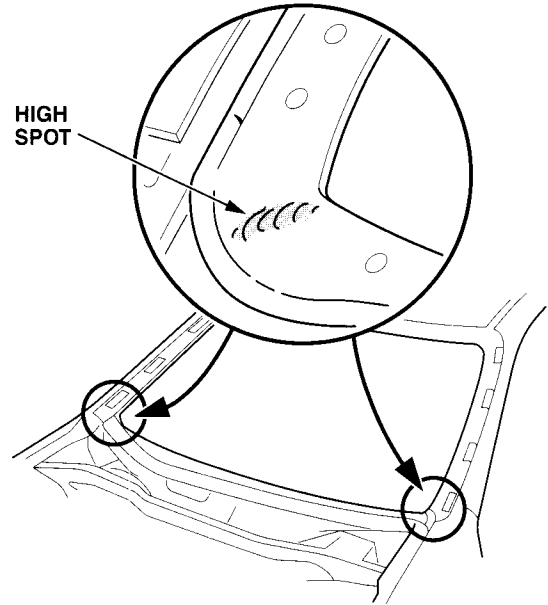
The windshield flange surface is uneven.

2. Inspect the flange area for any high spots, especially at the base of the lower pillar where the dashboard attaches.
- NOTE: You may need to remove some of the sealer to inspect the area.
