ServiceNews

March 2002

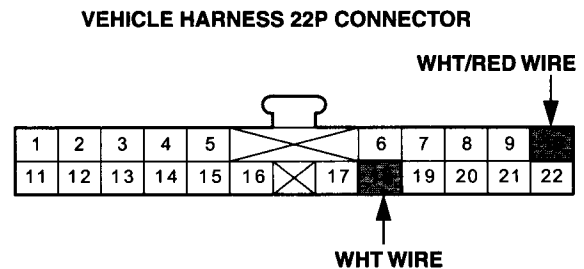
If you've used AII 23086, *Security System*, to install the accessory security system in an '02 CR-V, you might have noticed the illustration in step 16 for the vehicle harness 22P connector is a little tough to follow. The actual connector has more cavities than what's shown in the illustration, so it's hard to tell just where to insert the WHT and WHT/RED wires. Here's a connector diagram that will make it clear:

Wire side of female terminals.

The WHT/RED wire goes to the security unit, and it is hot at all times. The WHT wire goes to the security system LED. If these wires are inserted in the wrong cavities, the LED or possibly the entire security system may not work.
