# ***The things I get myself into!***

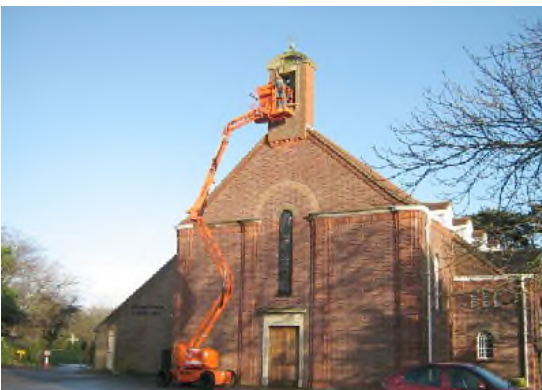
***Up there fitting the new cable to the clapper***

We went to a yacht chandler where we acquired a new cable and some shackles, and then it was up on the cherry picker again to fit the new cable to the bell. It was windy and there was a threat of a heavy shower, but we had to get the job done quickly because the light was beginning to fade. It was difficult removing the old shackle with 60 years of rust on it and the platform was moving a lot in the wind! With the new cable connected and fed the end down the lead tube we made our decent and hoped that I would be able to pick up the other end from below.
