**EXPERIENCE WITH DOUBLE HULL TANKERS  
AN OWNER'S VIEWPOINT**

**BERGESEN D.Y. ASA**

**TANKER STRUCTURE CO-OPERATIVE FORUM**

**TOKYO, OCTOBER 2000**

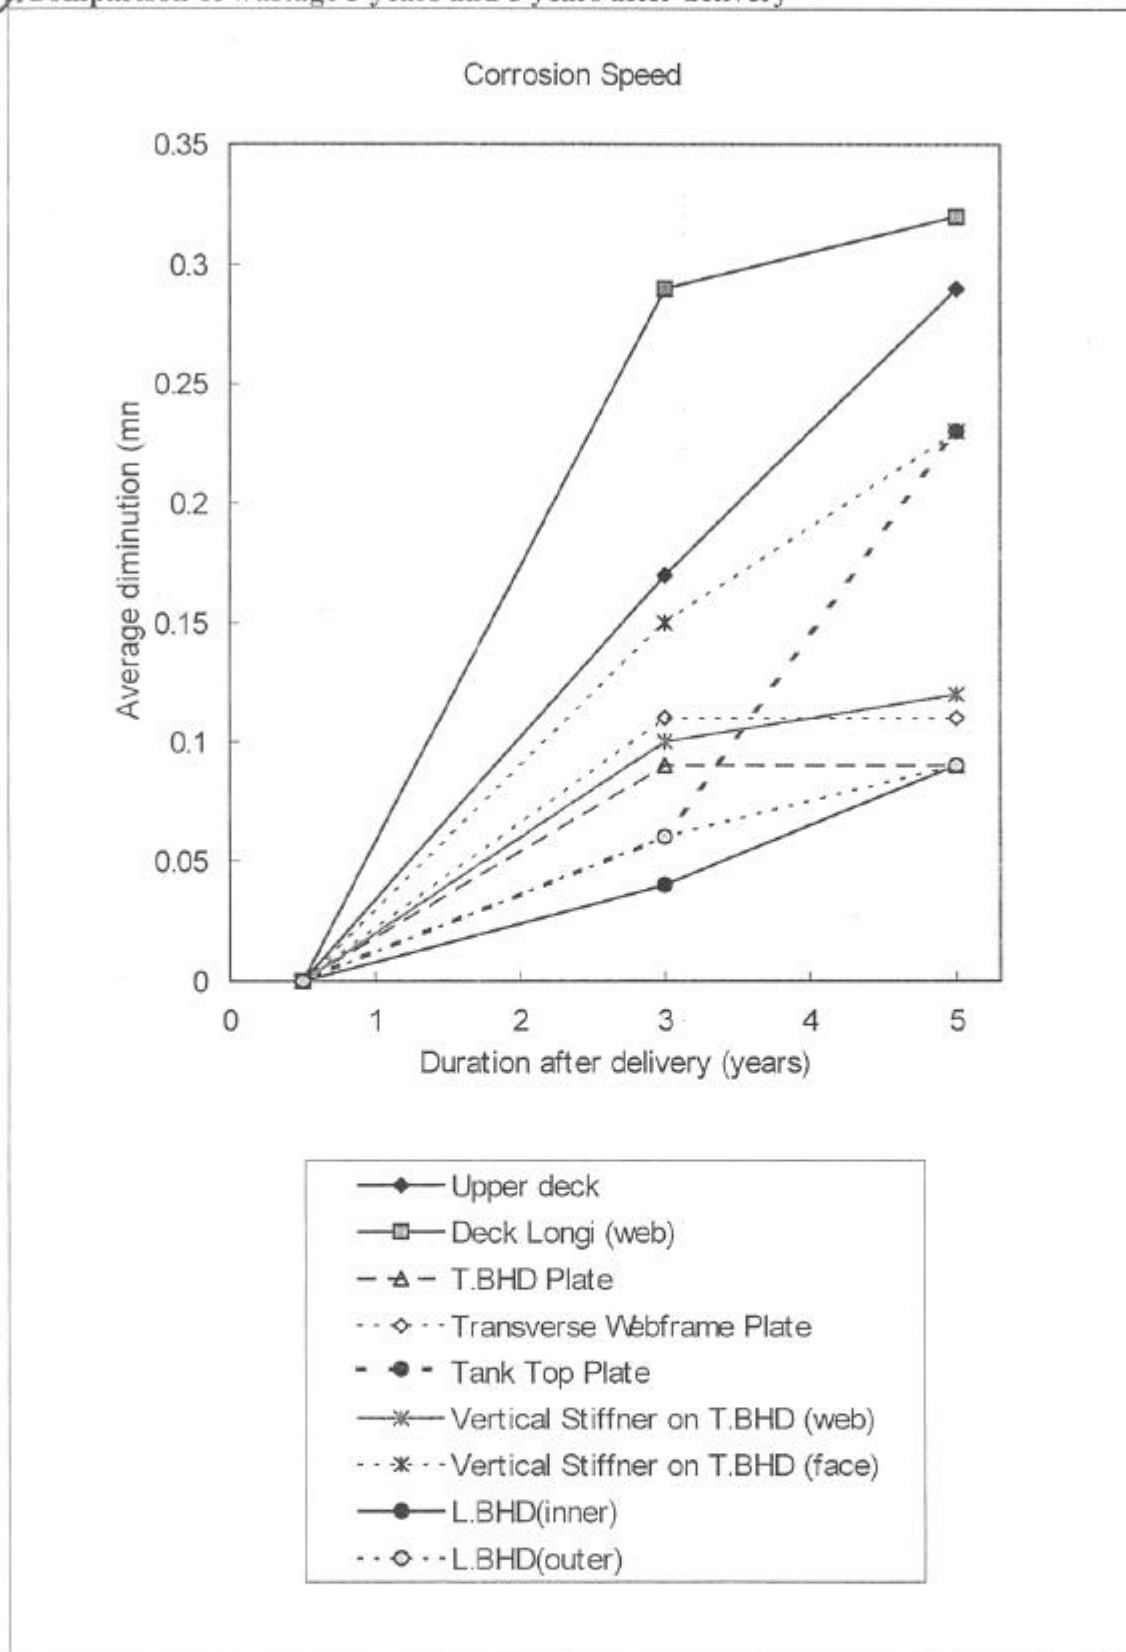
Fig.9. Comparison of wastage 3 years and 5 years after delivery

Photos were taken from the inspections above and are shown on photo no. 1 to no. 18. Table 1 gives a summary of the plate thickness diminution for each cargo tank. Table 2 gives the comparison of thickness diminution between 3 years and 5 years after delivery. The results of the measurements have been shown in Fig. 9. It is worth noticing that the shop-primer used in the cargo tanks for one vessel only delayed the corrosion on the inner bottom by two years. On this vessel the deepest pits were 4-5 mm whilst on the vessels without any primer the pits were up to 7-8 mm deep.

## Comparison of thickness diminution between 3 years and 5 years after delivery.

Table. 2 Comparison of Annual Diminution between 3 years and 5 years after delivery.

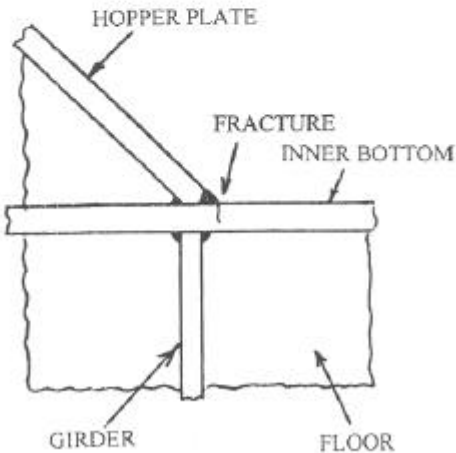
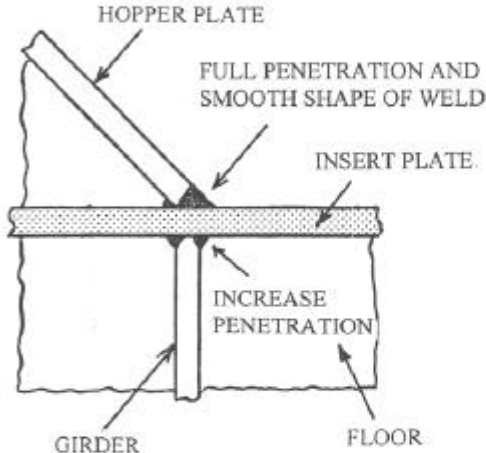
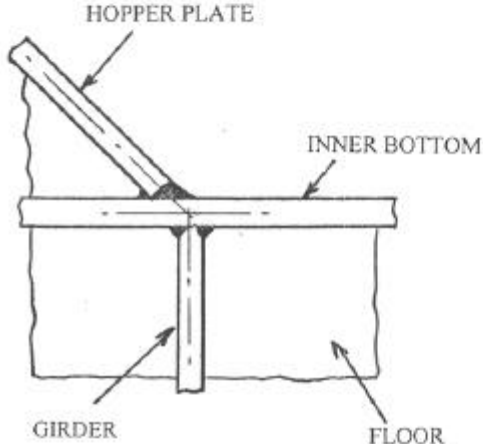
A school example where high stresses will cause cracks is the juncture of hopper plate to the inner bottom plate as shown in Fig. 1. The cracks shown in the bottom plating and in the floor below will not occur if proper attention is paid to those details as shown on the sketches taken from our VLCCs. Both increased plate thicknesses as well as avoiding the scallops are of importance. This is shown in Fig. 4 of the Manual.

| <b>LOCATION :</b> BILGE HOPPER<br><b>EXAMPLE :</b> CONNECTION OF HOPPER PLATE TO INNER BOTTOM<br><b>NO 1</b> | | <b>GROUP</b><br><b>NO 1</b> |
|---|---|---|
| <b>FACTORS CONTRIBUTING TO DAMAGE</b> <ol style="list-style-type: none"> <li>1. Stress concentration at juncture of hopper plate to inner bottom.</li> <li>2. Insufficient welding connection.</li> <li>3. Misalignment between hopper plate, inner bottom and girder.</li> </ol> | | |

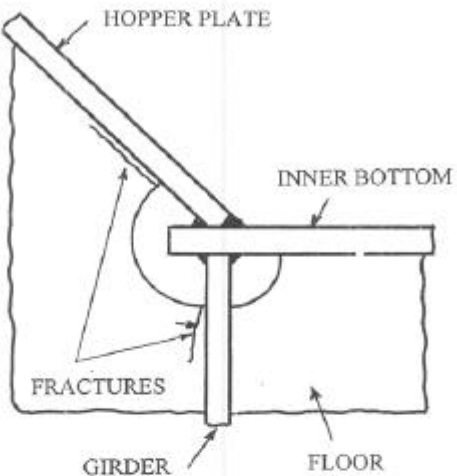
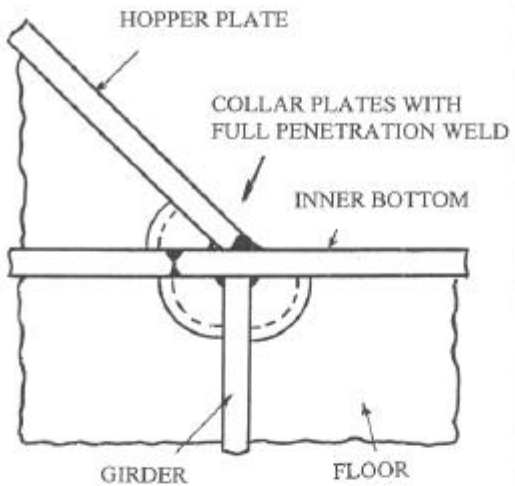
| LOCATION : INNER BOTTOM PLATE<br>EXAMPLE : FRACTURE AT CONNECTION OF BILGE<br>NO 1 : HOPPER PLATE AND INNER BOTTOM | | GROUP<br>NO 1 |
|---|---|---|
| <b>FACTORS CONTRIBUTING TO DAMAGE</b><br>1. Stress concentration at the knuckle | | |

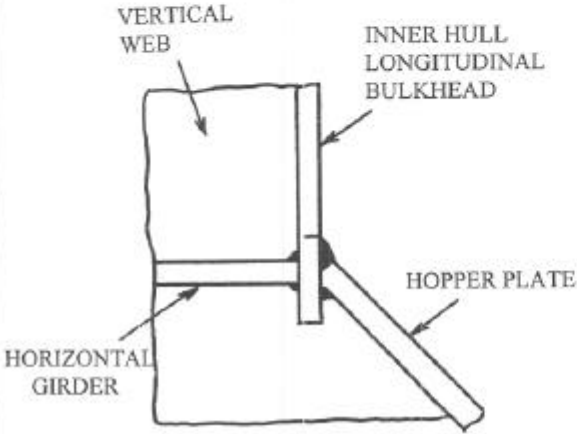
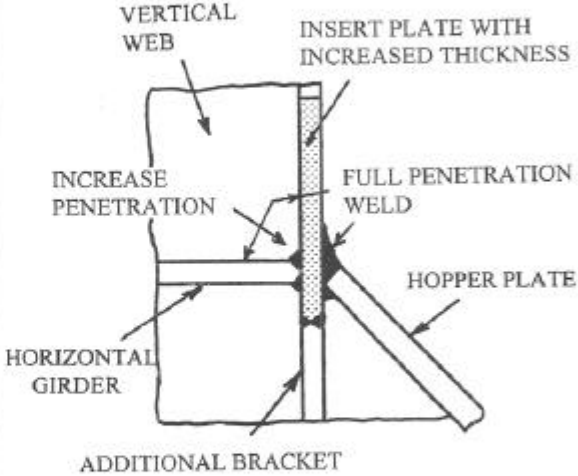
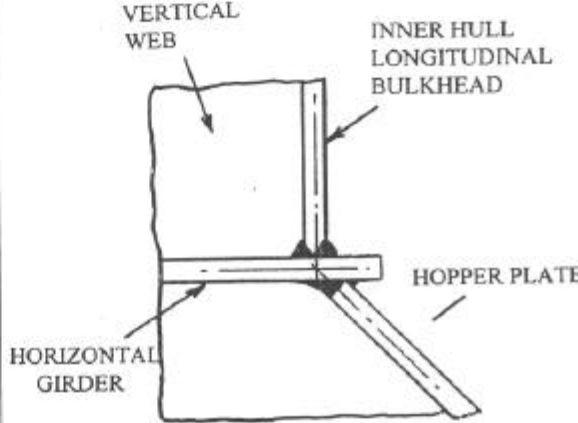
Similar defects may be found in the inner hull longitudinal bulkhead where this is connected to the hopper plate. Fig. 9 from the Guidance Manual shows two types in the proposed repair and also a new construction. We have used both types in our newbuildings as previously shown. You may note that the additional bracket which is fitted underneath the inner longitudinal bulkhead can only be done if the hopper plate is not too much inclined. Examples from our two vessels can be shown. It should also be noted that the longitudinals on the inner part of the hopper plate should be fitted with lugs in way of the transverse girder.

| <b>LOCATION :</b> BILGE HOPPER<br><b>EXAMPLE :</b> CONNECTION OF HOPPER PLATE TO OUTSIDE<br><b>NO 2</b> LONGITUDINAL BULKHEAD | | <b>GROUP</b><br><b>NO 1</b> |
|---|---|---|
| <b>FACTORS CONTRIBUTING TO DAMAGE</b> <ol style="list-style-type: none"> <li>1. Stress concentration at junction of hopper plate to outside longitudinal bulkhead.</li> <li>2. Insufficient welding connection and/or incorrect shape of the weld toe.</li> <li>3. Misalignment between hopper plate, outside longitudinal bulkhead and side stringer.</li> </ol> | | |

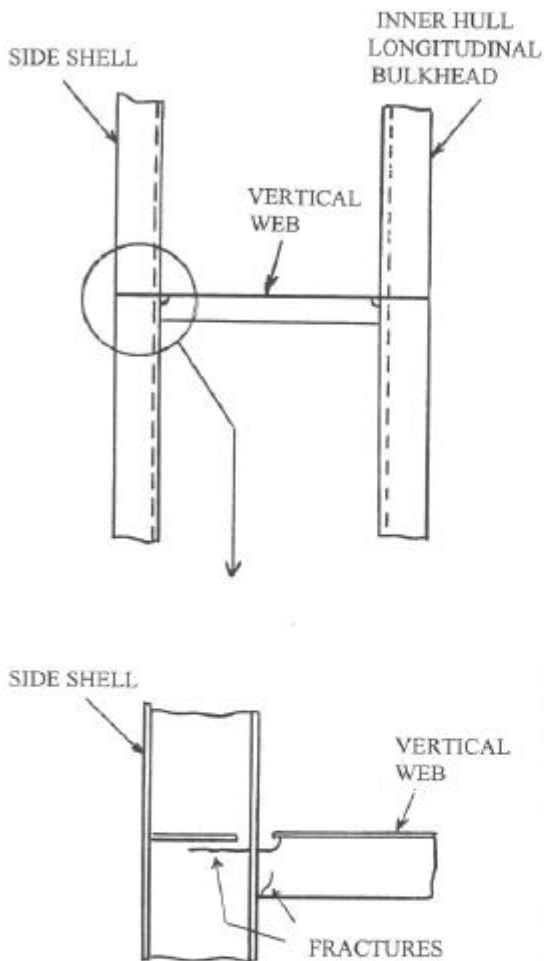
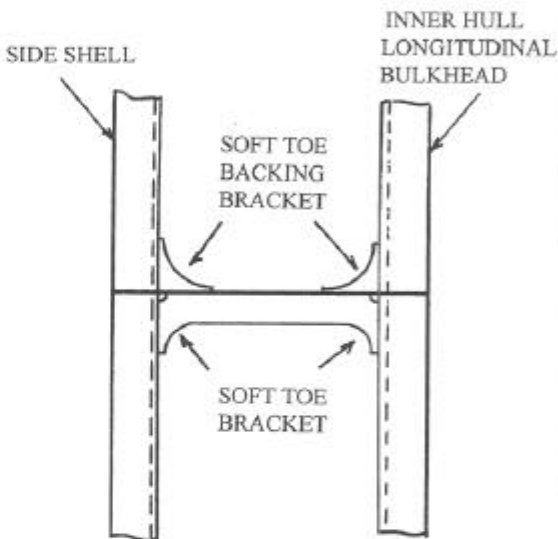
Probably the best known examples of cracks have occurred in the side longitudinals in way of the web frames and in the web frame itself. The double bracket solution as shown in the TSCF Guidance Manual Fig. 16 has in our opinion proved to be the best alternative. We adopted the same in our newbuildings as shown before.

| <b>LOCATION :</b> WING BALLAST TANK<br><b>EXAMPLE :</b> CONNECTION OF LONGITUDINALS TO TRANSVERSE WEBS<br><b>NO 2</b> | | <b>GROUP</b><br><b>NO 3</b> |
|---|---|---|
| <b>FACTORS CONTRIBUTING TO DAMAGE</b> <ol style="list-style-type: none"> <li>1. Asymmetrical connection of flat bar stiffener resulting in high peak stresses at the heel of the stiffener.</li> <li>2. Insufficient area of connection of longitudinal to web.</li> <li>3. High bending stresses in the longitudinal.</li> <li>4. Additional torsional stress due to a symmetry of the longitudinal (angle bar instead of symmetric T bar).</li> <li>5. Stress concentrations at the square angles at heel and toe of the connections.</li> </ol> | | |

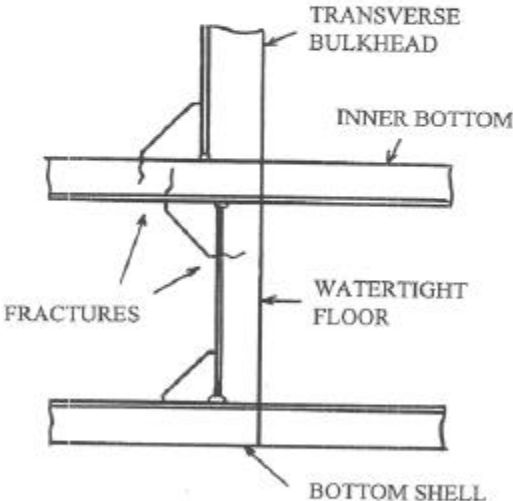
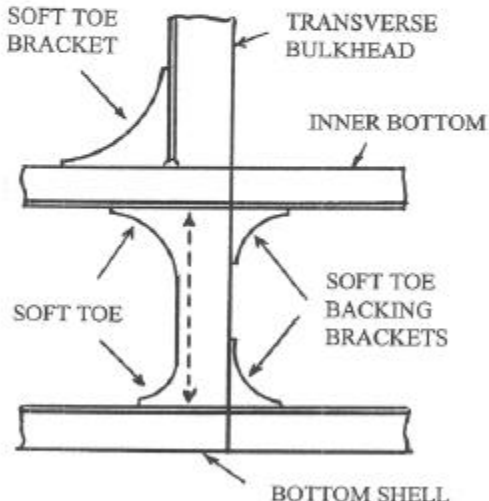
An other example which we also would like to recommend is the back brackets in the double bottom as shown in Fig. 20 in the Guidance Manual and on App. E which shows the detail as built.

| <b>LOCATION :</b> BOTTOM BALLAST TANK<br><b>EXAMPLE :</b> CONNECTION OF LONGITUDINALS TO WATERTIGHT FLOORS<br><b>NO 1</b> | | <b>GROUP</b><br><b>NO 4</b> |
|---|---|---|
| <b>FACTORS CONTRIBUTING TO DAMAGE</b> <ol style="list-style-type: none"> <li>1. Asymmetrical connection of bracket in association with a backing bracket which is too small.</li> <li>2. Relative deflection between adjacent floor and transverse bulkhead.</li> <li>3. Inadequate shape of the brackets.</li> <li>4. High stresses in the inner bottom longitudinal and the floor stiffener.</li> </ol> | | |
