**Report on the Result of Field Inspection  
conducted on  
April 19-23, 2004 in the Province of  
Zamboanga del Sur**

# **Social Sector Projects**

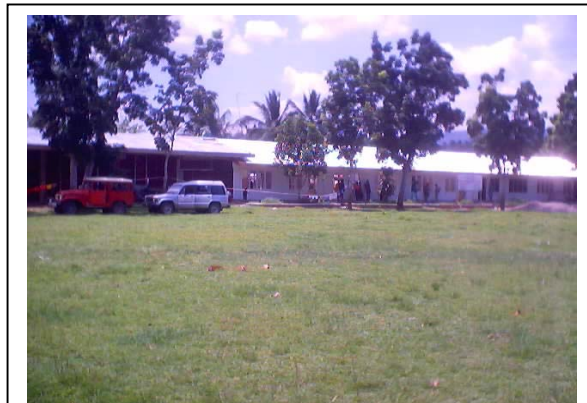
**Rehabilitation of Seven (7) Classroom**

1. During the construction phase, the contractor found out that in the scope of works, comfort rooms were not included in the program of work. Also, there were no beams in the old school building. As a result, the program of work has to be changed in order to accommodate the cost of materials of comfort rooms and the beams. In order to offset the expenses, the following changes were made:

from steel trusses to wooden trusses were used and exclusion of electrical works. Other factor for the delay of the project was due to lack or non-availability of supplies of good lumber.

2. It was also observed that contractor used only plain GI sheet instead of corrugated sheet.
3. The three (3) newly constructed comfort rooms overlapped adjacent property line.
4. The school principal informed the group that the Grade 3 books provided by the project were inadequate while the books for Grades 1, 2 4, 5 and 6 are sufficient.

1. It is recommended that before the preparation of building plan for the repair/rehabilitation, investigation or survey of the building for repair/rehabilitation be conducted first to avoid delay in the implementation caused by changes in POW.
2. Likewise, the PMO and contractor should give a file of the revised scope of works of the said repair/rehabilitation to the school officials.
3. There is a need to verify from the PMO on whether the construction of comfort rooms is within the POW in the repair/rehabilitation of school building.
4. It is recommended that the PMO should check whether the portion of the 3 classrooms encroached the adjacent property line.

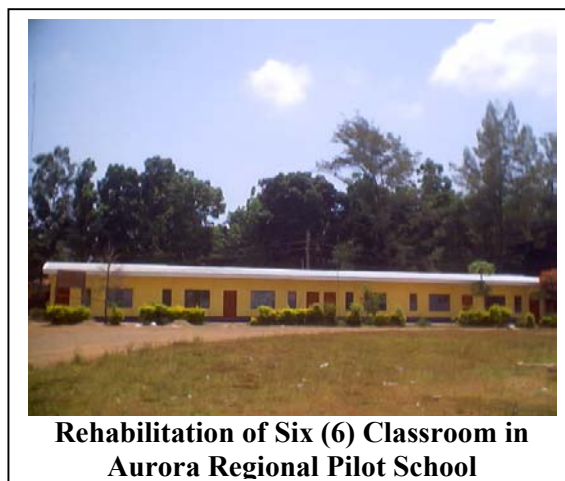
1. The school officials concerned were not involved in the preparation of the plan for the rehabilitation of the school building.
2. The comfort rooms were not constructed since they are not included in the scope of works.
3. Poor construction of the facade of the school building (front wall is not vertically straight)

1. There is a need to verify from the PMO on whether the construction of comfort rooms in the repair/rehabilitation of school building is included in the POW. Likewise, there is a need to inquire why the flooring was not repaired.
2. It is recommended that the concerned contractor should repair the front walls of the building and the poor condition of flooring.

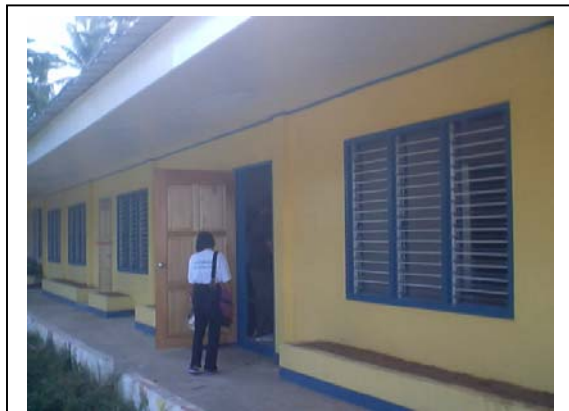
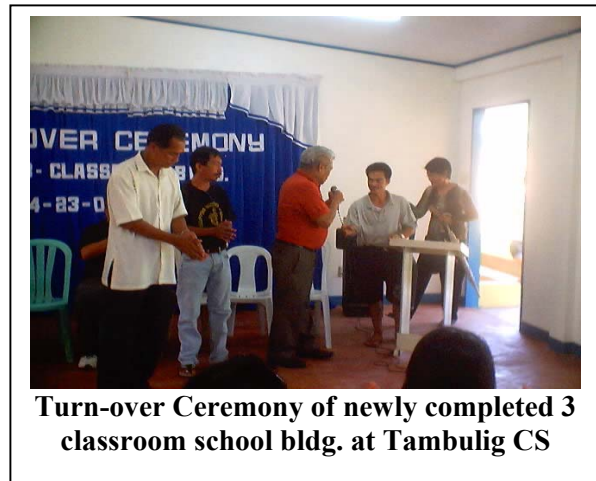
**Status:** The project is almost completed with minor finishing touches. The total project cost amounted to Php 597,323.67. The repair/rehabilitation included the construction of three (3) comfort rooms, with electrical works and with additional three (3) back doors. The material used in the roofing is color roofing.

**Findings:** Among the repair/rehabilitation project monitored, the aforementioned project is well implemented as compared to other projects visited.

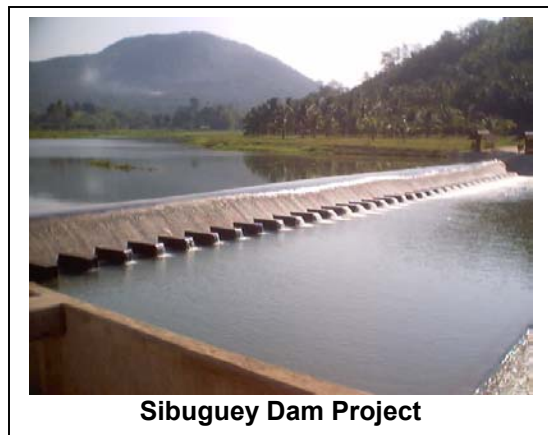
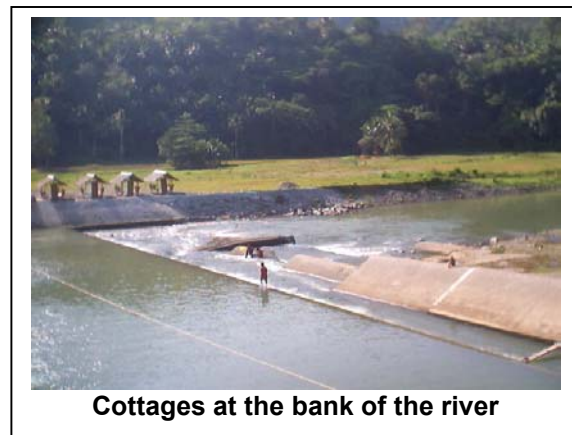
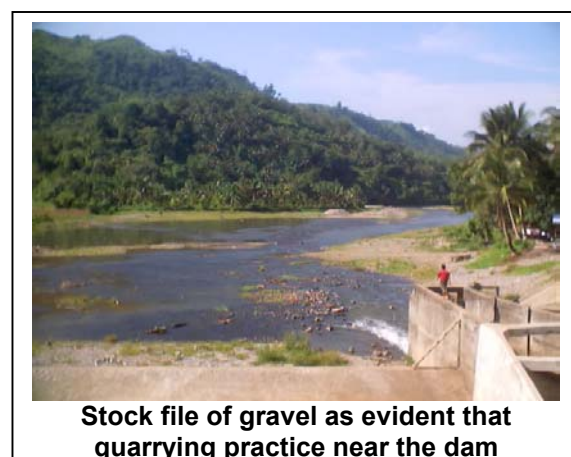
Some cottages were constructed near the dam, the plan is to make the dam as picnic ground and bathing area for local residents and visitors. Quarrying is practiced as evidence by stock files of gravel near the dam.

3. Enforce prohibition against sand and gravel quarrying within one kilometer upstream/downstream from major infrastructure (i.e., the dam site).

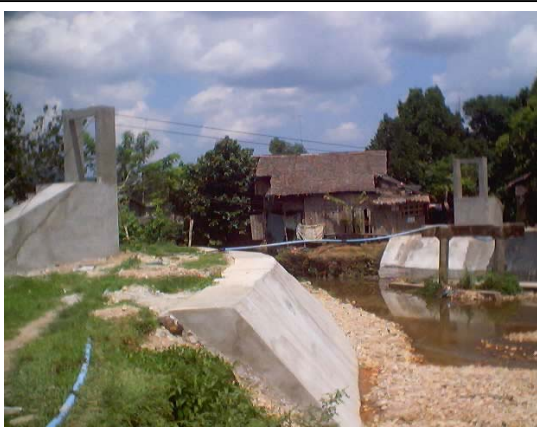
**Superstructure of the uncompleted Handina Bridge**

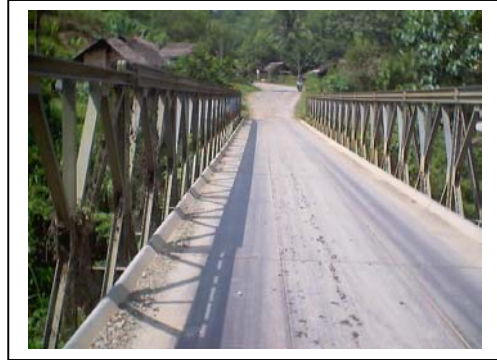
No capacity sign in one side of the approach, signs of deterioration on both approaches of the bridge since there were no flood control constructed in both the approaches. Lacks eight rings and pins on the supporting beams. Concerned LGU has incomplete data on the project since they were not consulted in the implementation of the projects. As a result, contractor is unknown to them.

LGU provide capacity signs in both approaches of the bridge, construct flood control in the both approaches to prevent scouring and check the specification of the project. Maintenance work should be done by the LGU specially on the rusted galvanized steel. LGU concerns should be consulted prior to the implementation of the project. LGU to include bridges in their maintenance program.

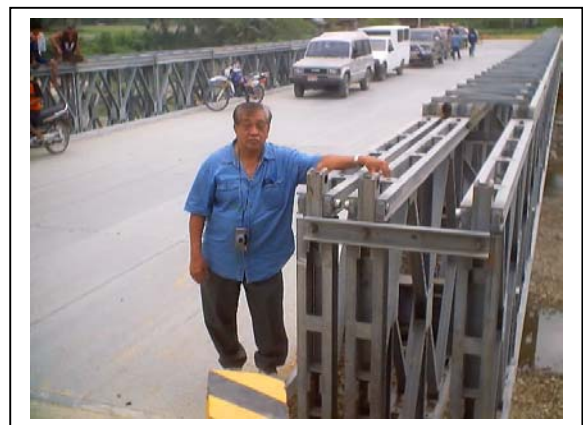
No capacity sign in both side of the approach, signs of deterioration on both approaches of the bridge since there were no flood control constructed in both the approaches and no sign of maintenance works. Cracks were seen in the right wing wall portion of the bridge. Concerned LGU has incomplete data on the project since they were not consulted in the implementation of the projects. As a result, contractor is unknown to them.

LGU provide capacity signs in both approaches of the bridge, construct flood control in the both approaches to prevent scouring and check the bolts and nuts if it loosen or tightens. Maintenance work should be done by LGU specially on the rusted galvanized steel and repair the cracks in the right wing wall. LGU concerns should be consulted prior to the implementation of the project. LGU to include bridges in their maintenance program.

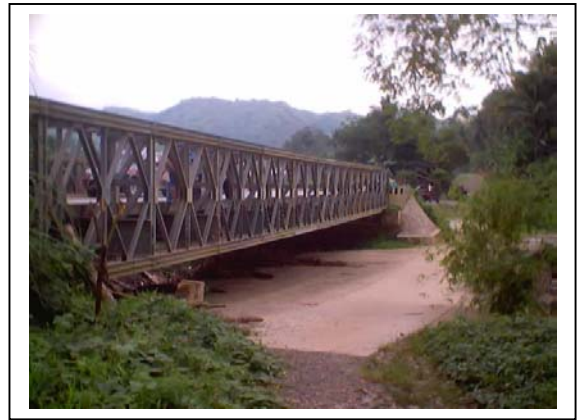
No capacity signs in both side of the approach, signs of deterioration on both approaches of the bridge since there were no flood control constructed in on the approaches and no sign of maintenance works. Concern LGU has no complete data

on the project since they were not consulted in the implementation of the projects. As a result, contractor is unknown to them.

LGU provide capacity signs in both approaches of the bridge, construct flood control in the both approaches to prevent scouring. Maintenance work should be done by LGU specially on the rusted galvanized steel. LGU concerns should be consulted prior to the implementation of the project. LGU to include bridges in their maintenance program.

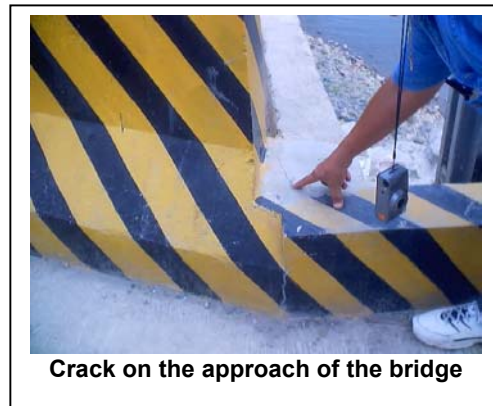
Crack on the approach of the bridge

No capacity signs in both side of the approach, signs of deterioration on both approaches of the bridge since there were no flood control constructed in on the approaches and no sign of maintenance works. Concerned LGU has no complete data on the project since they were not consulted in the implementation of the projects. As a result, contractor is unknown to them.

LGU provide capacity signs in both approaches of the bridge, construct flood control in the both approaches to prevent scouring. Maintenance work should be done by LGU specially on the rusted galvanized steel. LGU concerns should be consulted prior to the implementation of the project. LGU to include bridges in their maintenance program.

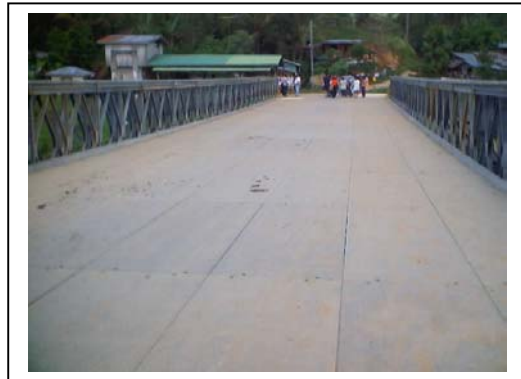
No capacity signs in both side of the approach, signs of deterioration on both approaches of the bridge since there were no flood control constructed in on the approaches and no sign of maintenance works. Road leading to the bridge is not aligned to the bridge. One side of the bridge is being used as drying of corn. Concern LGU has no complete data on the project since they were not consulted in the implementation of the projects. As a result, contractor is unknown to them.

LGU provide capacity signs in both approaches of the bridge, construct flood control in the both approaches to prevent scouring. Maintenance work should be done by LGU specially on the rusted galvanized steel. The association of farmers should make representation with the Department of Agriculture IX to provide farmers with a multi-purpose drying pavement. LGU concerns should be consulted prior to the implementation of the project. LGU to include bridges in their maintenance program.

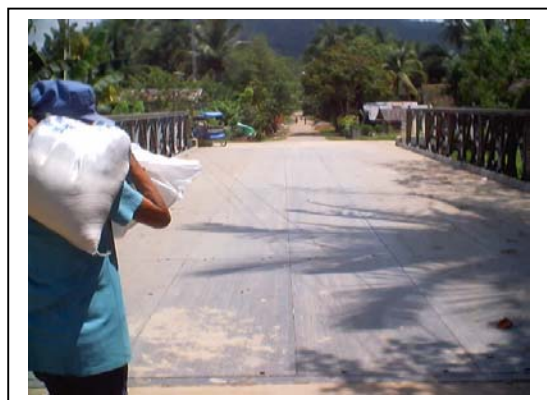
No capacity signs in both side of the approaches, signs of cracks on both approaches of the bridge due to inadequate curing of concrete. No flood control was constructed on both end of the approaches and no sign of maintenance works, trees and shrub are almost

on the bridge. Steel trusses of the bridge are being used as drying of clothes. Concerned LGU has incomplete data on the project since they were not consulted in the implementation of the projects. As a result, contractor is unknown to them.

LGU provide capacity signs in both approaches of the bridge and construct flood control in the both approaches to prevent scouring. Maintenance work should be done by LGU specially. LGU concerns should be consulted prior to the implementation of the project. LGU include bridges in their maintenance program.

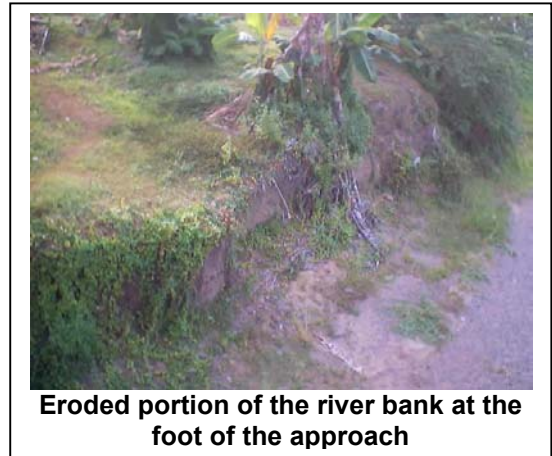
**Eroded portion of the river bank at the foot of the approach**

No capacity signs in both side of the approaches. No flood control measure was constructed on both end of the approaches and no sign of maintenance works. Concern LGU has no complete data on the project since they were not consulted in the implementation of the projects. As a result, contractor is unknown to them.

LGU provide capacity signs in both approaches of the bridge and construct flood control in the both approaches to prevent scouring. Maintenance work should be done by LGU.. LGU concerns should be consulted prior to the implementation of the project. LGU to include bridges in their maintenance program.

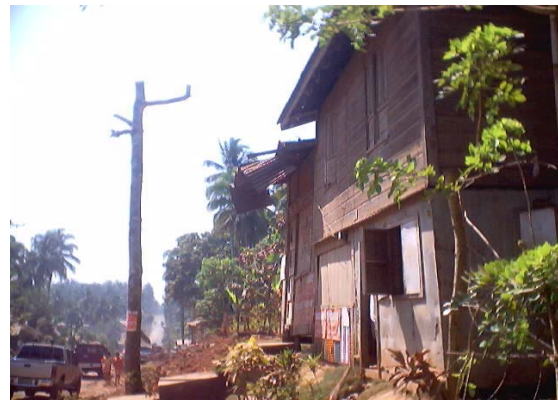
**Electric Poles and House affected**

Actual accomplishment reach to 6.45% as compared to its targeted accomplishment of 4.58% the project is ahead of schedule by 1.87%. Work is being hampered by the presence of utilities like 40 units of electric poles of ZAMSURECO, communication cable of PilTel and water pipes within road right of way. The contractor is willing to work on the relocation of the communication cable and water pipes since the cost is minimal while for the relocation of electric poles it has to be coordinated with ZAMSURECO since it will cost them Php 30,000 per pole. Accordingly, ZAMSURECO is hesitant to relocate the poles as this will result to a complete electric interruption.

Immediate relocation of affected electric poles to hasten project implementation.
