# President's Bridge Program Zamboanga Sibugay

Implemented by Tulay Ng Pangulo  
sa SZOPAD Mindanao/DPWH

***Result of Monitoring  
Conducted by RPMC IX on  
March 27-28, 2006 on the  
implementation of President's  
Bridge Projects (PBP) in the  
Province of Zamboanga  
Sibugay and Zamboanga del  
Sur***

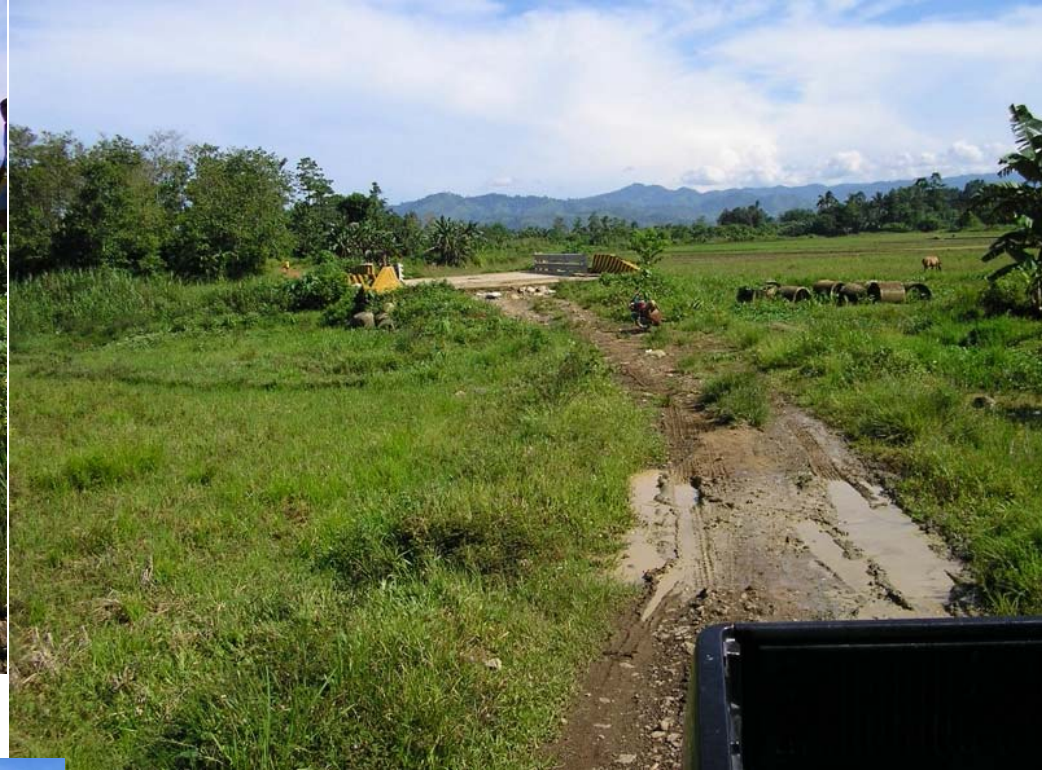
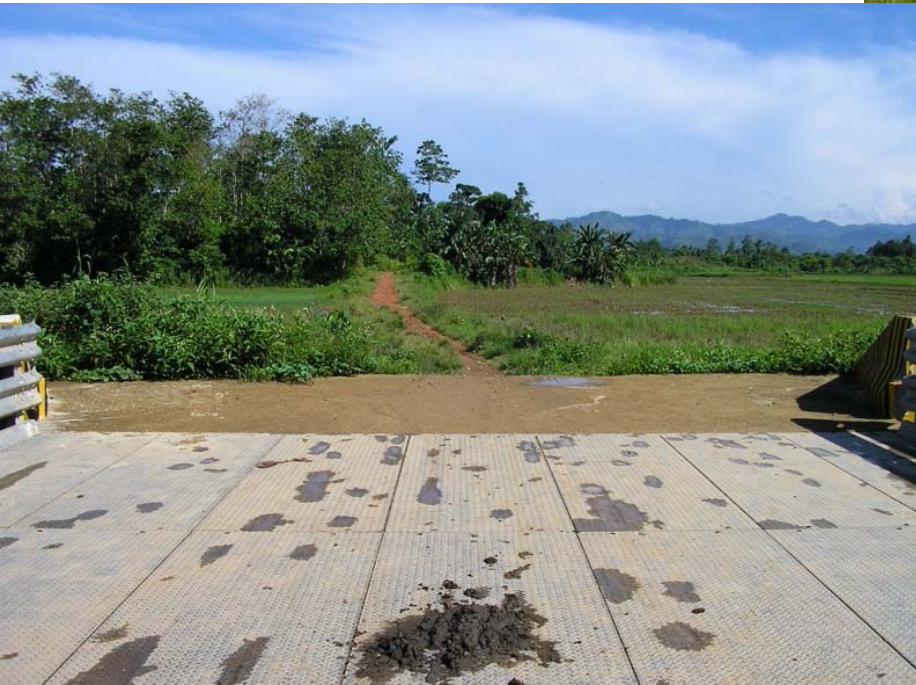
**Songcuya Bridge**

Location:  
**Diplahan, Zamboanga Sibugay**  
Project Cost: **P4,822,974.40**  
Evaluation: **No existing road. A wasted two-lane bridge leading to a small path way in the middle of a ricefield.**

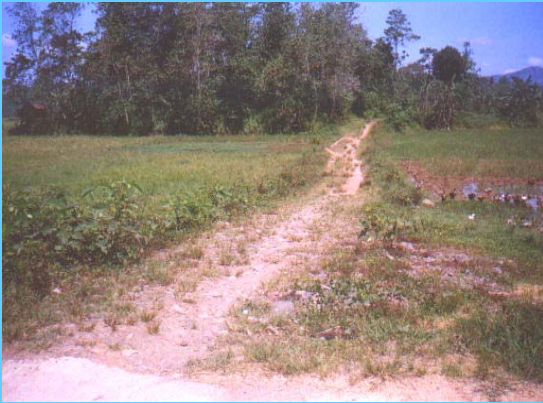
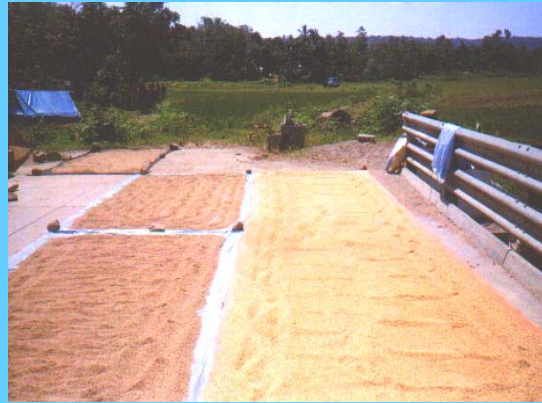
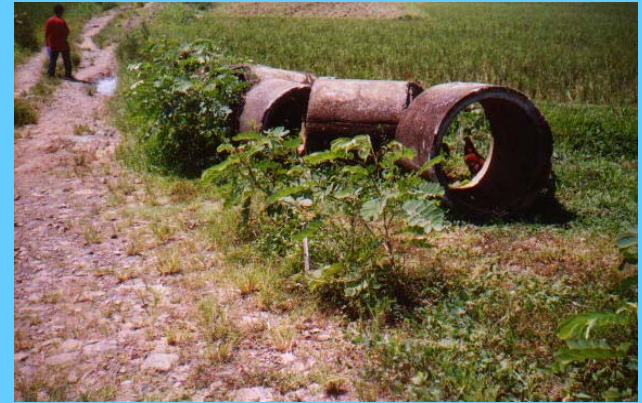
## **RPMC IX Evaluation on Songcuya Bridge, Diplahan, Zamboanga Sibugay**

- The bridge is located in the middle of the ricefield leading to a trail.
- The structure is being used as dryer of palay by nearby residents.
- Culvert pipe is also suitable for this particular project.
- Road Leading to the Bridge is unpassable. Accordingly, road to complement the bridge was already proposed in the INFRES program of DA IX.
- Lack maintenance. Grasses growing in both approaches.
- The bridge was implemented without RDC IX and PDC endorsement.

- The local government of Diplahan, Zamboanga Sibugay should maintain and upkeep the bridge to prolong its life until such time that the road to complement the bridge is implemented. Construct immediately corresponding roads

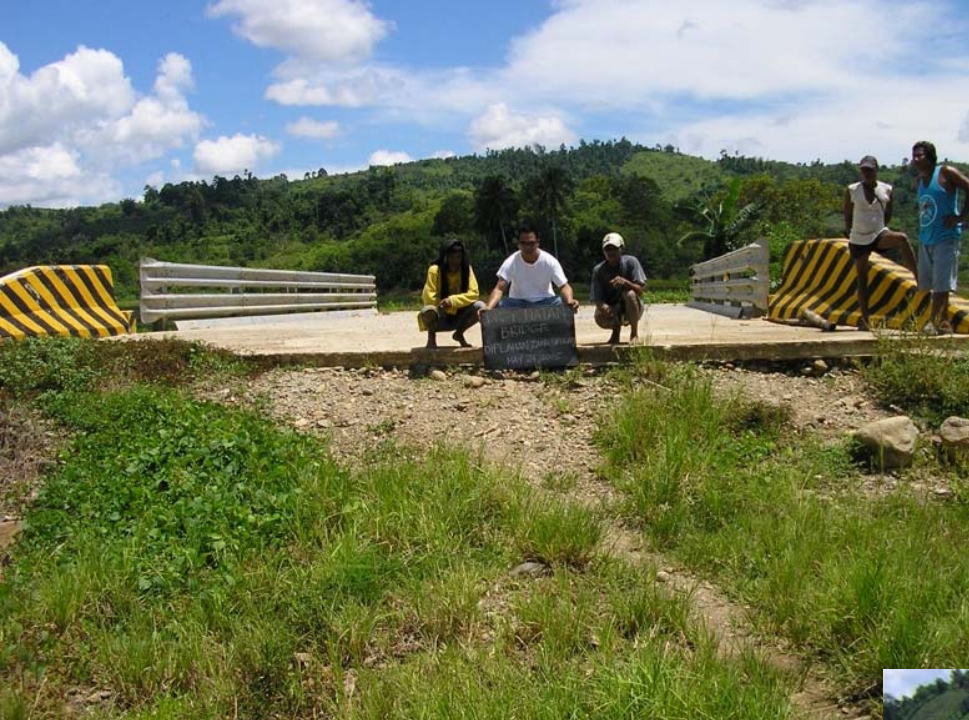
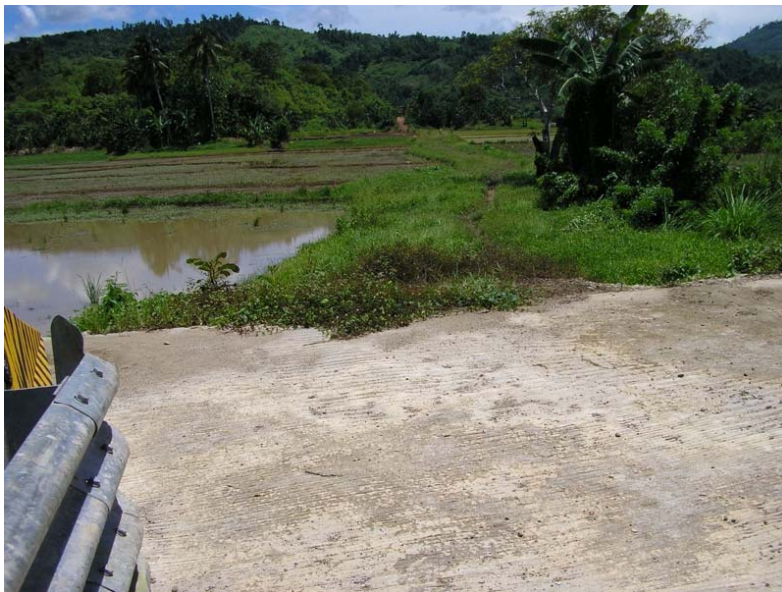
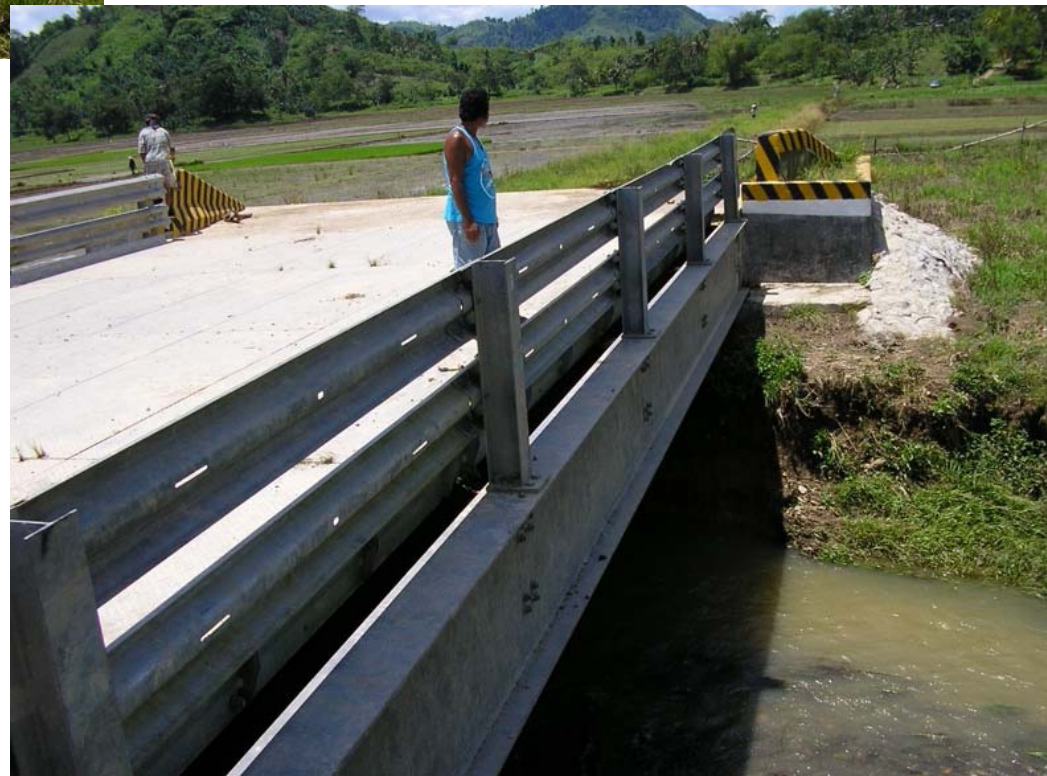
**Natan Bridge**

Evaluation:  
**A two-lane bridge built in the middle of a ricefield leading to nowhere.**

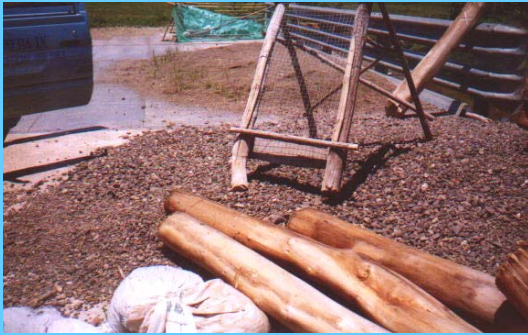
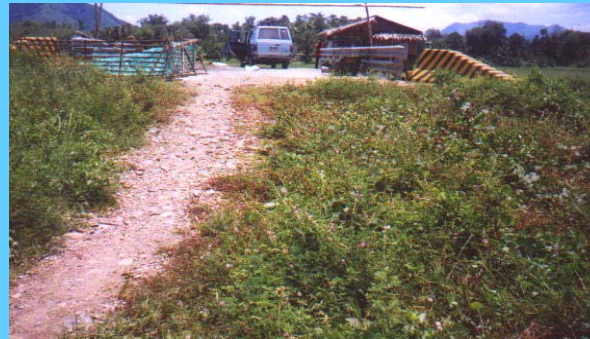
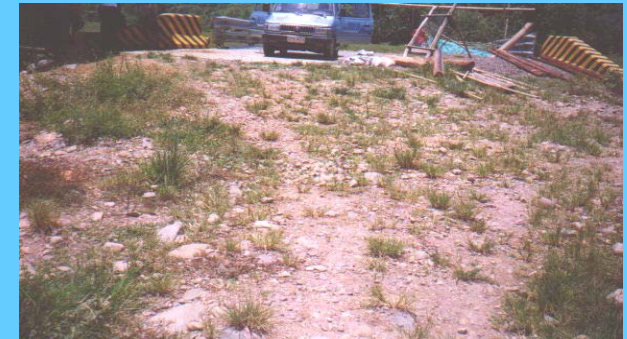
## **RPMC IX Evaluation on Natan Bridge, Diplahan, Zamboanga Sibugay**

- No road after the Bridge. Accordingly, road to complement the bridge was already proposed in the INFRES program DA IX.
- The structure is being used as hollow block making of one of the residents in the area, the deck of the bridge is being used to stock aggregates used for hollow block making and drying of finish blocks.
- Lack maintenance. Grasses are growing in both approaches as well as bushes on the trusses of the bridge.
- No flood control constructed and no capacity sign in place.
- The bridge was implemented without RDC IX and PDC endorsements.

- The local government of Diplahan, Zamboanga Sibugay should maintain and upkeep the bridge to prolong its life until such time that the road to complement the bridge is implemented.. Construct immediately road leading to the bridge. Provide flood control structure to prevent scouring of approaches and put capacity sign.

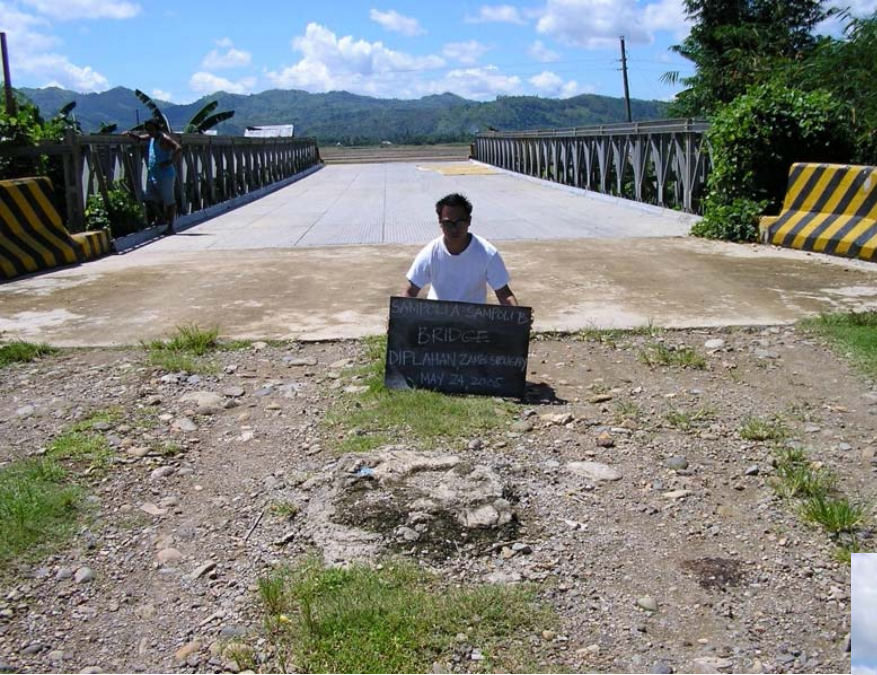
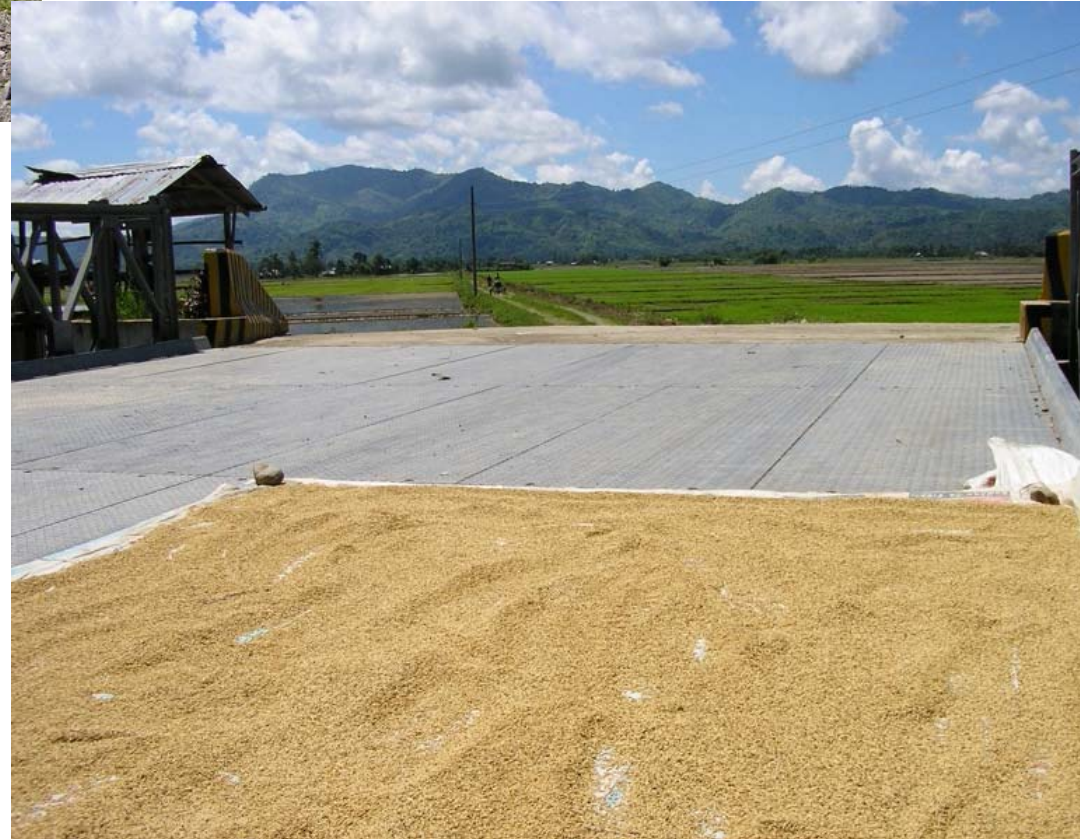
**Sampoli A- Sampoli B Bridge**

Evaluation: **A long costly two-lane bridge on a one-lane dirt road.**

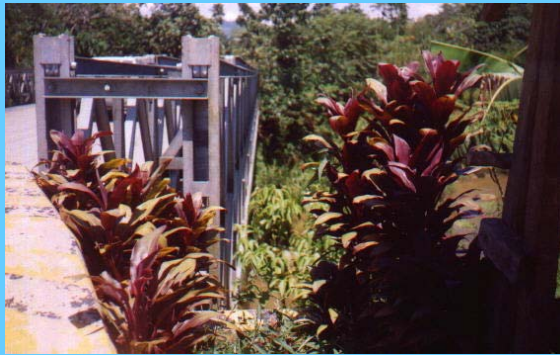
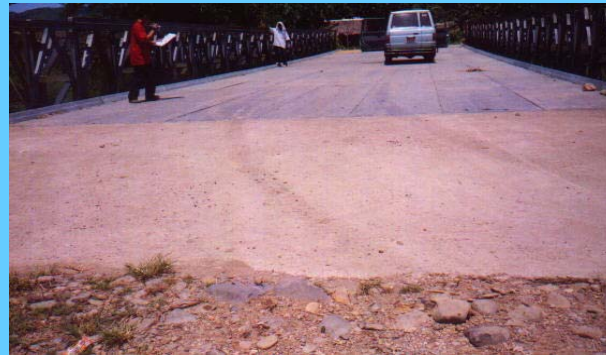
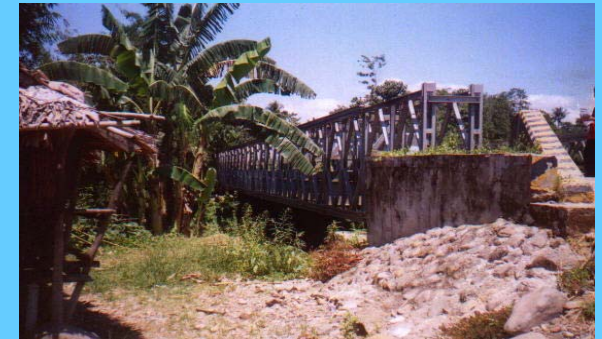
## **RPMC IX Evaluation on Sampoli A-Sampoli B Bridge, Diplahan, Zamboanga Sibugay**

- Lack maintenance. Grasses are growing in both approaches
- Bridge has a width of 7 meters constructed along the existing barangay road with a width of 4 meters. Bridge was constructed along the road leading to the municipality of Bayog, Zamboanga del Sur.
- Poor condition of approaches.
- No flood control constructed and no capacity sign on approaches.
- Implemented by virtue of PDC Res. No. 08 s 2002 and RDC IX Res. No. IX-016-2002

The local government of Diplahan, Zamboanga Sibugay should maintain and upkeep the bridge to prolong its life. Rehabilitate both approaches of the bridge. Provide flood control to prevent scouring of approaches and put capacity sign.

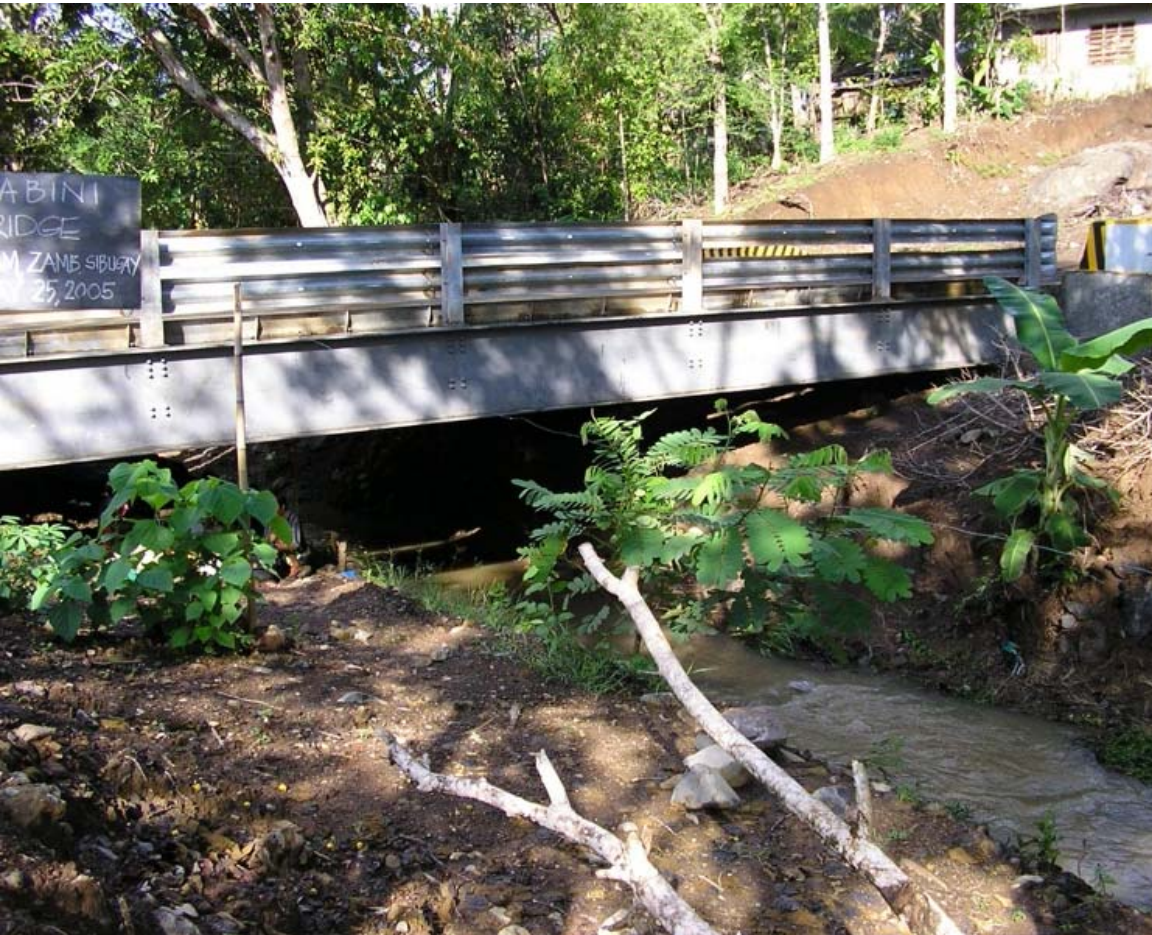
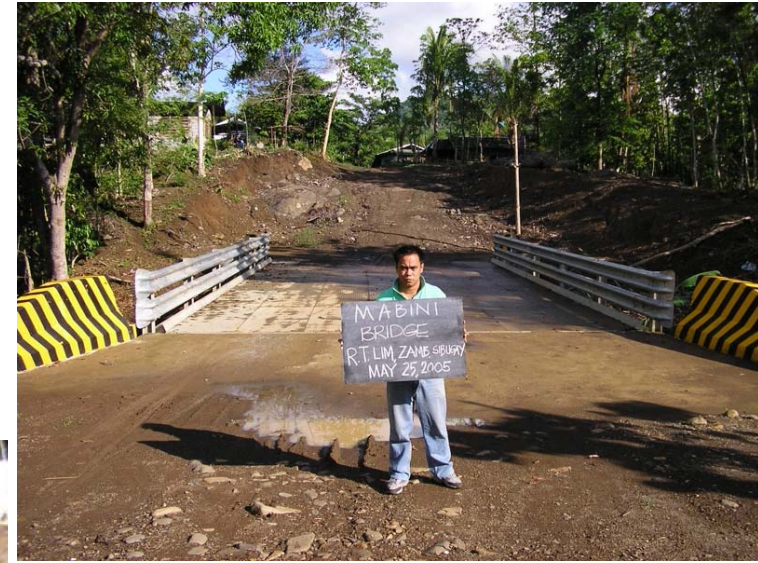
## Mabini Bridge

Evaluation:  
**A costly two-lane bridge  
built over a small creek  
leading to a one-lane  
rough road.**

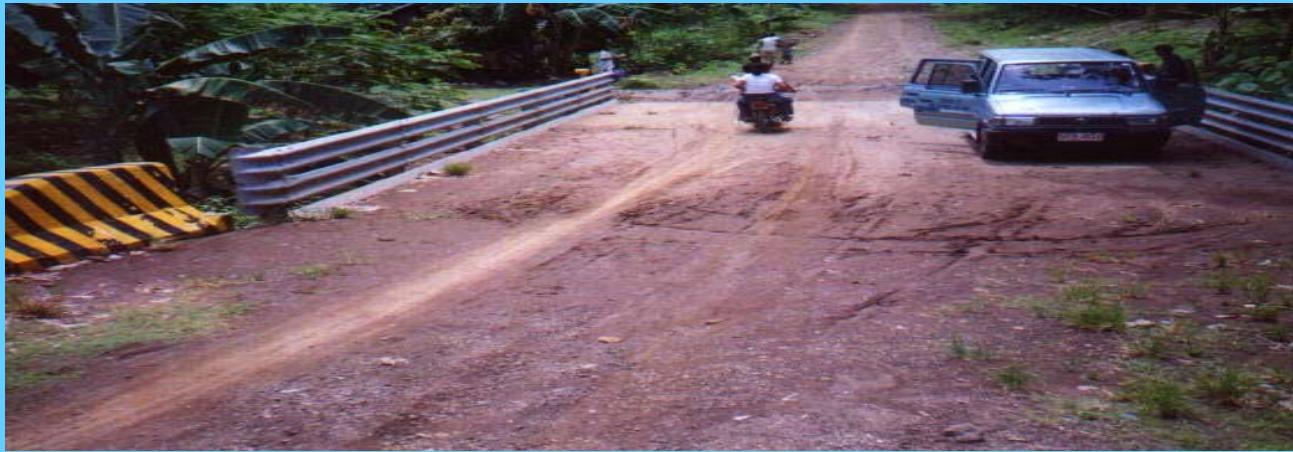
## **RPMC IX Evaluation on Mabini Bridge, R.T. Lim, Zamboanga Sibugay**

- Lack maintenance. Grasses growing in both approaches and engulfing the trusses of the bridge. Bridge has a width of 7 meters constructed along the existing barangay roads with a width of 4 meters.
- Dirt and mud covers the deck of the bridge
- No flood control constructed and no capacity sign on approaches.
- Implemented without PDC and RDC IX Resolution.

The local government of R.T. Lim, Zamboanga Sibugay should maintain and upkeep the bridge to prolong its life, cut grasses and bushes along the approaches of the bridge and which are engulfing the trusses of the bridge. Provide canals on both side of the road leading to the bridge to prevent rain water flowing on the deck of the bridge. Provide flood control to prevent scouring of approaches and provide capacity sign.

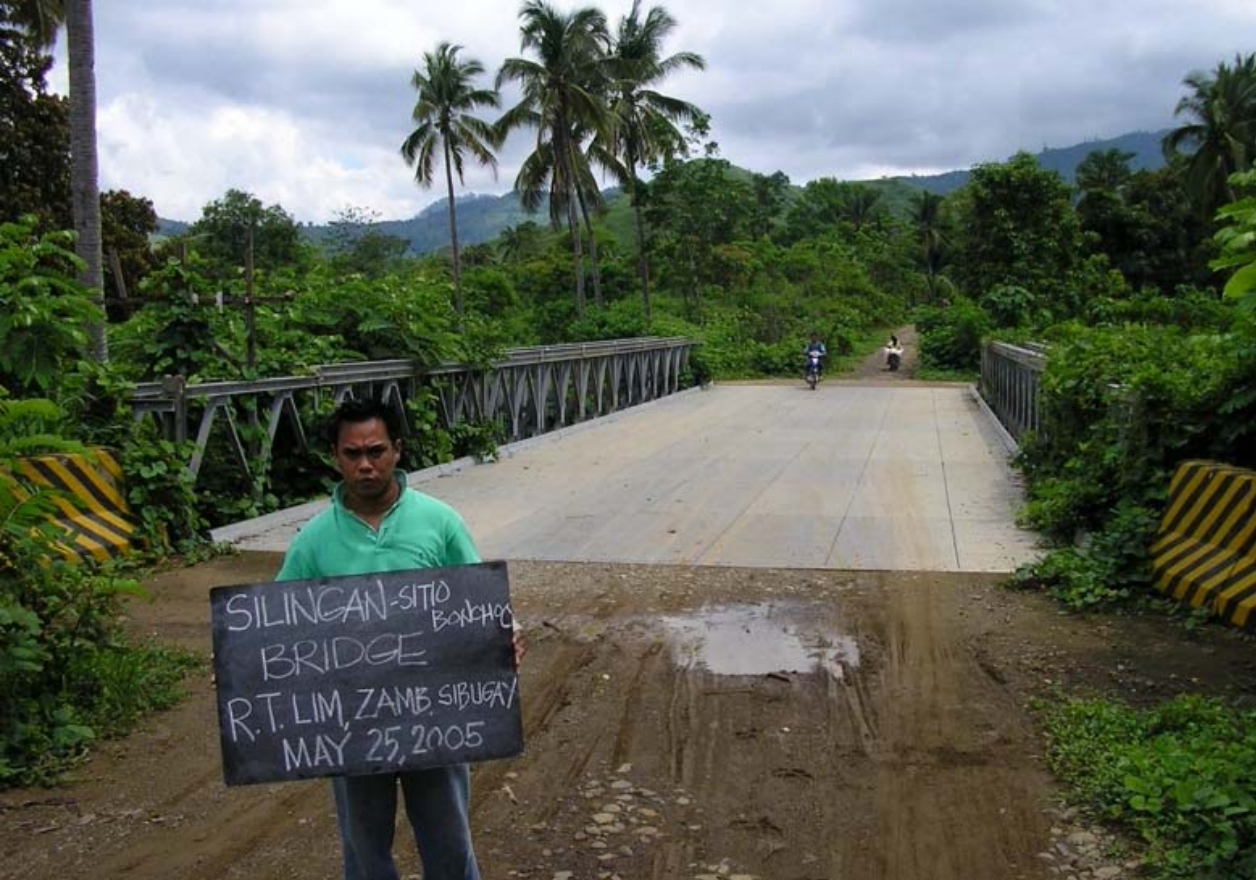
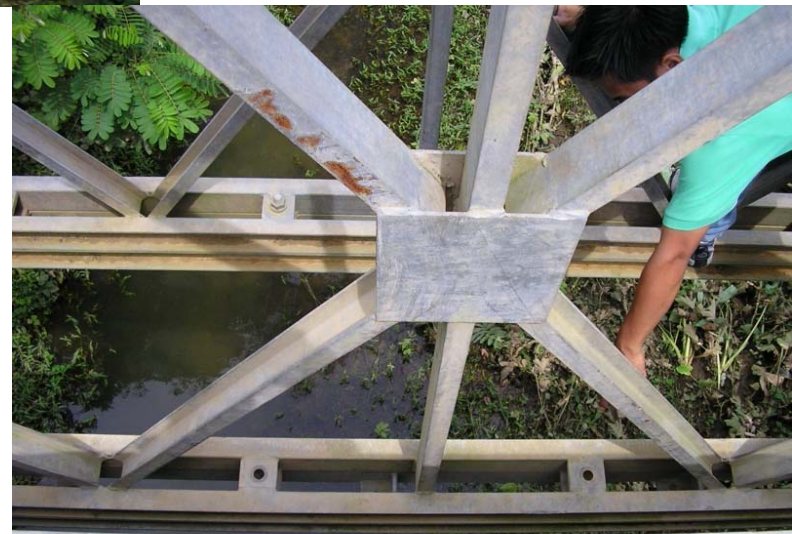
**Silingan Bridge**

Evaluation: **A costly double-lane bridge on a single lane dirt road. A number of metal screws and bolts missing.**

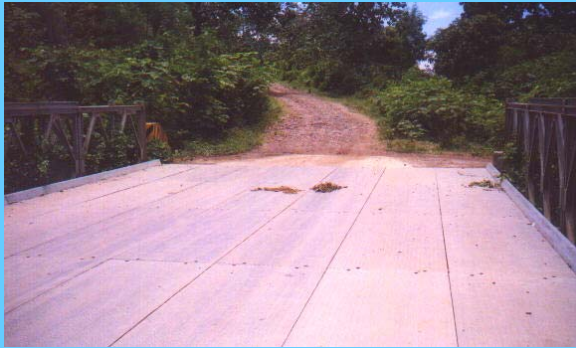
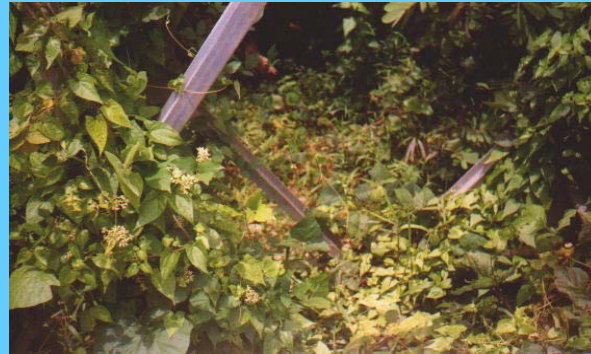
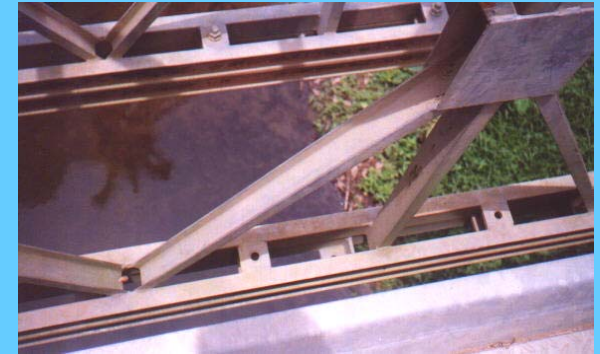
## **RPMC IX Evaluation on Silingan Bridge, R.T. Lim, Zamboanga Sibugay**

- Lack maintenance. Grasses growing in both approaches and bushes engulfing the trusses of the bridge. Dirt and mud covers the deck of the bridge.
- Bridge has a width of 7 meters constructed along the existing barangay roads with a width of 4 meters.
- No flood control and no capacity sign on approaches
- Implemented by virtue of PDC Res. No. 08 s 2002 and RDC IX Res. No. IX-016-2002

The local government of R.T. Lim, Zamboanga Sibugay should maintain and upkeep the bridge to prolong its life, cut grasses and bushes along the approaches of the bridge which are engulfing the trusses of the bridge. Provide canals on both side of the road to prevent rain water flowing on the deck of the bridge. Provide flood control to prevent scouring of approaches and provide capacity sign.

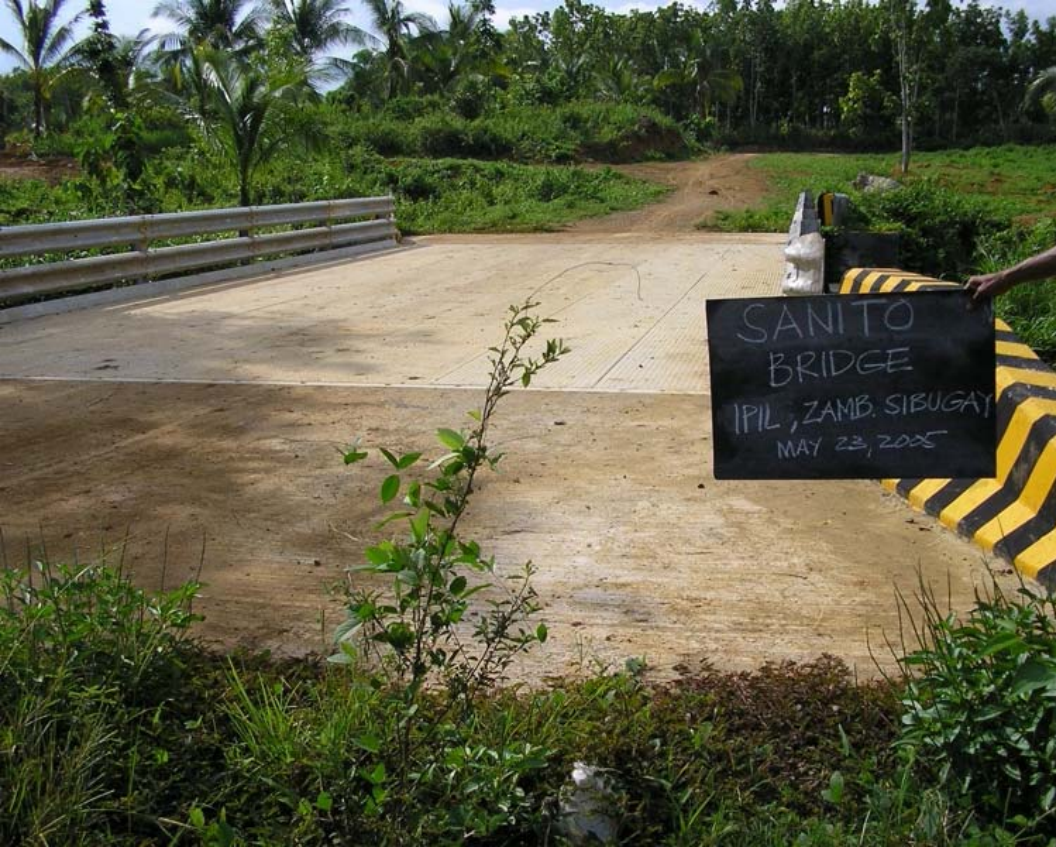
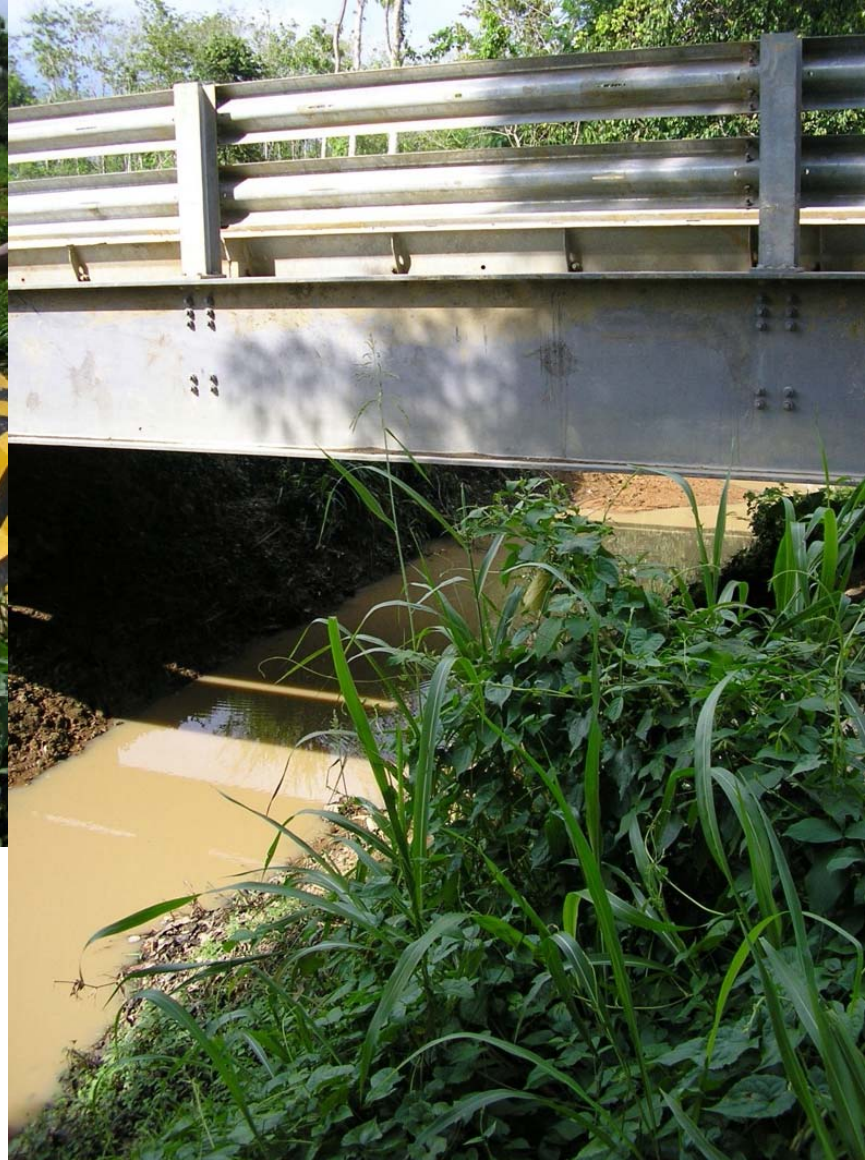
## **Sanito-Santan Bridge**

**A costly two-lane bridge on a single-lane dirt road crossing a small creek.**

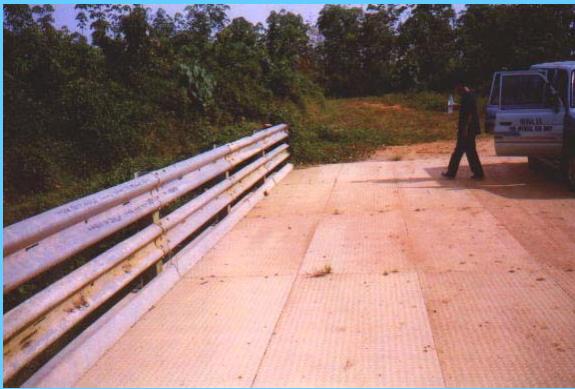
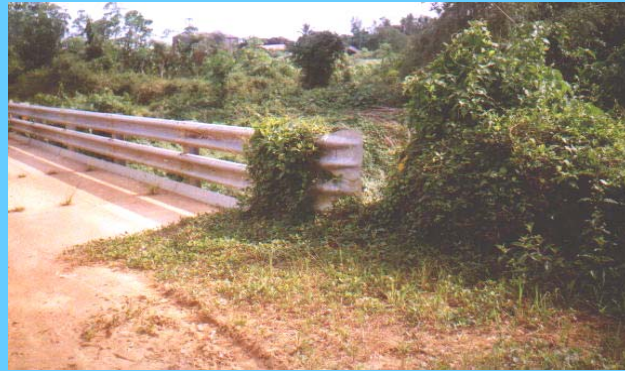
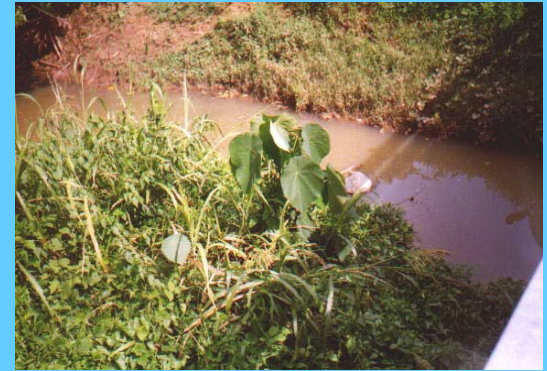
## **RPMC IX Evaluation on Sanito-Santan Bridge, Ipil, Zamboanga Sibugay**

- Lack maintenance. Grasses are growing in both approaches and bushes are engulfing the trusses of the bridge. Dirt and mud on the deck of the bridge was observed.
- Bridge has a width of 7 meters constructed along the existing barangay roads with a width of 4 meters.
- Accordingly the bridge is not being used.
- No flood control and no capacity sign on approaches
- Implemented without PDC and RDC IX Resolution

The local government of Ipil, Zamboanga Sibugay should maintain and upkeep the bridge to prolong its life, cut grasses along the approaches of the bridge and bushes engulfing the trusses of the bridge. Provide canals on both side of the road to prevent mud flowing on the deck of the bridge. Provide flood control to prevent scouring of approaches and provide capacity sign.

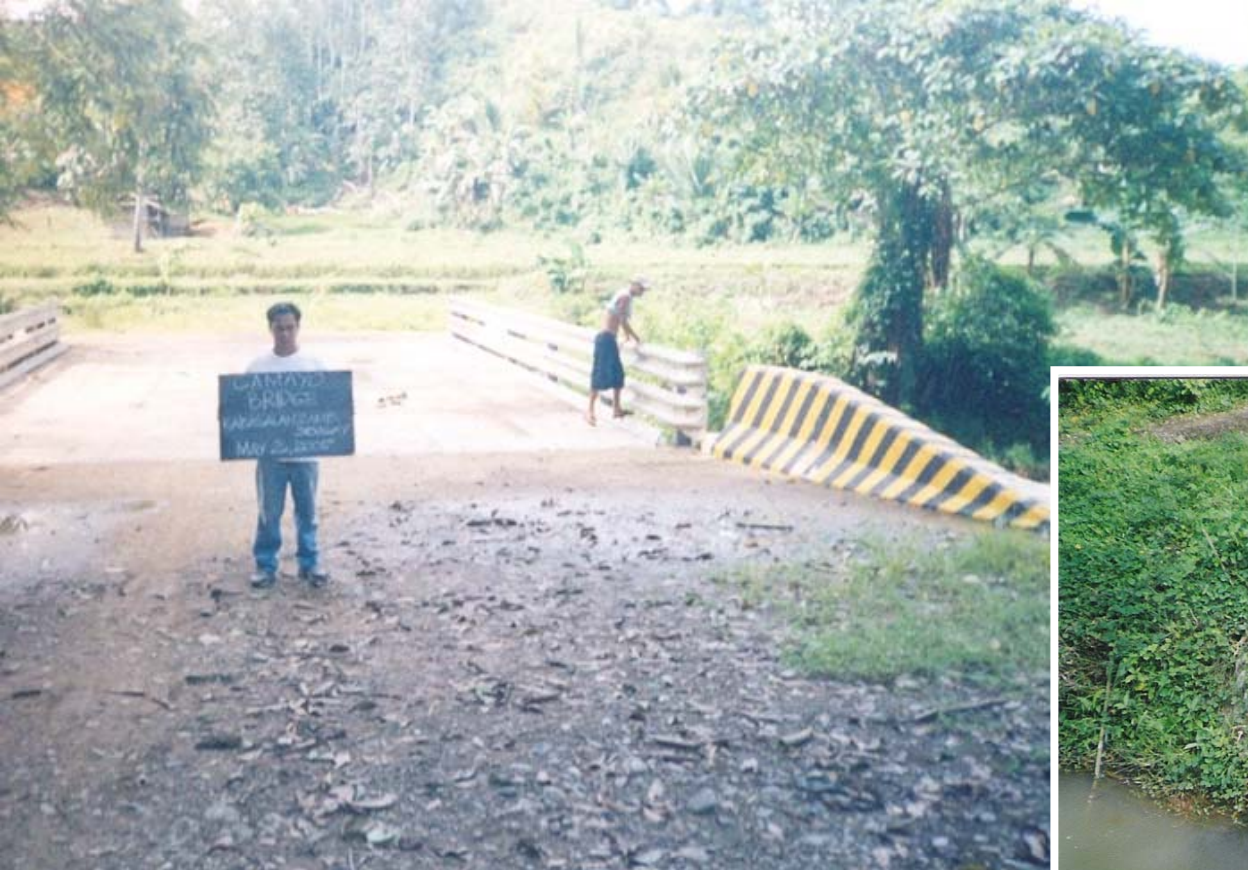
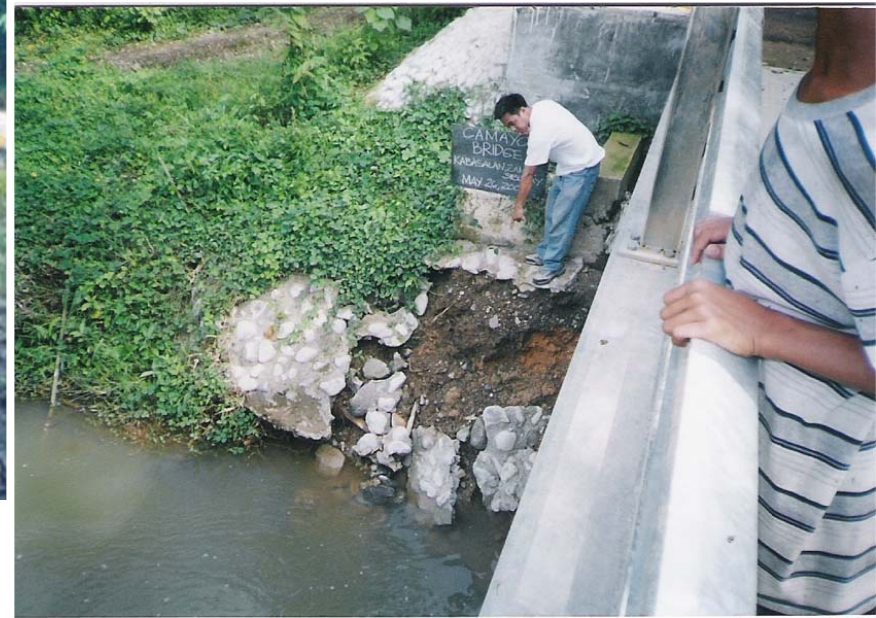
## Camayo Bridge

**A costly two-lane bridge leading to the single lane dirt road.  
Erosion under the bridge is already evident.**

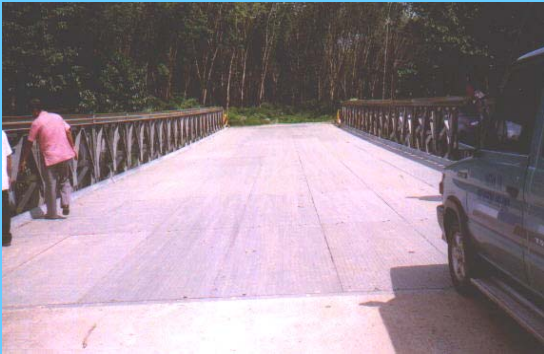
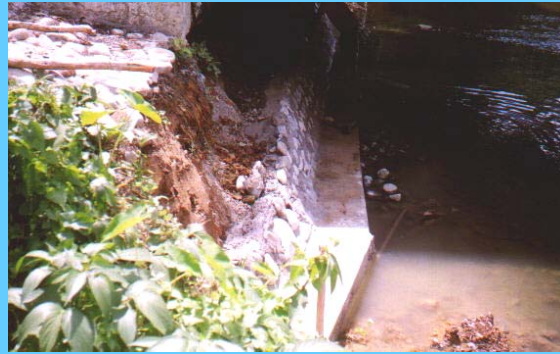
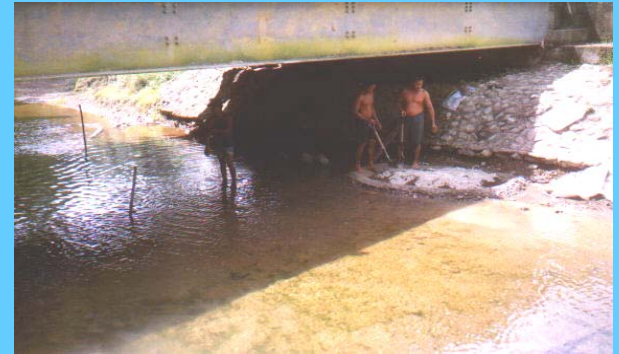
## **RPMC IX Evaluation on Camayo Bridge, Kabasalan, Zamboanga Sibugay**

- At the time of field inspection, construction of flood control is ongoing, Mayor Chu of Kabasalan is personally supervising the ongoing maintenance of the bridge. Well maintained bridge.
- The bridge connects to three (3) Barangays
- No bridge capacity sign.
- Implemented without PDC and RDC IX Resolution

The local government of Kabasalan, Zamboanga Sibugay should continue maintenance and upkeep of the Bridge. Provide bridge capacity sign

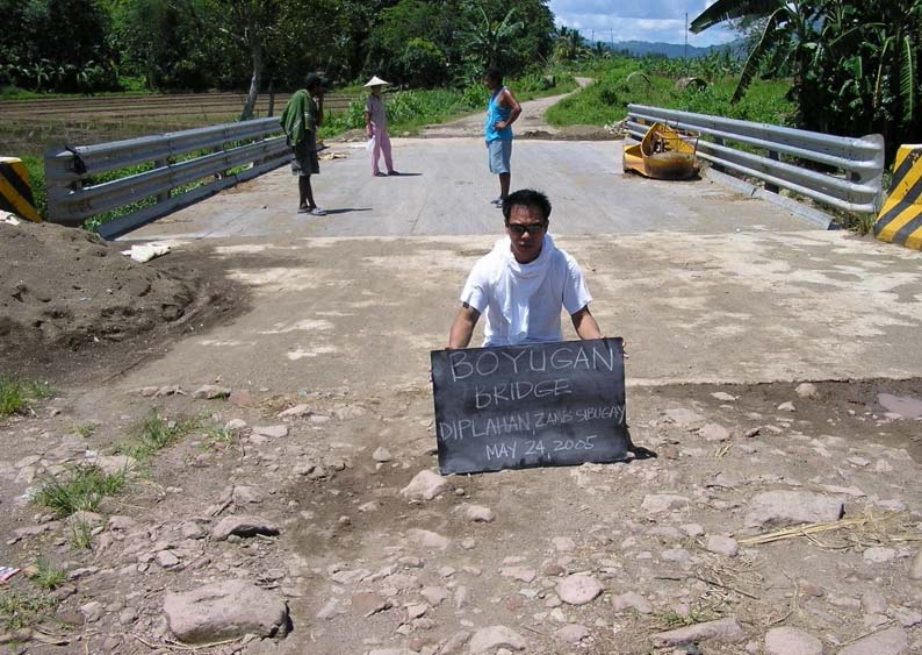
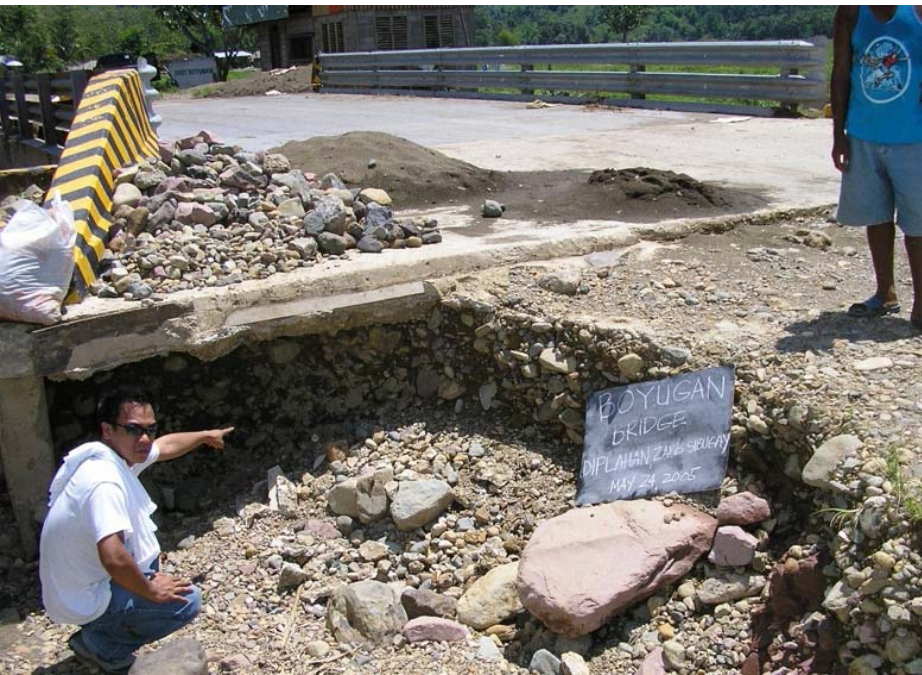
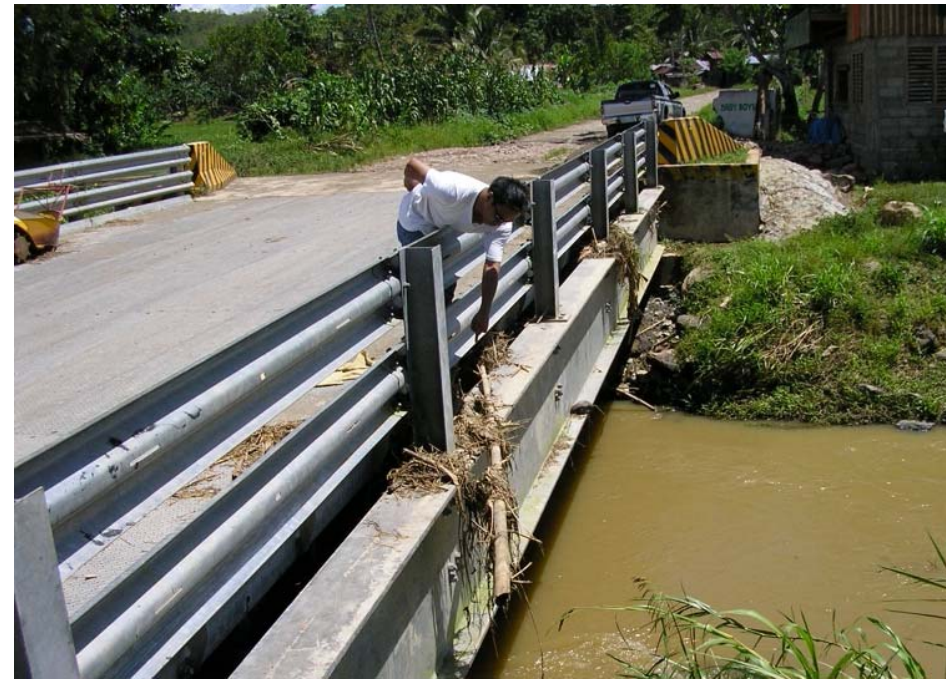
**Boyugan Bridge**

Evaluation: **A costly two-lane bridge with a weak foundation, on a single-lane dirt road. The river overflows to the bridge when the rains fall.**

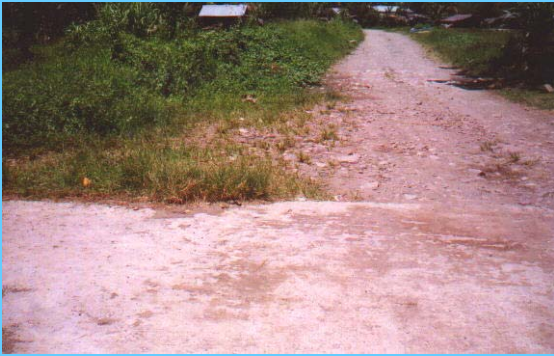
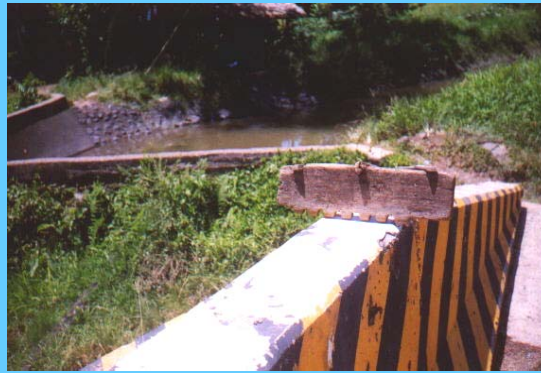
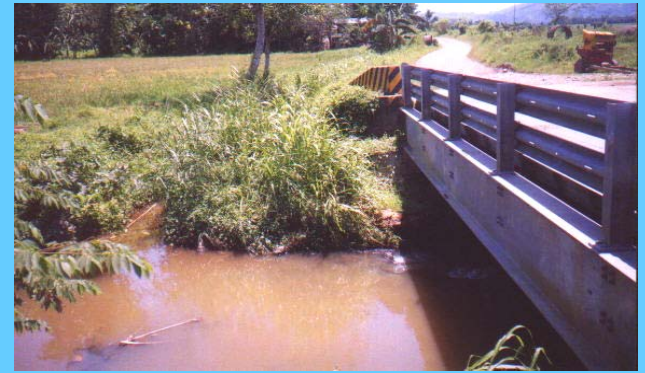
## **RPMC IX Evaluation on Boyugan Bridge, Diplahan, Zamboanga Sibugay**

- Lack maintenance. Grasses are growing in both approaches and engulfing the trusses of the bridge. There are mud and dirt on the deck of the bridge.
- Bridge has a width of 7 meters constructed along the existing barangay roads with a width of 4 meters only.
- No Capacity sign
- One side of the approach has already deteriorated due to scouring, since no flood control was constructed on both approaches
- Implemented without PDC and RDC IX Resolution

The local government of Diplahan, Zamboanga Sibugay should maintain and upkeep the bridge to prolong its life, cut grasses along the approaches of the bridge and bushes engulfing the trusses of the bridge.. Rehabilitate both approaches and construct Flood control to prevent scouring and provide capacity sign.

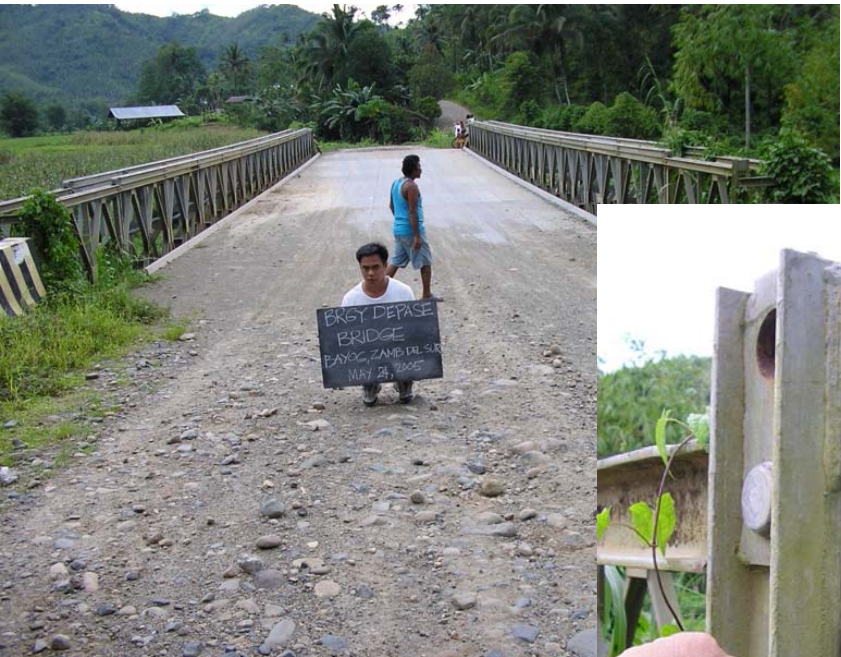
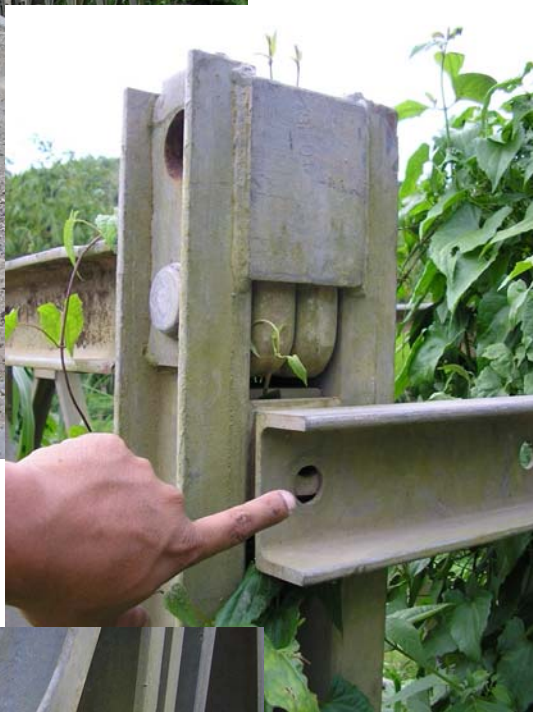
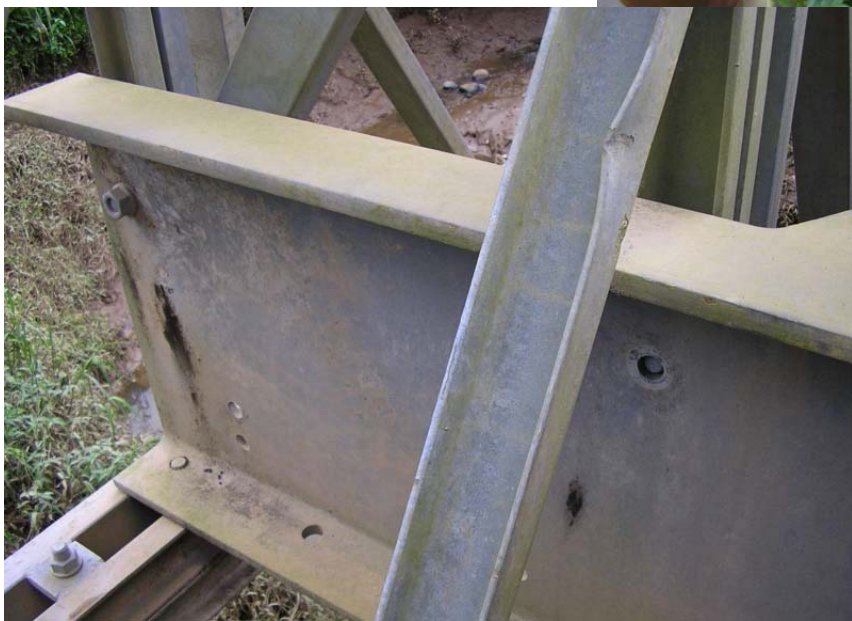
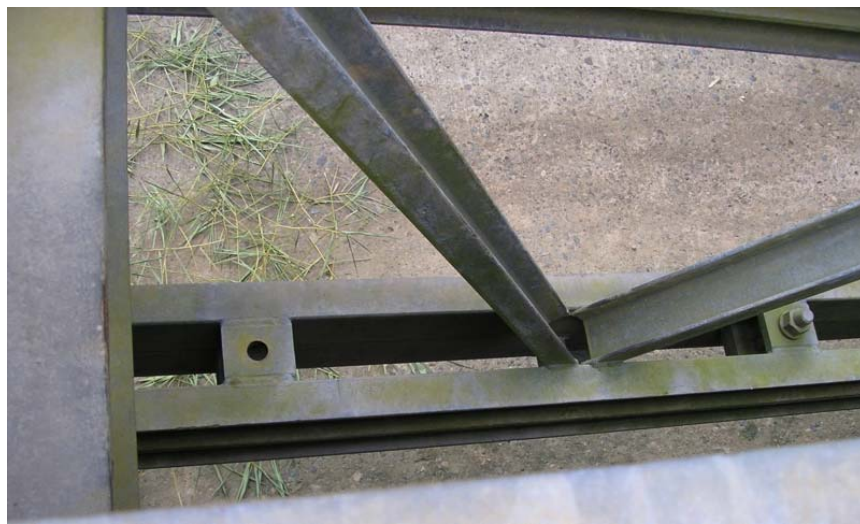
**Depase Bridge**

Evaluation: **A sub-standard  
two-lane bridge with a  
number of missing metal  
screws and bolts  
connecting to a single lane  
dirt road.**
