# President's Bridge Program Zamboanga Sibugay

Implemented by Tulay Ng Pangulo  
sa SZOPAD Mindanao/DPWH

***Result of Monitoring  
Conducted by RPMC IX on  
March 27-28, 2006 on the  
implementation of President's  
Bridge Projects (PBP) in the  
Province of Zamboanga  
Sibugay and Zamboanga del  
Sur***

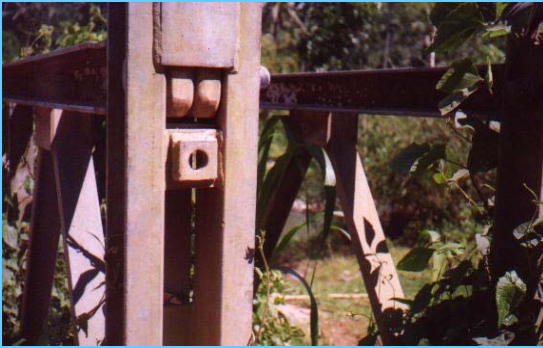
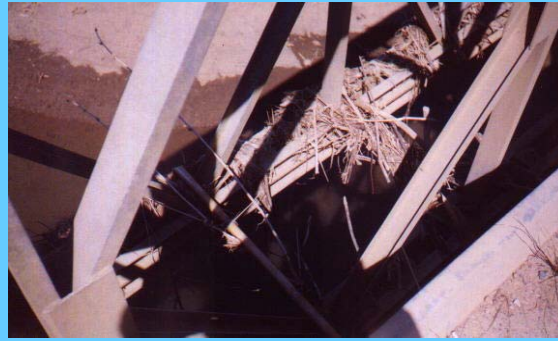
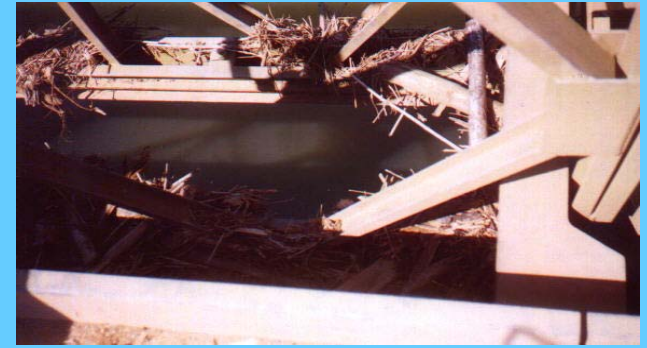
## **RPMC Evaluation on Depase Bridge, Bayog, Zamboanga del Sur**

- Lack of bolt and channel bar on the truss on one side of the bridge. Accordingly, it was cannibalized by one of the residents and charges were already filed against the culprit together with the one who bought the bolt and channel Bar.
- The bridge was constructed along provincial road that lead to Buug, Zamboanga Sibugay
- Lack maintenance. A traces of trash brought about recent flood were still hanging on the trusses of the bridge.
- No Flood Control at the approach of the bridge and no capacity sign.
- Implemented by virtue of PDC Res. No. 05-2001 and RDC IX Res. No. IX-011-01

The local government of Bayog, Zamboanga del Sur should maintain and upkeep the bridge. For the LGU to request the Tulay Ng Pangulo sa SZOPAD Mindanao/DPWH for the replacement of bolt and channel bar for the bracing of the truss that support the bridge. Construct flood control to prevent scouring of the approaches and provide capacity sign.

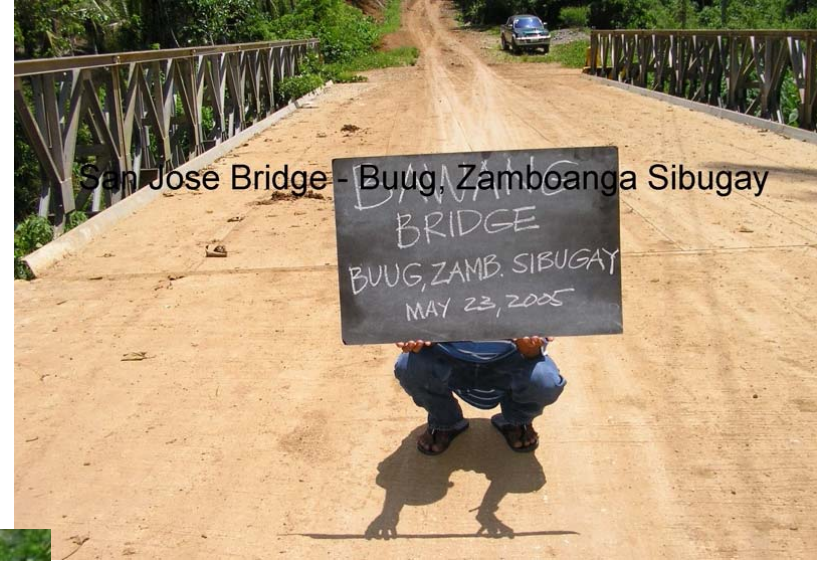
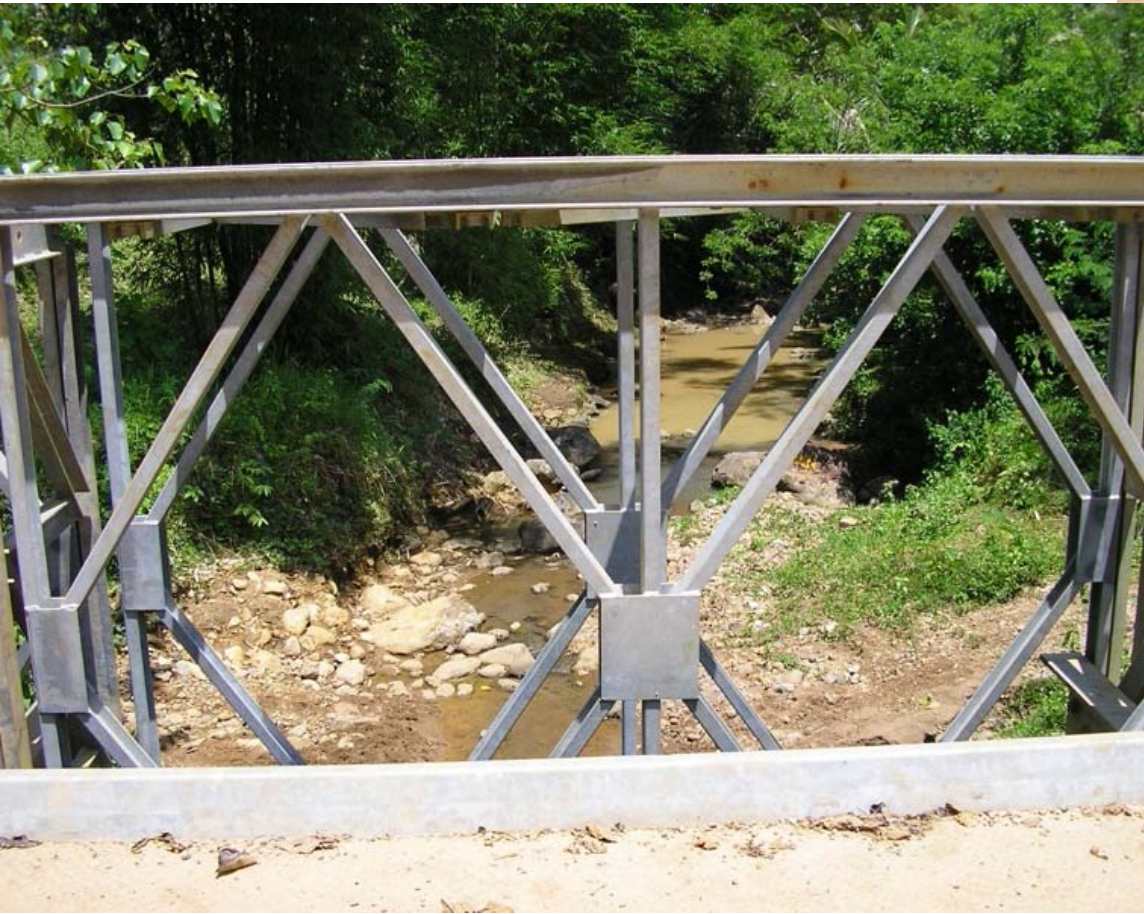
## San Jose Bridge

**Evaluation: A costly two-lane bridge leading to a single lane dirt road below, crossing a small stream.**

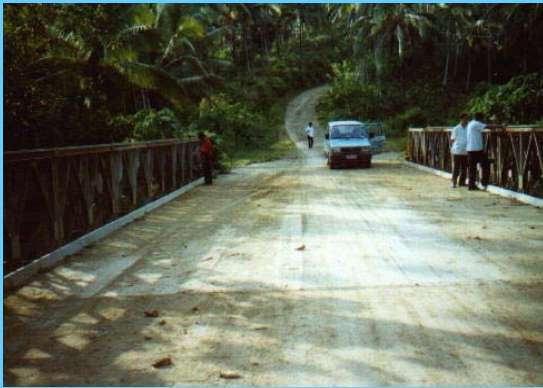
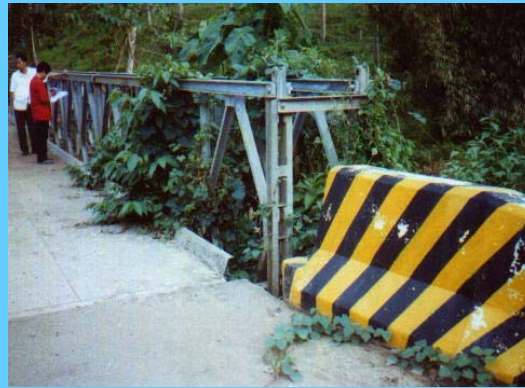
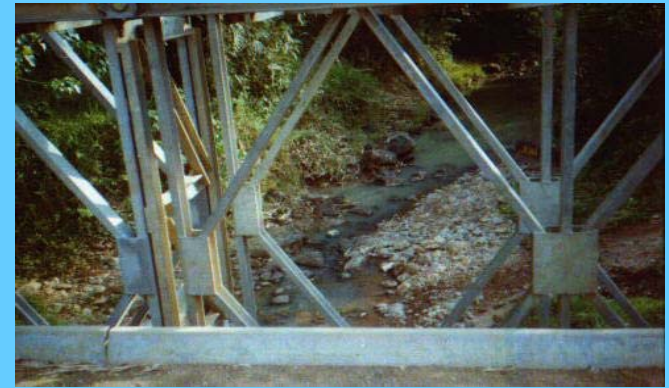
## **RPMC IX Evaluation on San Jose Bridge, Buug, Zamboanga Sibugay**

- Lack maintenance. Grasses are growing on both approaches and bushes are engulfing the trusses of the bridge
- Bridge has a width of 7 meters constructed along the existing barangay road with a width of 4 meters only.
- No Flood Control at the approach of the bridge
- The deck of the bridge was covered with mud.
- No capacity sign

The local government of Buug, Zamboanga Sibugay should maintain and upkeep the bridge, provide canals on both side of road leading to the bridge to prevent water flow on the deck of bridge. Construct flood control to prevent scouring of the approaches and provide capacity sign.
