RAPTOR G2 SE

Updated: August 6, 2007

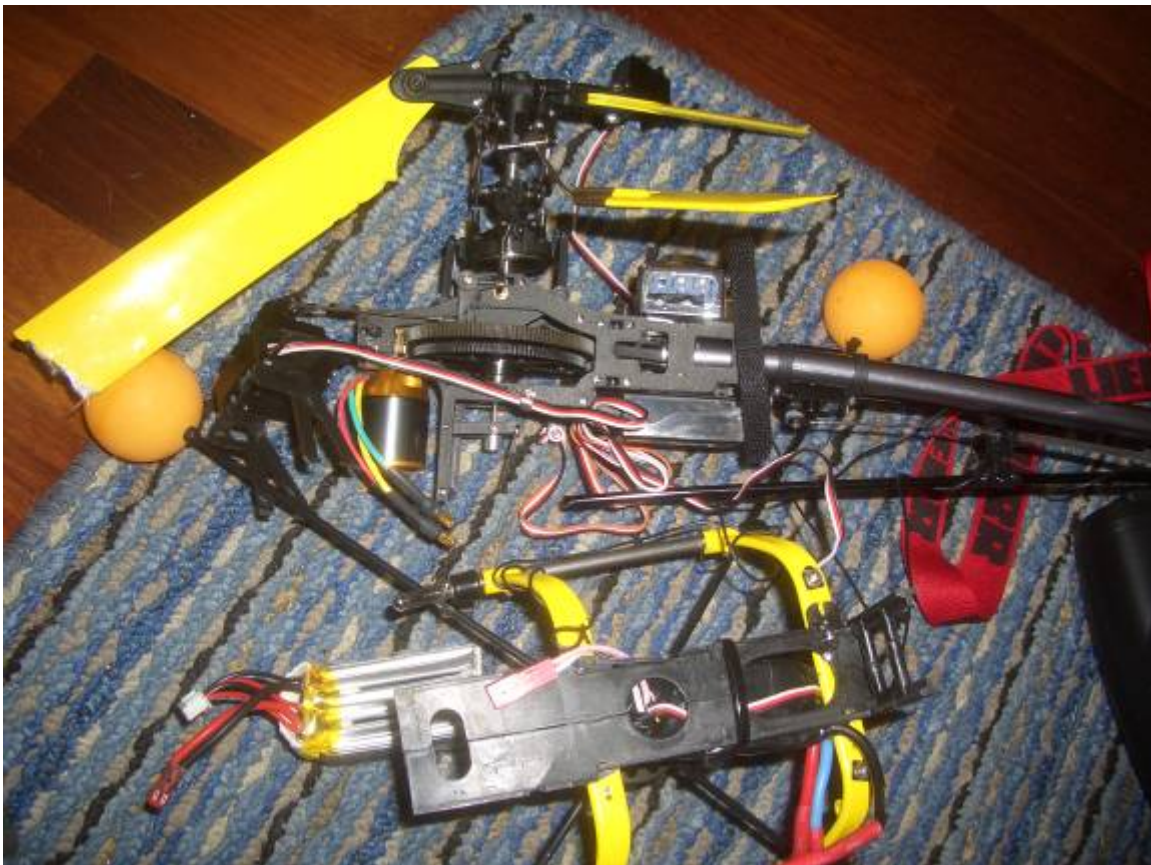
Figure 1: Accidents Happen

After this accident, a journey down a road of repairs began. The damage looks extensive, but it was quite limited considering the severity of the crash. Some parts were reused, such as the main frame, but the main blade holders were not. Ironic, since the main frame was destroyed and the holders showed no damage; it was done to reduce to risk of failure causing impalement of nearby spectators. The situation is listed in Table 1 below.

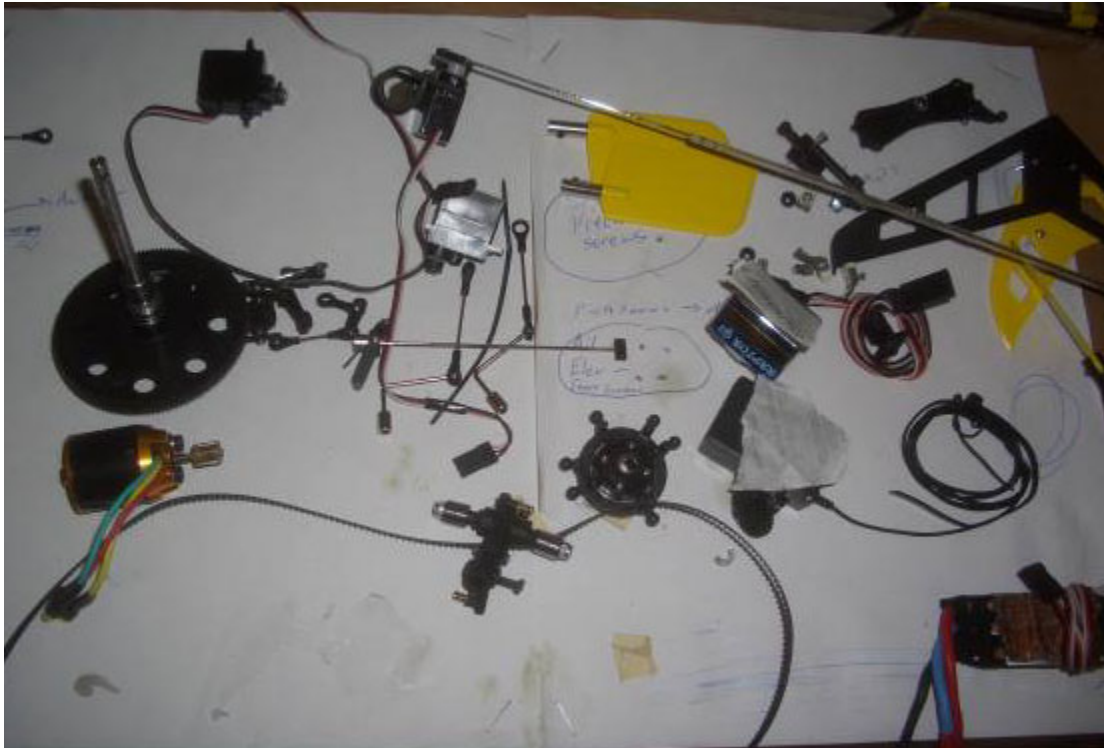
Figure 2: Raptor Parts

Organization of the parts is essential, as to not lose any screws or small parts. Recording setup notes indicating where parts are placed makes things much easier when reconstructing. An exploded view of the parts makes everything a lot easier, shown below in Figure 2 and listed in Table 2.

Most of the deconstruction is straight forward, unscrew and pull apart, with the exception of the steering dowel in the sliding set, you must remove the steering shaft before pushing out the steering dowel, confusing right? Check out Figure 8, read that section, and you'll see clearly what you must do. Click on [→ Figure 8 ←](#) to jump to the figure within this PDF. The rest of the deconstruction and reconstruction should be fairly straight forward, if you lose track of where parts go, check out the exploded diagram below.

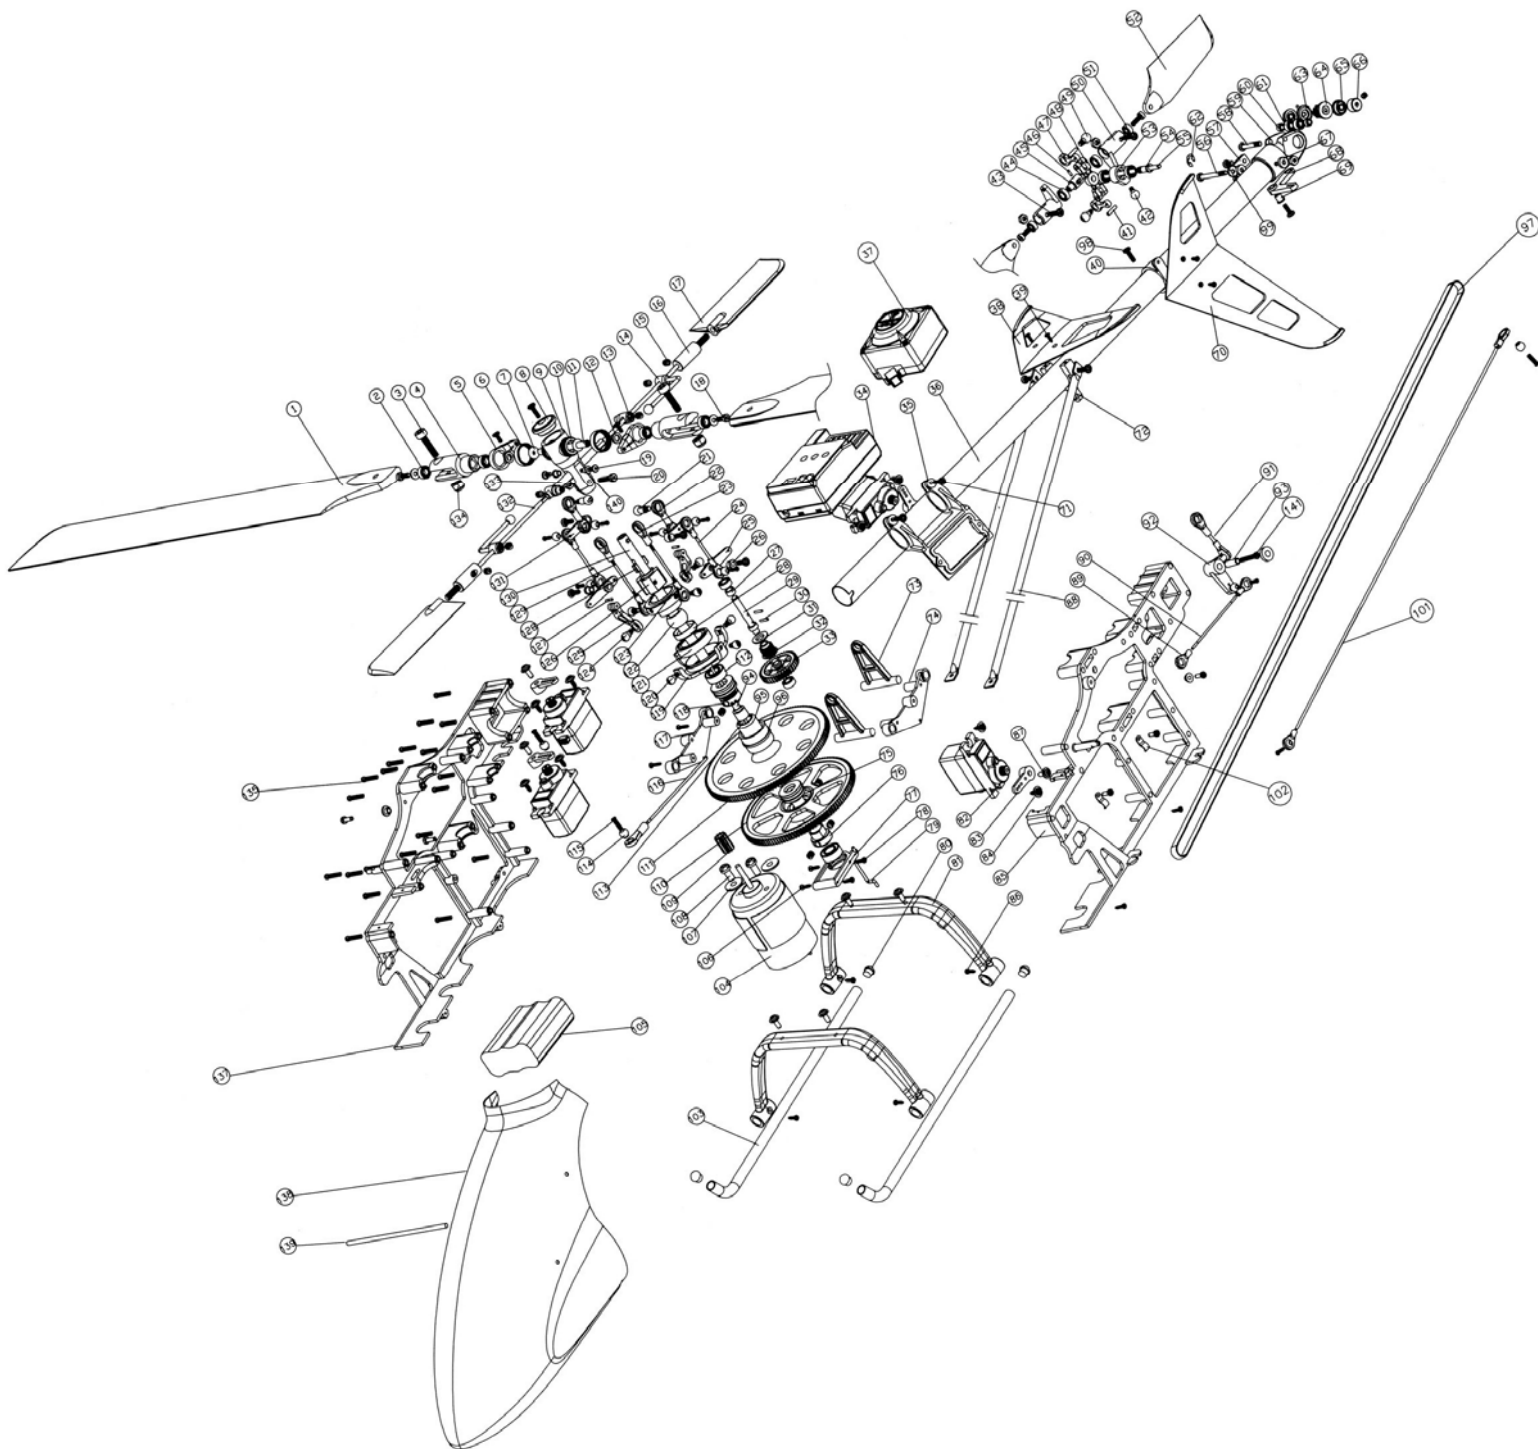
IMPORTANT: One important point that is not straight forward; the linkage heads must be pushed on by the right side, sometimes they're marked with a #5, check if this side is tapered, it should be, that's the side that must be pushed in, if the other side is pushed in, it will create a loose fit and a lot of play in the linkage will result. Thanks to FMB42 for pointing this one out.

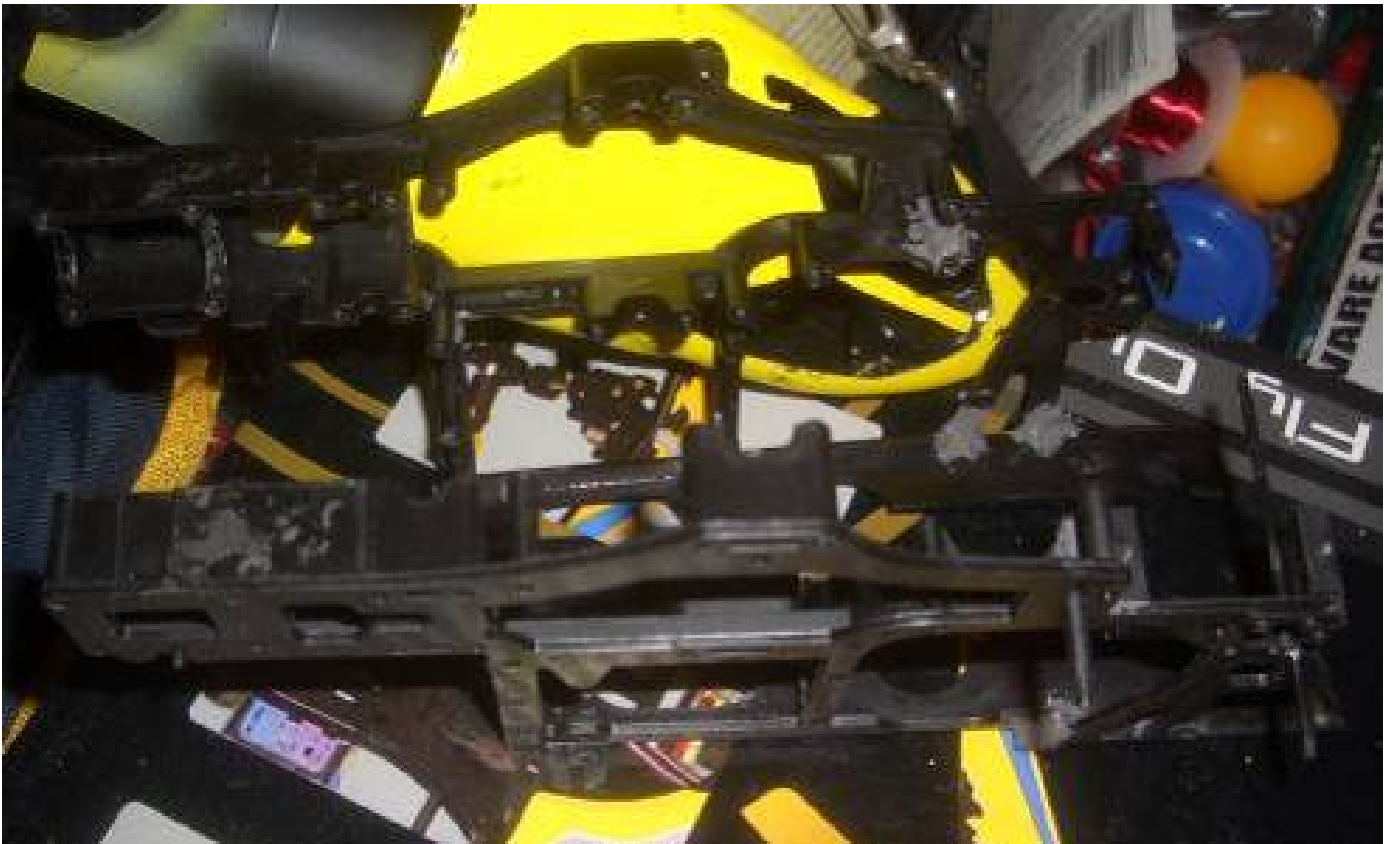
Figure 3: The Repaired Main Frame

The main frame was in 6 pieces, but was easily superglued then JB-Welded back together. Original JB-Weld was used, which means 48 hours must pass before the glue is sufficiently hardened. Once hardened it is stronger than the plastic; because of this, a small dremel bit was used to create pits and holes in the frame so that the JB-Weld could properly hold the frame together. The frame is slightly heavier than before the repairs, but is now stronger in those areas. The repairs are shown below in Figure 3. It should be noted that the frame integrity has been compromised; any non-visible damage will pose a huge risk which can lead to another crash.

The JB-Weld used to repair the frame doesn't become strong very quickly, it is supposed to cure in 24 hours, but seems to continually become stronger up to 48-72 hours. Once it is hard, the frame is tough, twisting and pulling doesn't cause much stain. The body was screwed together with the gears placed inside. The canopy holder is superglued at one side so that it doesn't move around. Everything is assembled, and prepared for the arrival of new parts. Parts begin showing up.

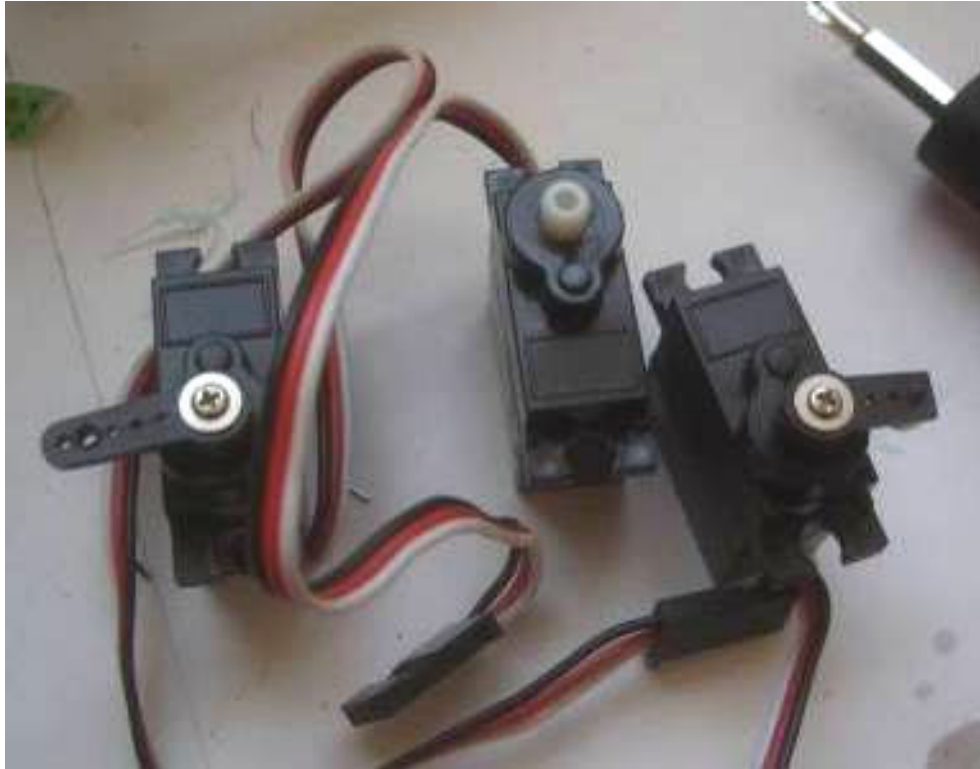
Figure 4: New Servos

Nitroplanes shipped 3 servos, one without a horn, one with a horn ready for insertion as the pitch servo, and one with a horn and ball joint ready for installation as a cyclic servo. It is very helpful that Nitroplanes understands damaged servos also mean damaged horns and balls. The servos are all installed and adjusted, as shown below in Figure 5.

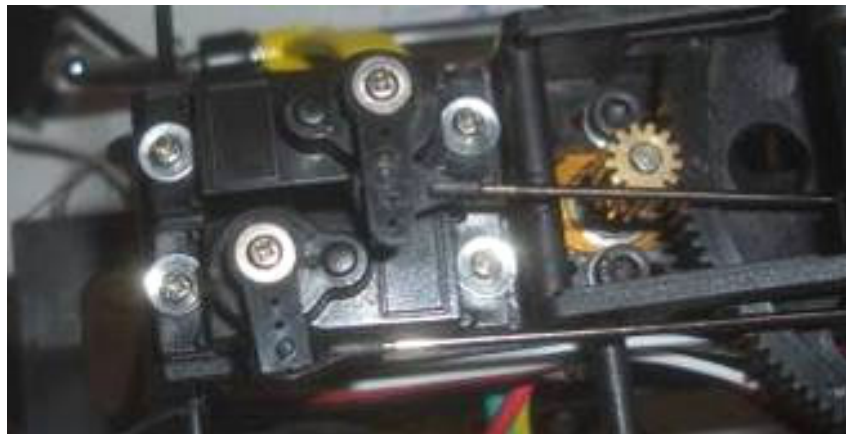
Figure 5: Cyclic Servo Setup

Everything was powered up with all servo horns removed, the servos plugged into the receiver, and trims set to center on the remote. Once the servos all centered, the power was unplugged and horns were all placed as close to perpendicular to the strike of the

servos as possible, as shown above in Figure 5. The pushrod adjustments were adjusted later, which is in ADJUSTMENTS.

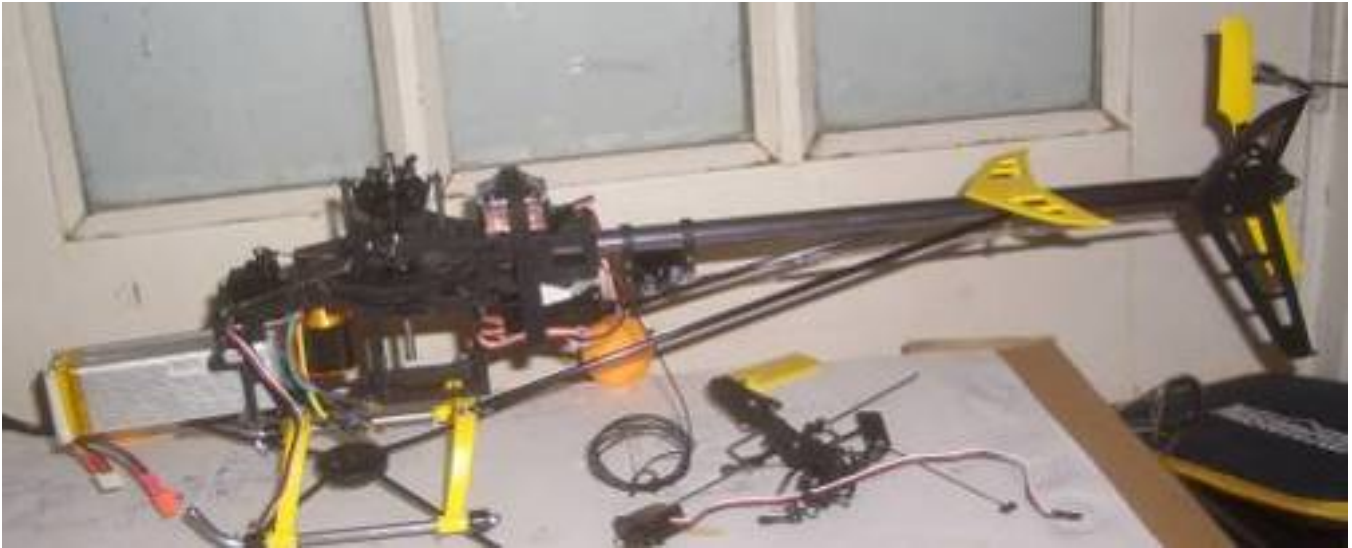
Figure 6: Completion is on the Way

With all electronics in place, the Raptor has come a long way, but is far from the end of the road. The new main shaft is firmly installed so that it doesn't come loose during flight; the 2 bolts holding it in place have come loose before, they need to be very tight, it is suggested that all critical parts be CA'd, superglued, or loctite'd. While we're on that subject, my swashplate almost fell apart during flight, a postflight inspection found that the bearing cover had fallen off, I bent the rim of the cover so it would be snug, and pushed it back in. The swashplate assembly is in 3 major parts, these parts should be CA'd, but they are not, the chances of the swashplate falling apart mid-air are high, it happens with this design very often, it should be taken apart and CA'd.

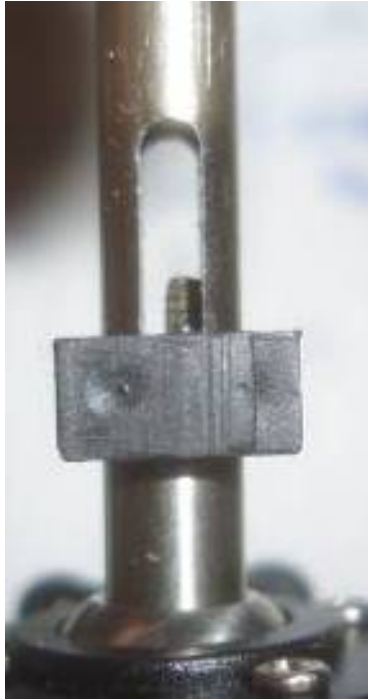
Figure 7: Steering Dowel

Figure 7 above shows the steering dowel outside the slot in the main shaft. The amount that the center rod must penetrate the steering dowel is a fine adjustment that must take place properly, or else complete loss of control could occur during flight. I found that holding the bottom of the center rod with needle nose pliers and turning the rotor head was the best way to install the rod, rather than turning from the bottom, where clearance is limited.

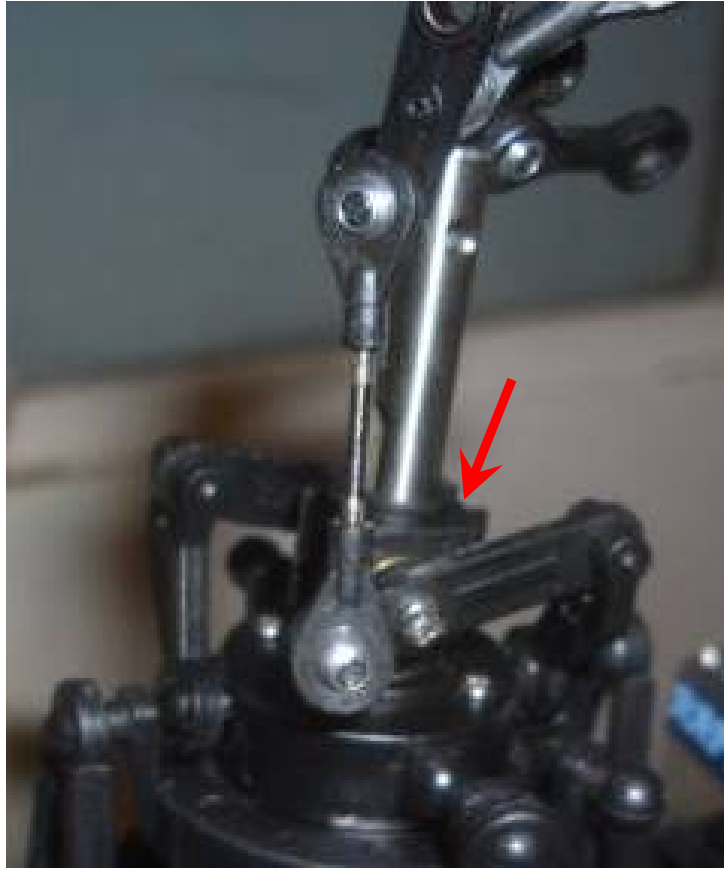
Figure 8: Shaft Sliding Set

Once the sliding set has been put in place right-side-up, pointed out in Figure 8 by the red arrow, the steering dowel can be pushed into the center and through the main shaft slot; this sliding set can be installed upside-down, double check that this doesn't happen. The center shaft (small rod that controls the pitch by moving the sliding set) was turned clockwise from below until it screwed into the steering dowel; the distance it penetrates is adjusted in detail once all assembly is complete; how this was done is told in the chapter on adjustments.

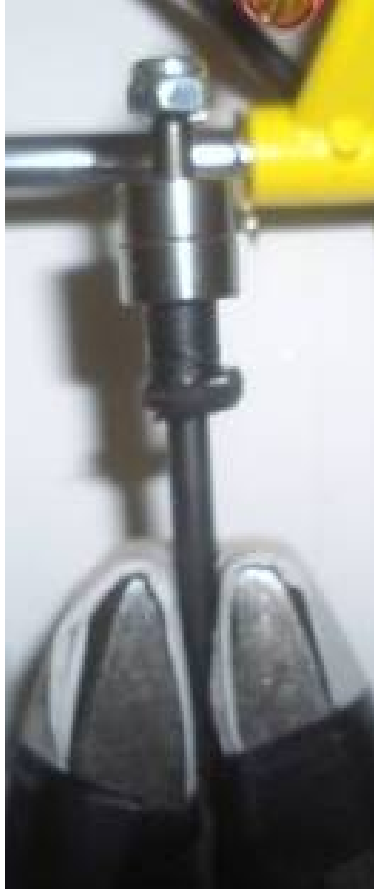
Figure 9: Transverse Shaft

The new transverse shaft is straight, but one nut screws in easier than the other, to solve the problem of varying penetration lengths, pliers were used to hold the shaft while the nut (the nut that screws in the tightest, the looser nut is installed last) was screwed in until the bolt became flush with the end of the nut, as shown in Figure 9 above. Paper was taped on the pliers so that no damage was caused to the shaft being held.

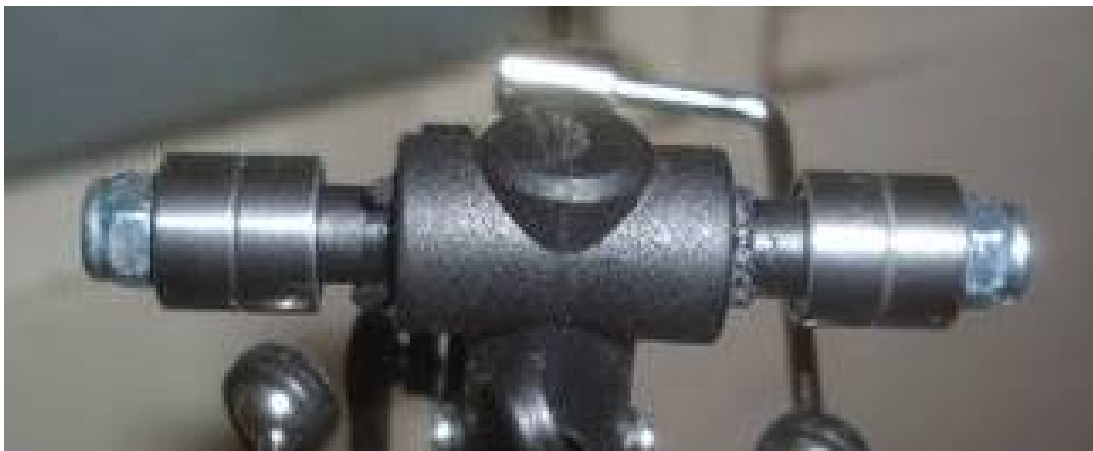
Figure 10: Rotor Head

When the transverse shaft is installed, both sides are equally screwed in, and there is very minimal slack in the transverse shaft. There has to be some play so that the main blades can self balance. Over/under tightening leads to imbalance and major vibrations.

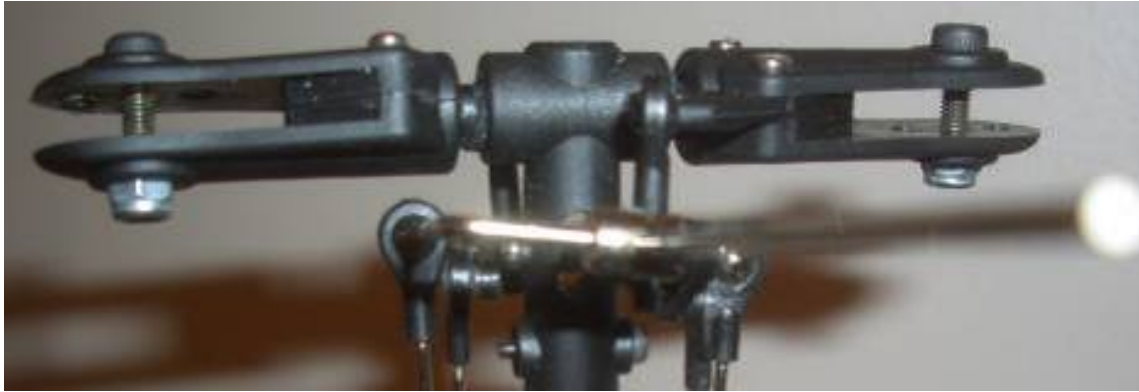
Figure 11: Rotor Head Assembly

The main blade holders that survived the crash were retired, and new guns were enlisted. Critical parts that experience a crash are always replaced and never put into service again. The Raptor has reached the end of the busy construction road, with the end of one chapter begins another.

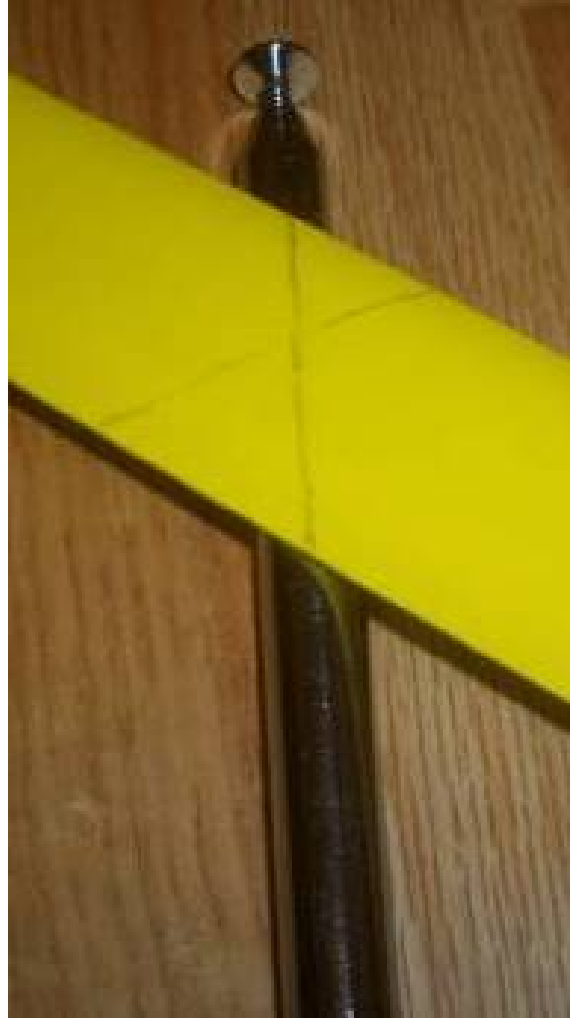
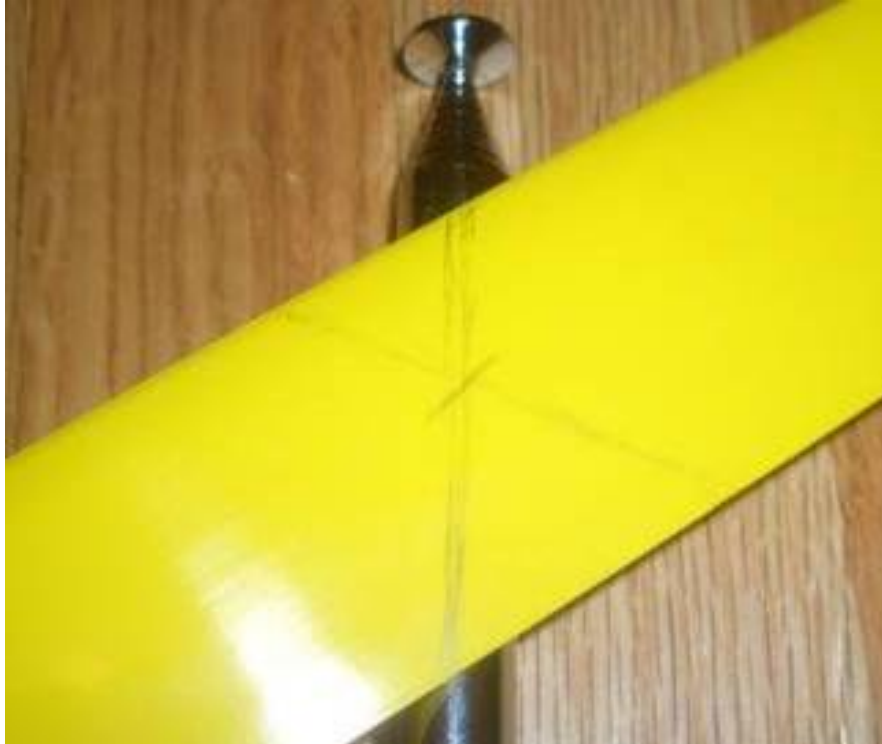
As essential to the Raptor as new parts, is the balance of the blades. Thanks to Jim, X marks the spot, the center of gravity (CG). A pencil was used to mark the blades, and the antenna was used as the pivot point. A blade was placed at -45 degrees and marked, then placed at +45 degrees and marked again, this indicates the CG spot.

Figure 12: Finding Center of Gravity for Blade 1

Figure 13: Finding Center of Gravity for Blade 2

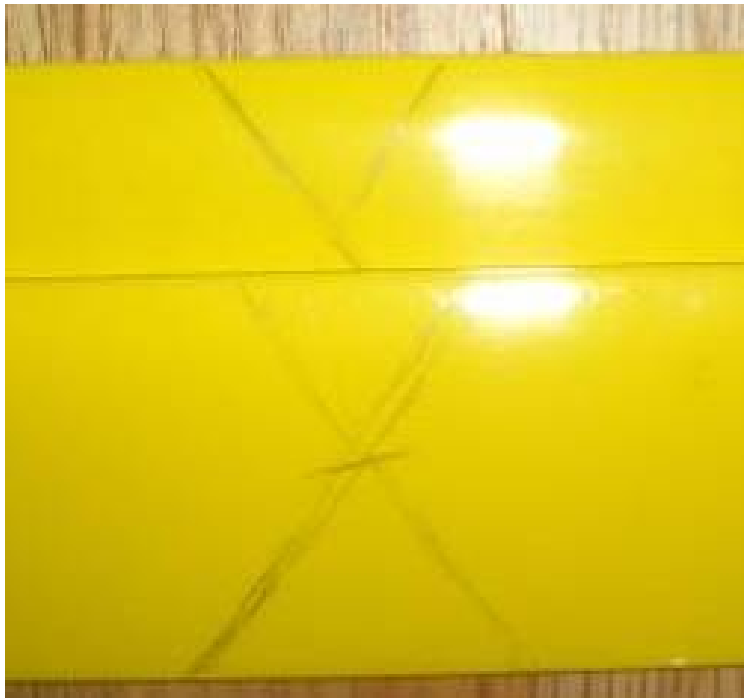
Figure 14: Comparing Center of Gravity Between Blade 1 and 2

In comparing the CGs of the blades, it is evident that they are different. Tape was added to shift the CG of both blades to the same location. The CG will move towards the tape applied. The CG will be displaced greater if the distance between the tape and original CG is greater. Once the CG has been calibrated to the same location, overall weight must also be equal. This can be done with a mini-scale, or the balance method.

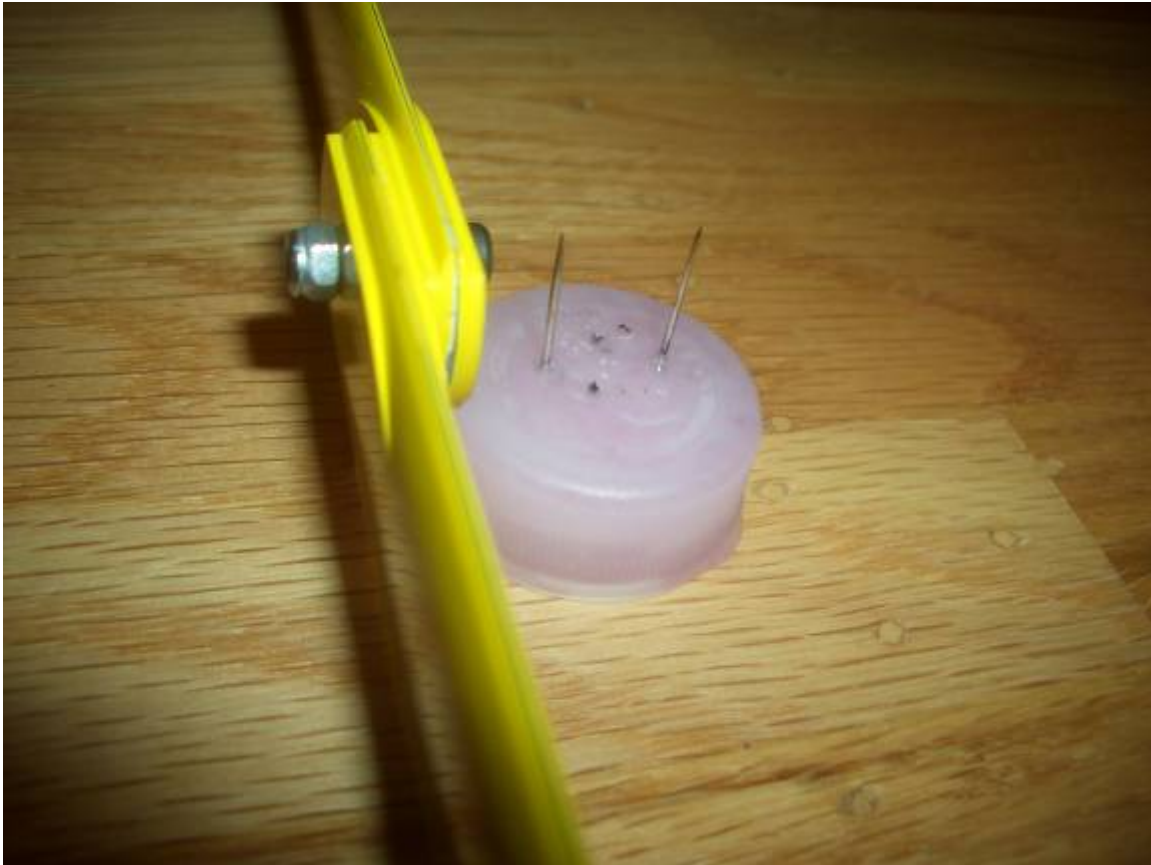
Figure 15: Needle Stand

A needle stand was made of 2 needles and a bottle cap. The needles were pushed through the cap at the proper locations to contact the bolt head and nut. The needle back was cut, and wax from a candle was melted to fill the bottle cap. As the wax cooled, the needles were adjusted so they evenly contact the bolt head and nut. Once completely cooled, balancing began. You could also make something out of 2 straight edges for balancing, instead of the needles.

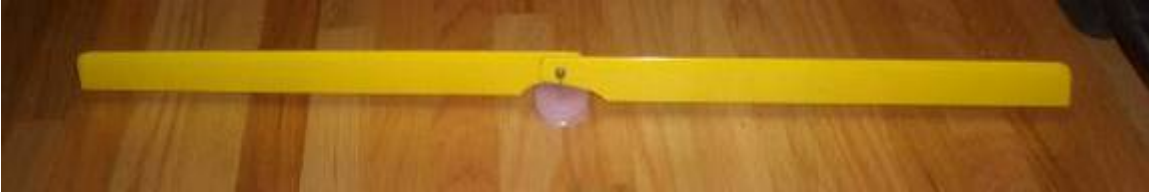
Figure 16: Blades Balancing on Needle Stand

In balancing the blades, tape was applied to the CG ONLY, in order not to move the CG and cause a mismatch in CGs between blades. Clear packing tape was placed on the lighter blade. The tape was left sticking up into the air, rather than completely wrapping it around the blade. Once enough tape was placed on the lighter blade, excess tape was cut off until both blades sat level to the floor. The balanced blades run much smoother than imbalanced blades.

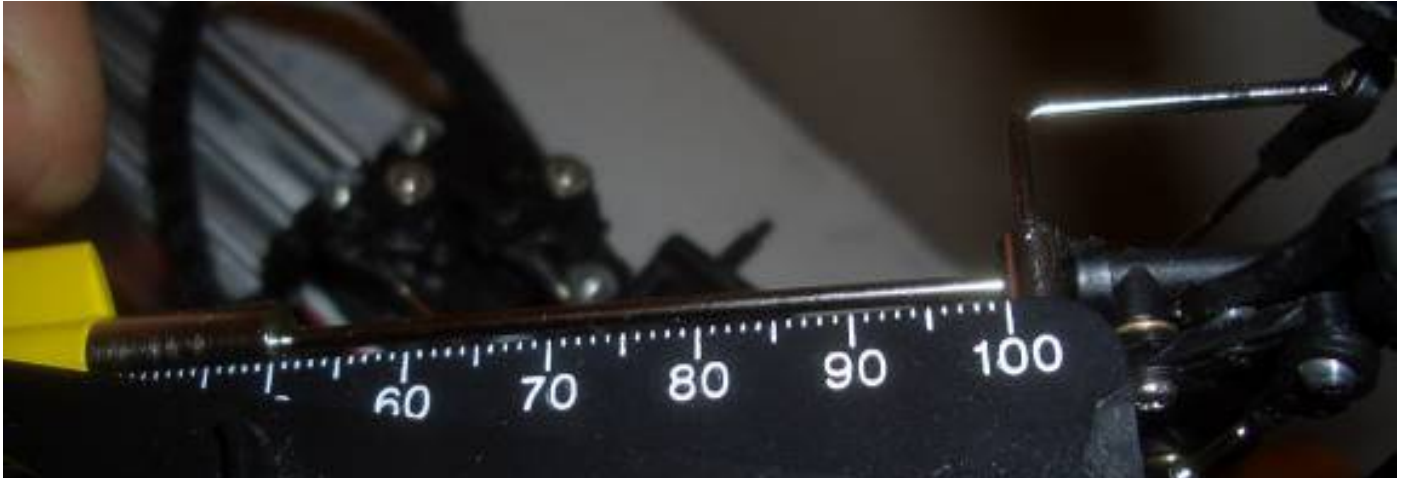
Figure 17: Flybar Distance

The flybar paddles were fixed to the flybar. The distance between each flybar was adjusted to the same measurement. This is an important balance that'll reduce vibrations.

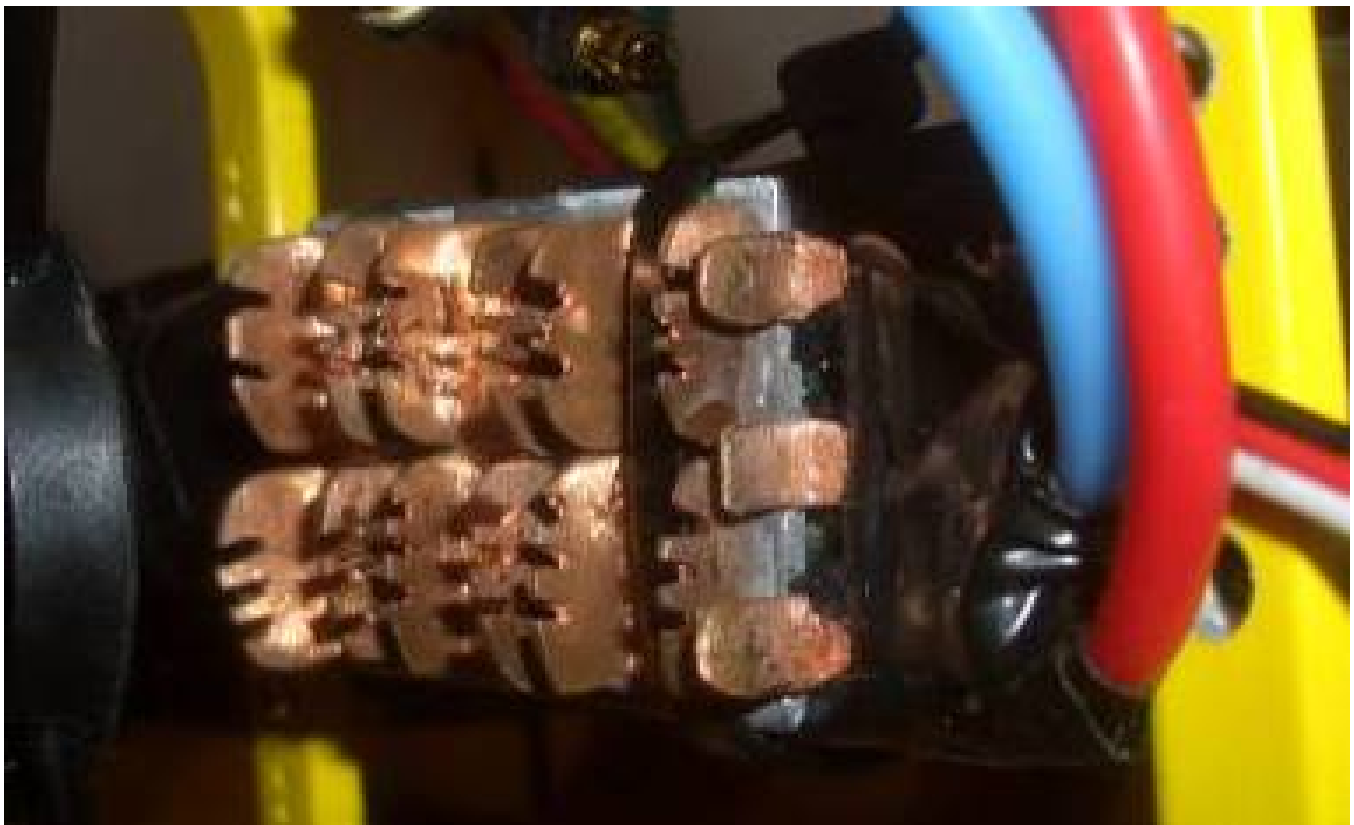
Figure 18: Electronic Speed Control Heatsink

The brushless ESC had a very poor heat sink that didn't contact all intended surfaces. Copper heatsinks were glued to the existing aluminum plate, and the aluminum plate was completely glued to the heated surfaces to be cooled. It is suspected that the ESC fails due to overheating. This modification has kept everything cool and working properly.

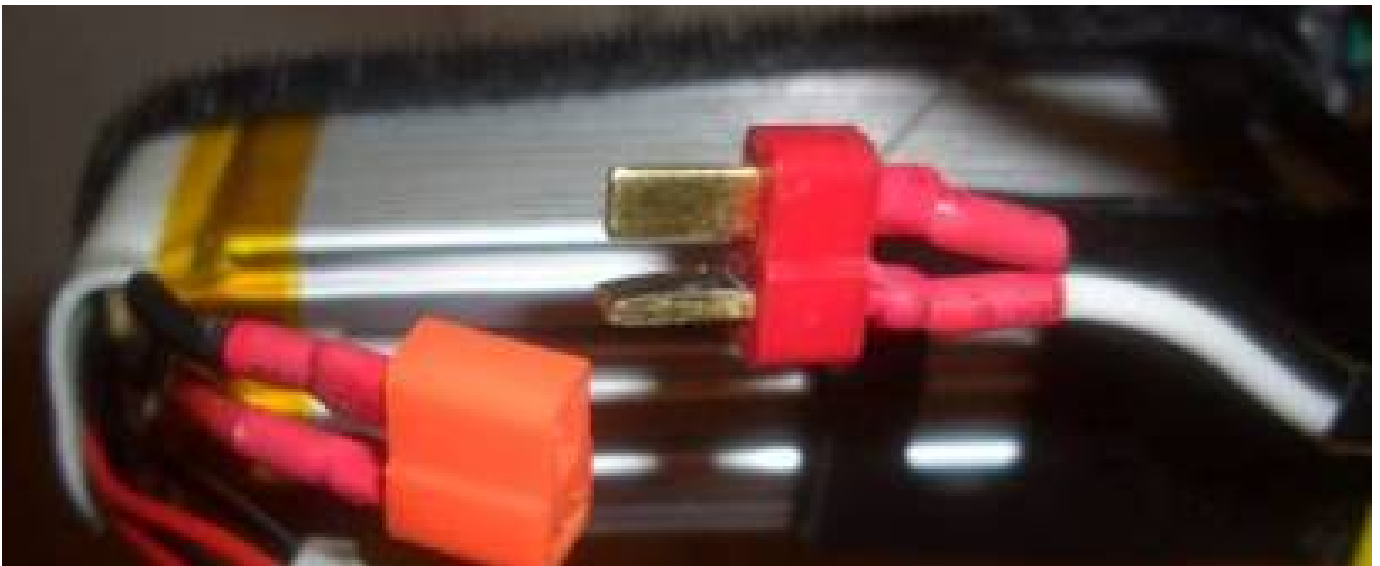
Figure 19: Upgraded Battery - T-Connector

An upgraded 2200mAh battery calls for an upgraded T connector. A thicker wire has also been soldered to the ESC to take advantage of the 12C discharge rate.

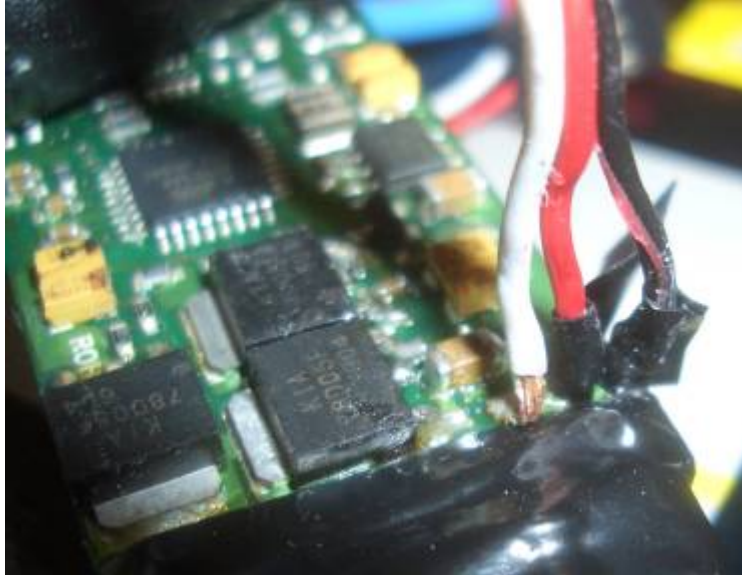
Figure 20: Electronic Speed Control Wires

After soldering the power wires to the ESC, the wires going to the receiver were taped up individually, and wrapped as a whole. They are bare at the bottom and really close to the negative terminal of the power; this could short-out and damage components. This actually occurred, but luckily nothing was broken. Caution with these wires, make sure a short doesn't occur.

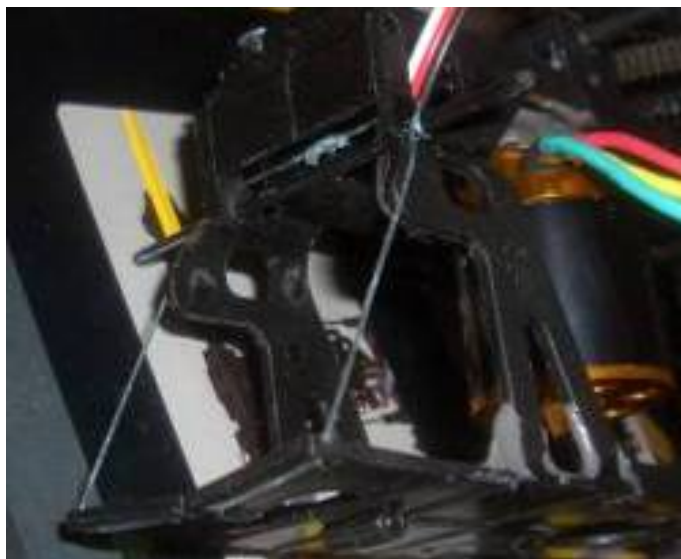
Figure 21: Reinforced Battery Tray

As shown above in Figure 21, adding tension supports to the battery tray will help reduce the chance of cracking the frame. Using fishing line here really strengthens the platform where the heavy 2200mAh battery sits, it takes all the force from the center of gravity of the battery and transfers it to the stronger upper frame. Without this support, the frame is supporting the battery 2 cm into the length of the battery, which is about 10 cm long, this means the cantilever effect is large, causing large tensile stresses to crack the frame. When installing the tension lines, small holes were drilled in the corners of the platform to thread the fishing line through, and a small amount of tension was placed in the line, which causes the platform to bend slightly upwards, this will take all of the tension off the point where cracking occurs at the frame.

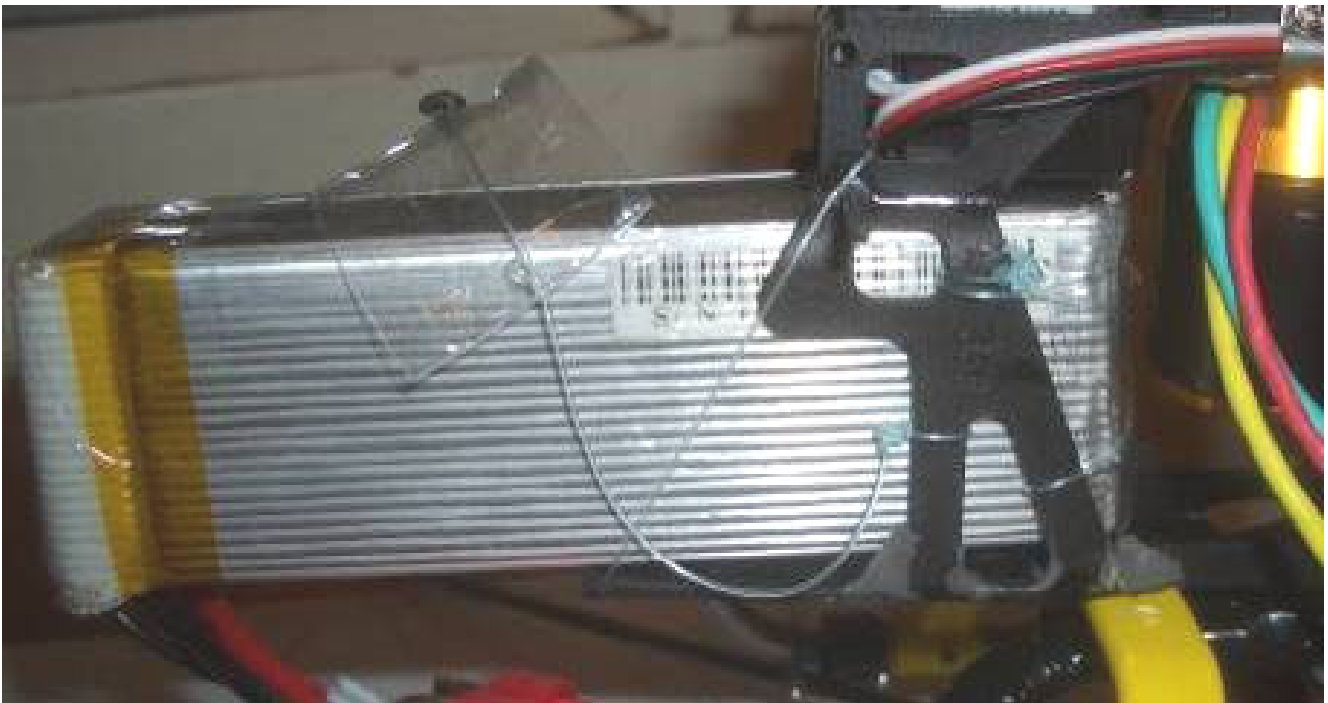
Figure 22: 2200mAh LiPO Restraint – Not Applied

A restraint system was added to fully secure the large 2200mAh LiPO. Fishing line, 25lb test, is used to harness the back of the battery near the outrunner; pop bottle plastic is used to create a smooth support that won't damage the LiPO. A single line, and plastic is used to hold the front of the battery.

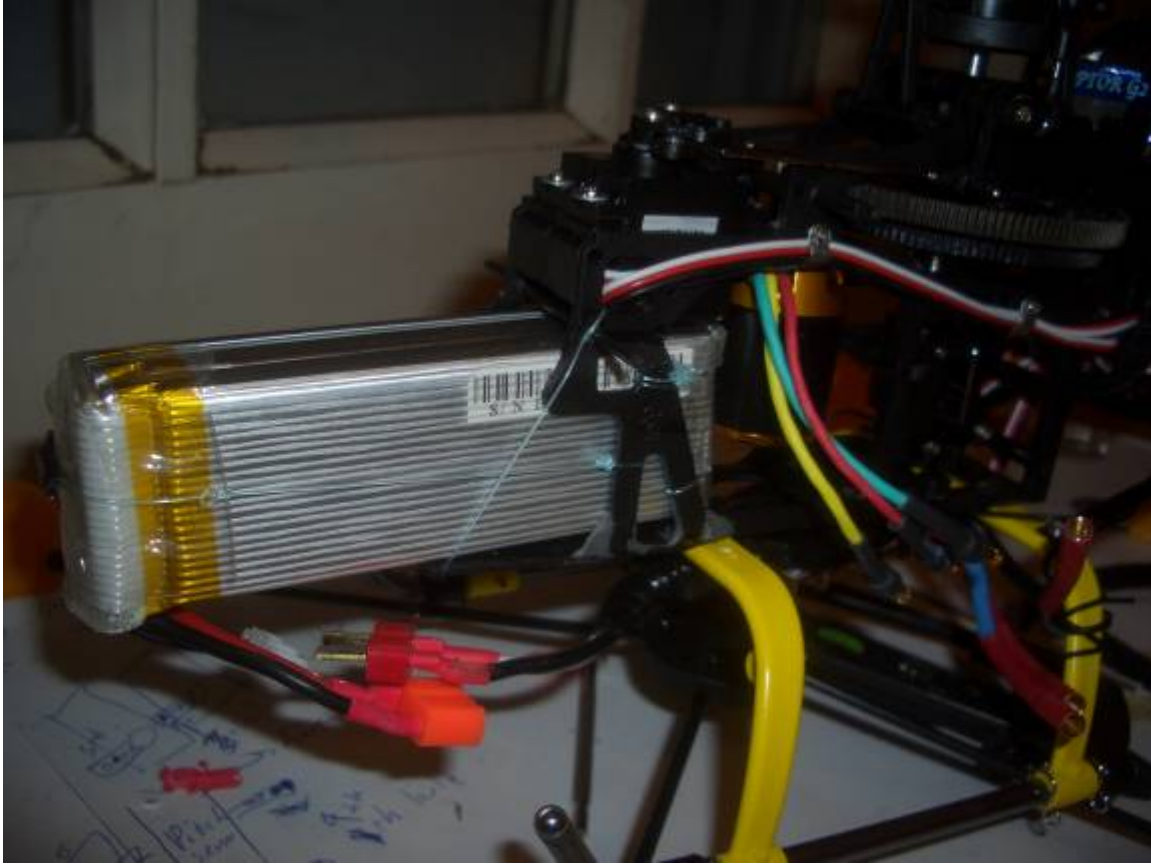
Figure 23: 2200mAh LiPO Restraint - Applied

Placing the front support around the battery tightly holds the back of the battery against the harness near the outrunner, the battery is secure from lateral movement. A Velcro strap is placed around the battery and the battery tray to restrain vertical movement. It is important to get the backing as close to the outrunner as possible without touching it. The battery will not fit in the canopy if it is too far out.

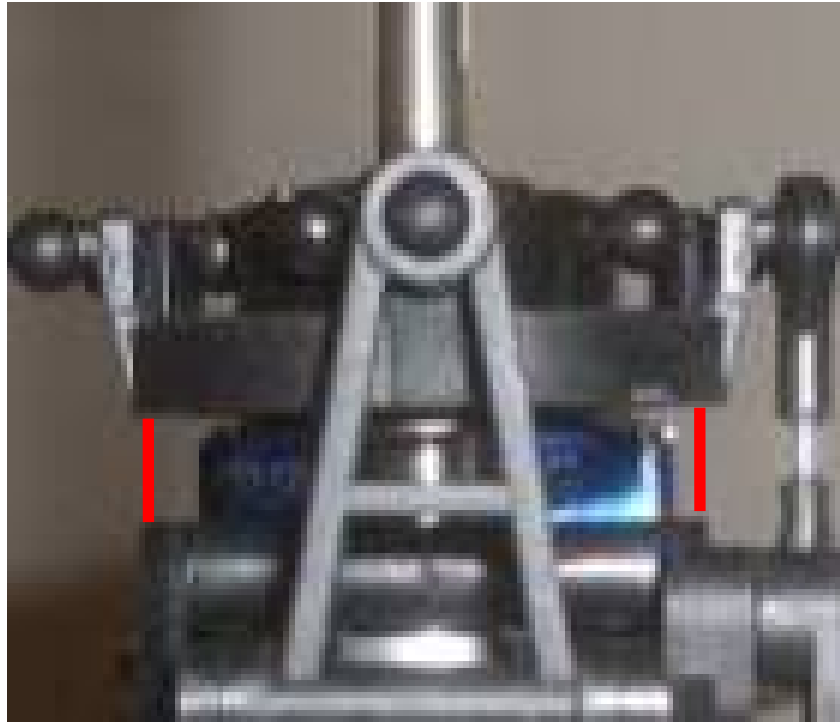
Figure 28: Left-Right Cyclic Before

Setting the trims to their centers, and powering up the remote, then the Raptor forces each servo to its center position. After achieving the centers of the servos, power was disconnected and adjustments were made as necessary. Figure 28 below shows the swash plate from the front, from this view, it was evident the control arm must be shortened to bring the right side down, leveling out the swash plate to correspond with the center position of the servo.

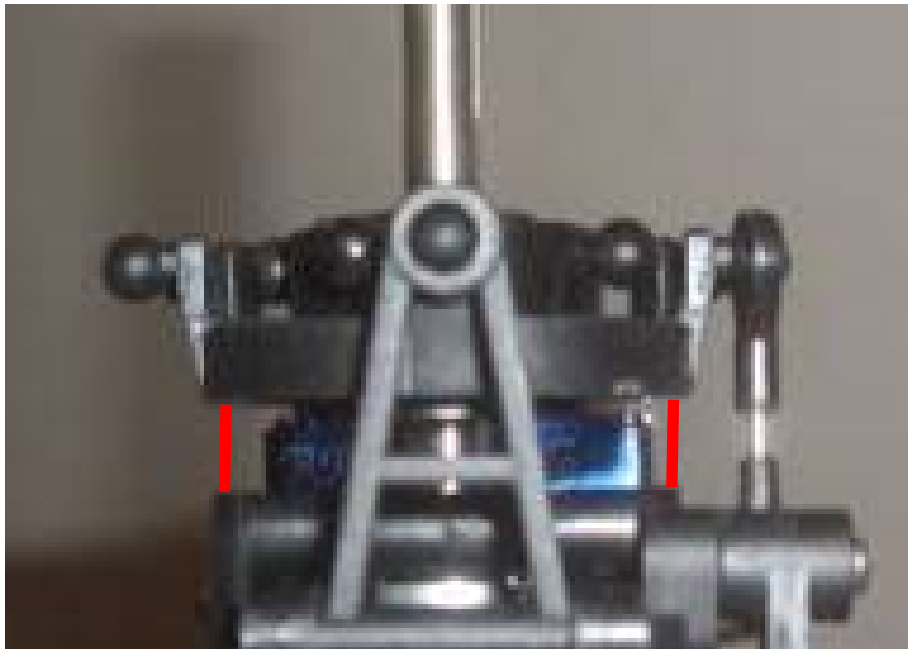
Figure 29: Left-Right Cyclic After

Upon disconnecting the control arm and tightening by one turn, the swash plate leveled out. The same was done with the forward-backward cyclic. I placed the ball joints on

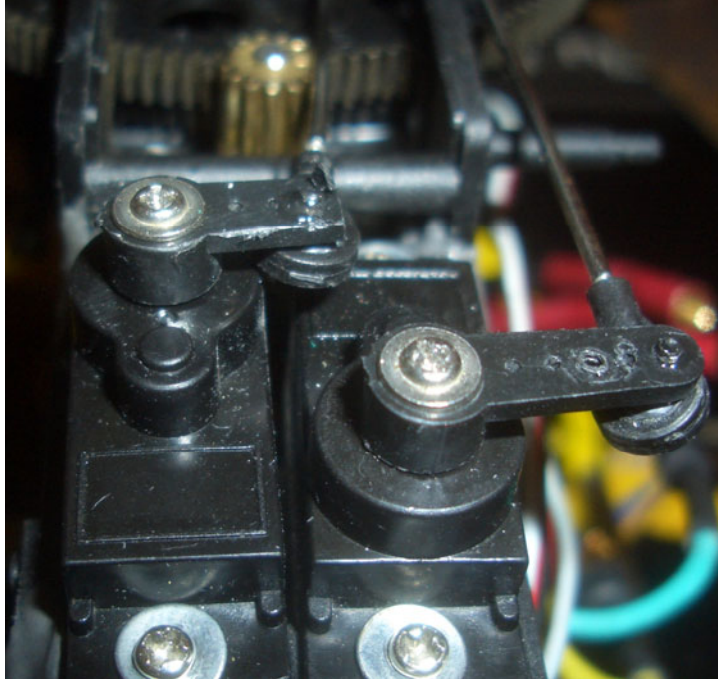
Figure 30: Cyclic Servo Horns

the 3rd hole, and 5th hole from the center for the forward/backward and left/right cyclic, respectively. They belong on the 3rd hole, and should be left that way. I did this because in 3D flight mode, forward and backward was responsive and had full range, but left and right seemed to lack range. By placing the ball joint on the 5th hole to achieve more range, but leave it on the 3rd hole unless you want to test it out.

When placing the ball joint in different holes, tap the holes using the self tapping screw that holds down the servo horn, after it's been screwed into the servo horn, the ball joint can be screwed in easily.
