RAPTOR G2 SE

Updated: August 6, 2007

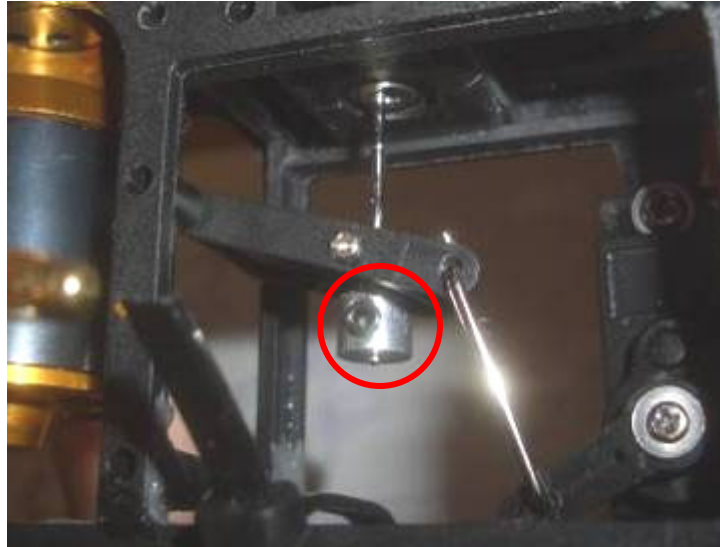
Figure 31: Pitch - Normal

The figure above shows the lowest possible position of the servo. This is the lowest position that doesn't cause the center rod to touch the main shaft.

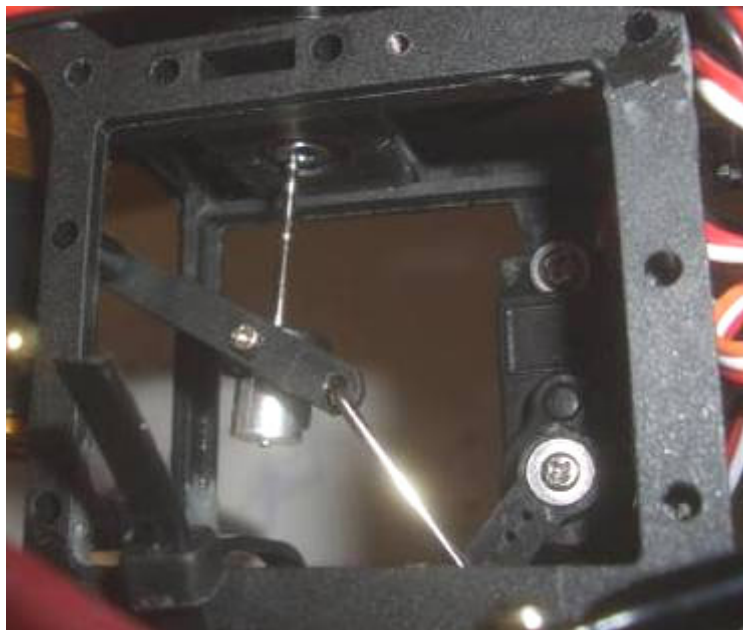
Figure 32: Pitch - Normal.....NOTTTT

The figure above shows a dangerous condition, where the servo is capable of pulling the U-Shape connector so low that the center rod touches the main shaft, this can cause a catastrophic failure, where the rod is unscrewed from the steering dowel. Adjustments must be made to avoid this scenario before any further adjustments are made. Once the pitch horn, and center rod/steering dowel have been adjusted, pitch is surveyed and adjusted accordingly.

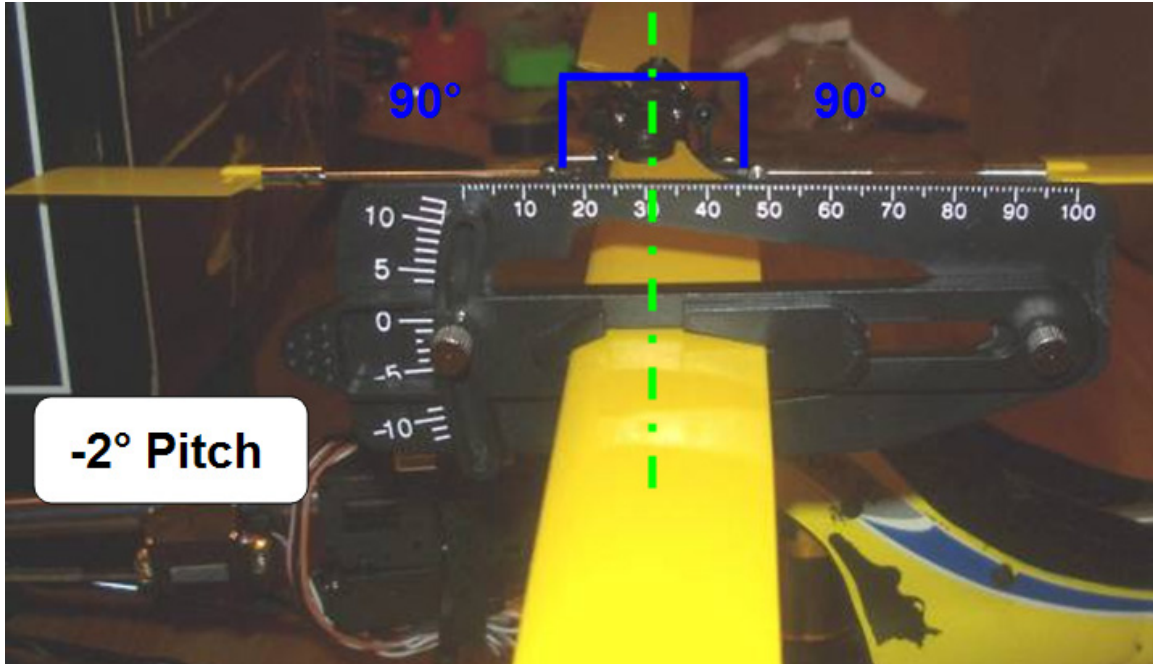
Figure 33: Pitch Gauge

A pitch gauge was used to adjust pitch angles. Figure 33 above shows how I measure pitch. I make sure the flybar is perpendicular to the main shaft, and that the main blades are coming straight out on the blade grips. I then place the pitch gauge on the blade and line up the flybar with the top of the pitch gauge as shown in Figure 33, the pitch gauge reading in this case is -2 degrees. Blade pitch angles were tested and recorded for stunt mode. Results of the first test are shown below in Table 3.

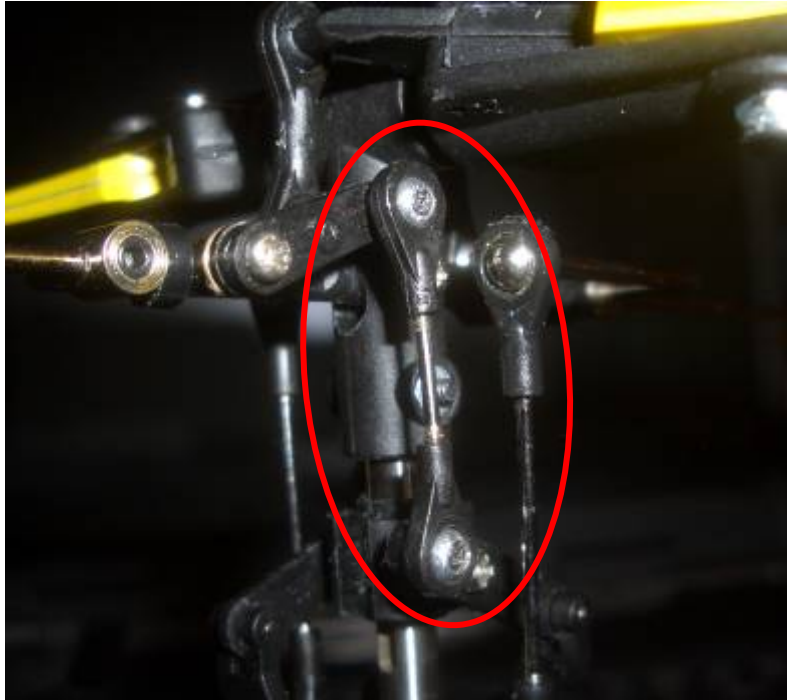
Figure 34: Pitch Connecting Rod

The results indicated that blade 2 had too much positive pitch. This was corrected by reducing the length of the connecting rod to the rocker arm, as shown in Figure 34. Remember that the sockets must be placed onto the ball in the correct direction (One side is tapered to be pushed onto the ball, the other is TIGHT and should never be pushed on to the joint), so the socket must be turned 360 degrees for each incremental adjustment. Pitch was increased or decreased incrementally by reducing or increasing the length. When the pitch of both blades were adjusted to equal, blade tracking is assumed to be proper, but this is checked at preflight tests.

This was reduced by removing, and turning clockwise incrementally until a pitch angle of 0 was achieved. Leaving the helicopter on, with the remote's pitch range set to 0 will ensure the pitch angle is set to 0 when the remote is set to 0. Completion of the adjustments to the center rod/steering dowel and pitch angles were double checked and confirmed.

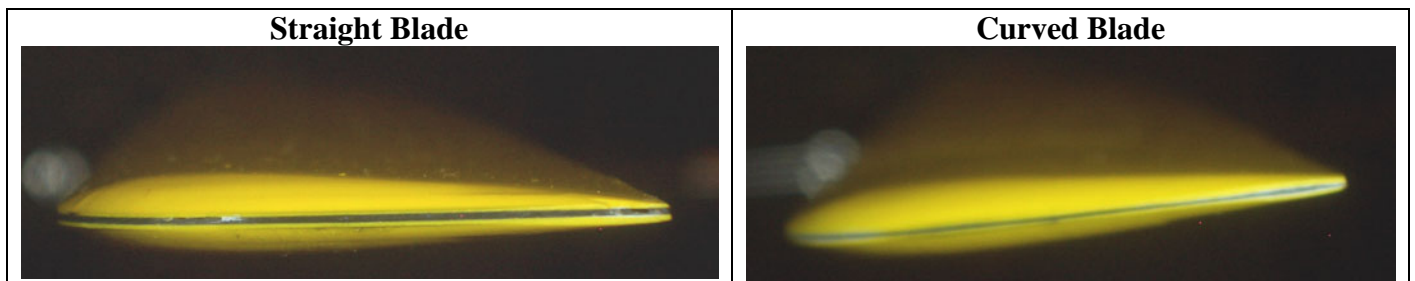
Figure 35: Blade Curves

In addition to the above adjustments, blades should be checked for fracking as described in the manual. The same control arm adjustment is used to reduce fracking, so as to not make the adjustments above obsolete, we must make sure the overall pitch remains the same. We need to adjust the blade pitch with respect to overall blade pitch; look down the length of the blades and check for curving which causes changes in pitch down the length of the blade. Fracking only occurs when there are differences in pitch between blades; for instance, find the blade that curves towards the end and causes a negative pitch towards the end of the blade, this is the blade that must be adjusted with positive pitch, assuming the other blade is less curved. If a blade is curved with positive pitch, reduce that blades' pitch slightly. This phenomenon is shown below in Figure 35.

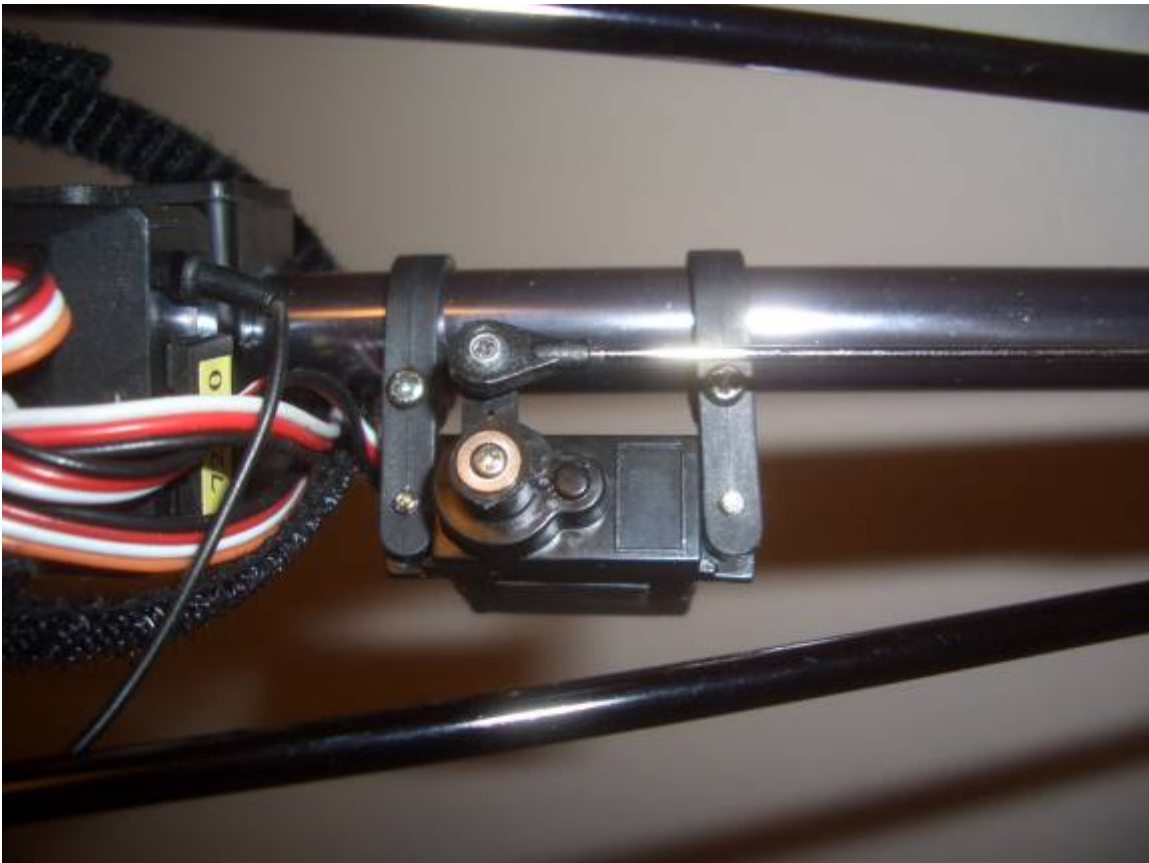
Figure 36: Rudder Servo

The rudder servo horn is 90 degrees at center adjustment, as shown below in Figure 36. The servo straps are loosened so that the servo can slide up and down the tail boom. The systems are powered up and the rudder stick is moved to the extreme left and right, the extremes should be reached fully on the tail shaft and the servo shouldn't make a sound when at an extreme, as shown in Figure 38. If it pushes against both extremes or cannot reach the extremes, the "extent" adjustment on the gyro must be adjusted. This can be done using the plastic flat head provided, increase or decrease until the range is within limits. Once the extremes are both reached without the servo constantly pushing, tighten the strap screws.

The servo should be positioned so the rod is centered down the tail boom. A big problem that can occur is bending of the push rod when pushing. Extra supports were made using a piece of bamboo and tape. This was taped to the tail struts and push rod casing. This problem can be tested by keeping the tail slider from reaching the extreme when the servo is pushing, if the rod bends then a support should be made, otherwise poor rudder control, and spinning of the helicopter may occur.

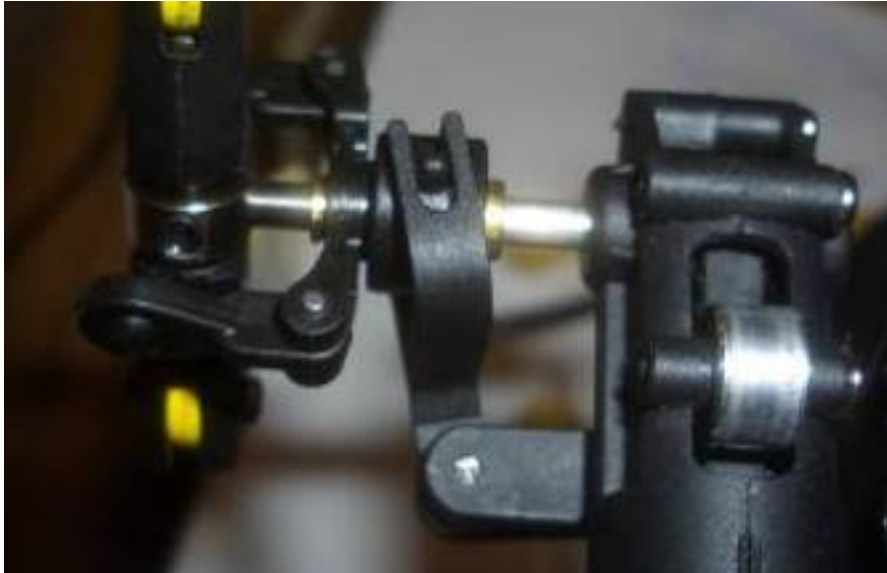
Figure 37: Tail - Initial Position

The initial position doesn't look like the center. The servo horn should be perpendicular to the servo strike at startup. If the horn is off center, the center position will also be off center even if the extremes are properly adjusted.

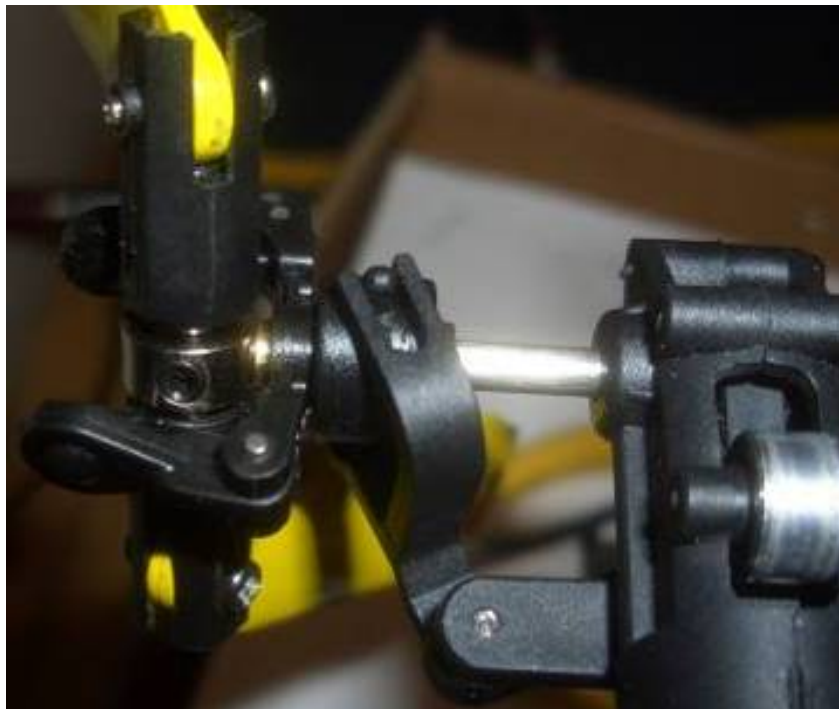
Figure 38: Tail - Extreme Position

The extreme should be reached on both sides of the shaft and the servo should not constantly push on the extreme. Once this has been adjusted, tighten the servo tail mounts.

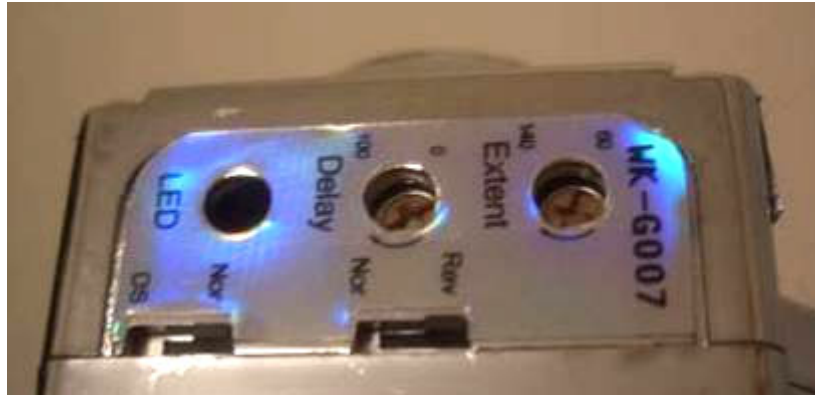
Figure 39: Gyro - G-007

The rear servo provided by Exceed RC is a conventional servo. The G007 is capable of powering a high powered digital servo with the flip of a switch, this switch is left in Nor mode since DS mode causes a conventional servo to move slower and to overheat.

The Delay is set to 0 by turning the potentiometer to the counterclockwise extreme. The gyro gain is set to 100% by turning on dip switch 12 (WK-0701) and adjusting dial V2 to the clockwise extreme. The servo gain adjustment can be set from 0% to 100% by setting V2 from 12 o'clock to 5 o'clock, respectively. The tail exhibited the hunting effect; this is resolved by setting the servo gain to 80% and adding a delay through the gyro.

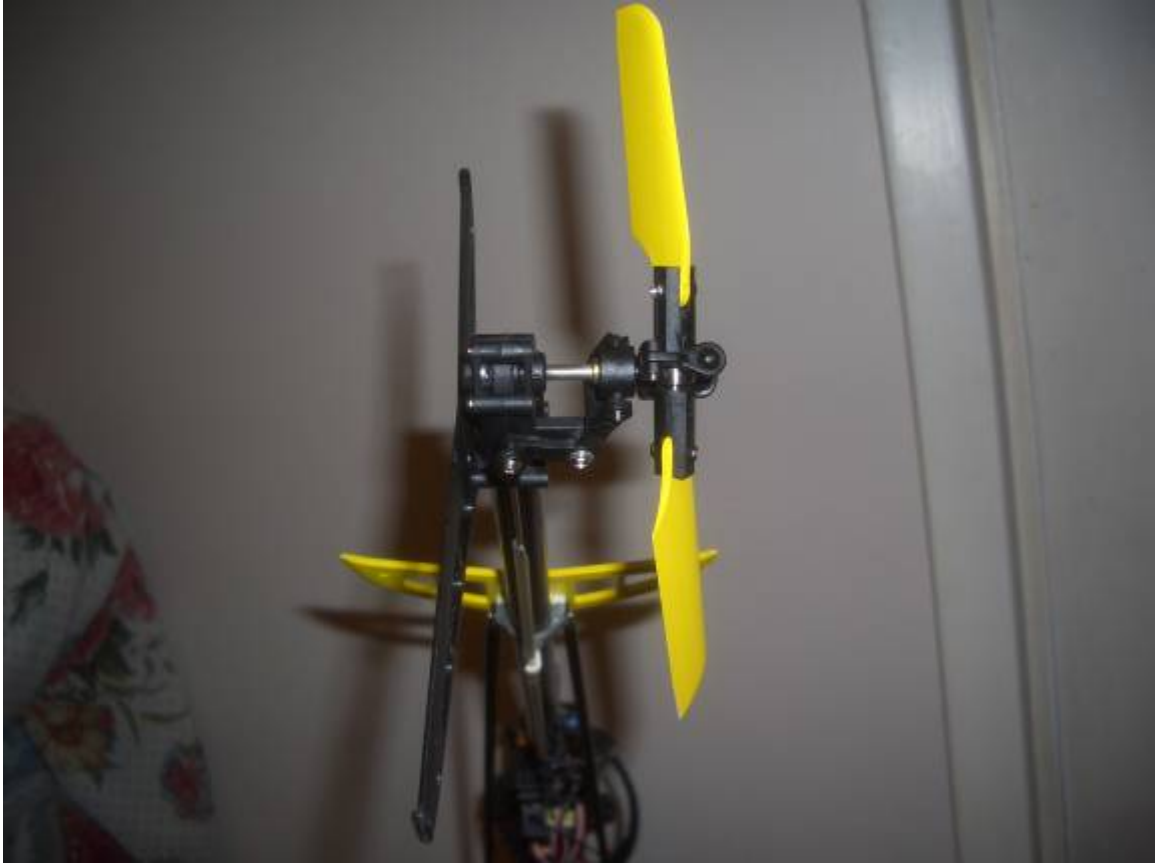
Figure 40: Tail - Rotated Clockwise

To test that the reverse switch is correct, the Raptor is rotated clockwise, the pitch should become positive to counteract the clockwise rotation.

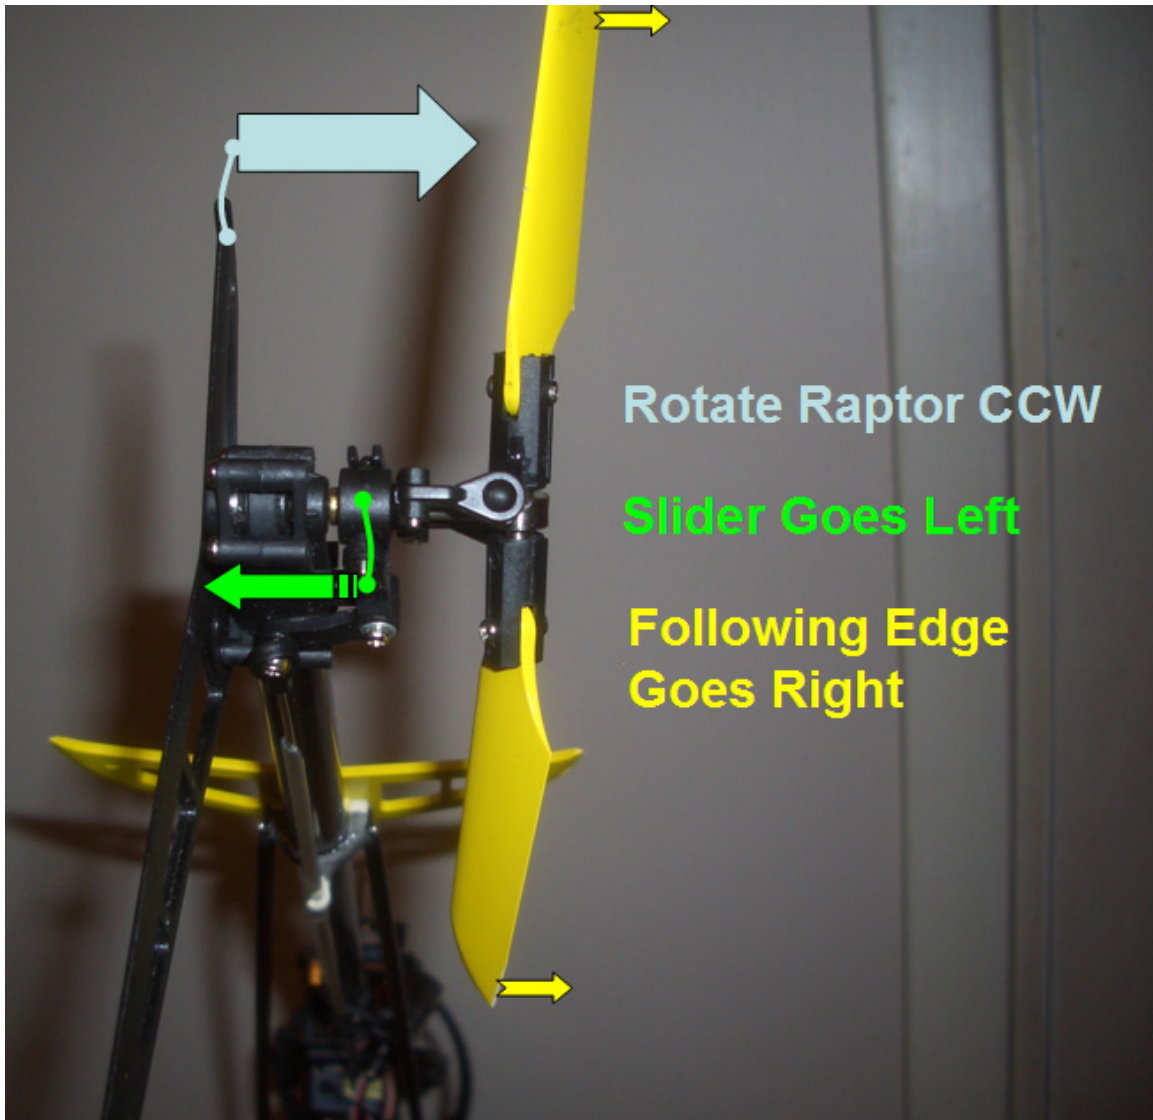
Figure 41: Tail - Rotated Counterclockwise

By rotating counterclockwise, the pitch should become negative to counteract the counterclockwise rotation. The main rotor is spun clockwise to ensure the correct function of the tail blades, which is counterclockwise when looking from the right side in Figure 41 above. The rudder and gyro have now been setup properly.
