# **Hay Creek / Scott Canyon Watershed Assessment**

Prepared by the  
Gilliam County Natural Resources Department  
for the  
Hay Creek/Scott Canyon Working Group

June, 2003

# Hay Creek & Scott Canyon Watershed Gilliam County, Oregon

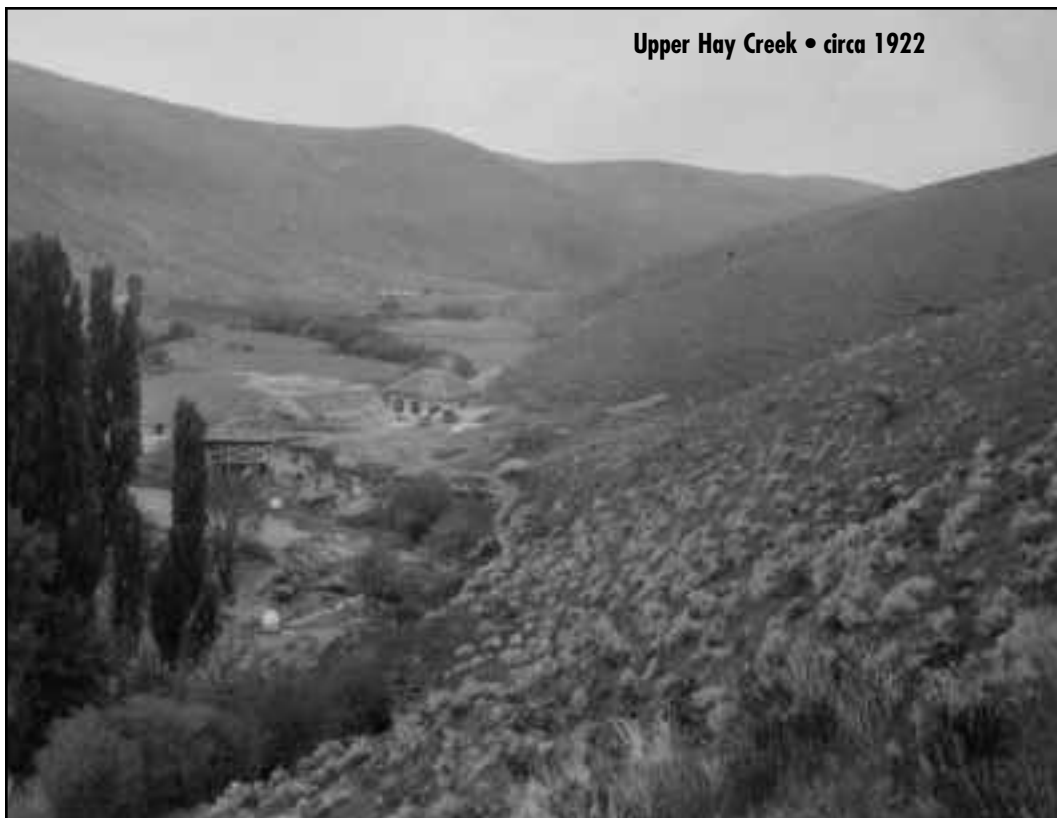
Upper Hay Creek • circa 1922

Historic photos show cottonwoods and willows growing in upper Hay Creek where the city water supply is located. There are old logs and woody debris left in some sections of Hay Creek further demonstrating the existence of historic tree communities. Large scale flood events have significantly shaped riparian and aquatic habitat conditions as evidenced by the deposition of large log remnants and scouring of the stream channel.

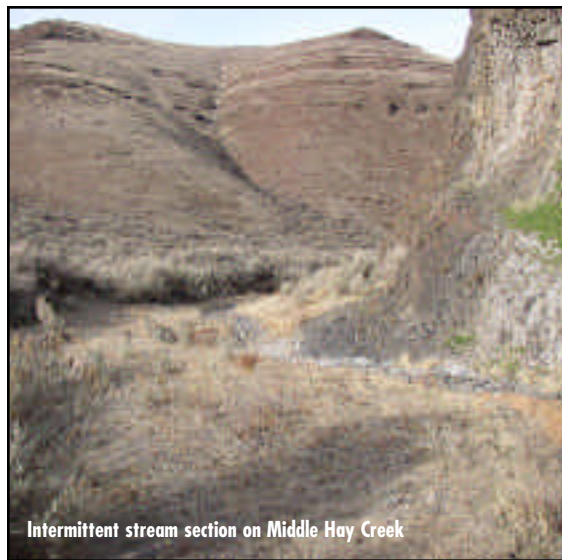
Sections of the Hay Creek stream system were documented during field studies going underground during certain times of the year. Two sections in middle Hay Creek total just under a mile (.95) and one section on upper Hay Creek went underground approx. 1/8 of a mile (.18). The field observations were noted mid-December, 2001.

Intermittent stream section on Middle Hay Creek

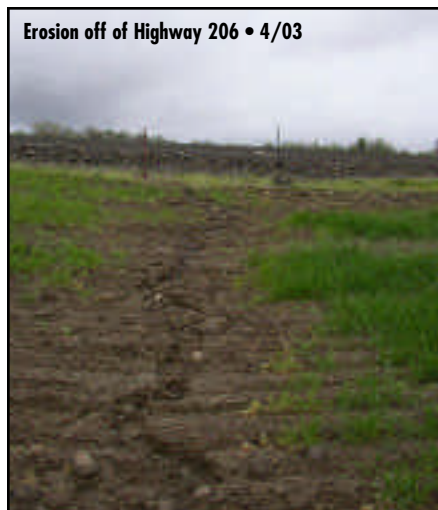
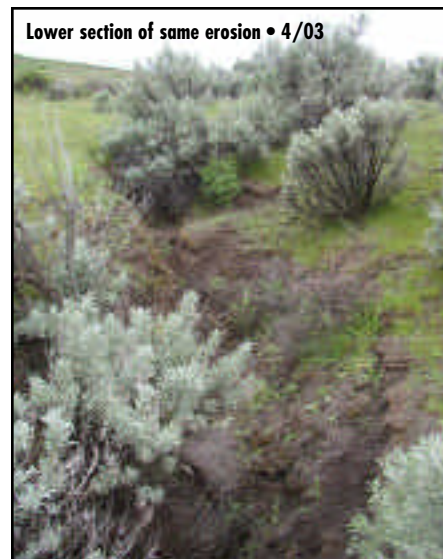
The State of Oregon Department of Transportation did not have a culvert survey for the stretch of highways bordering the watershed. However, while doing some upland field studies it was noted that runoff from Highway 206 had contributed to severe gullies through CRP and ungrazed grass areas.

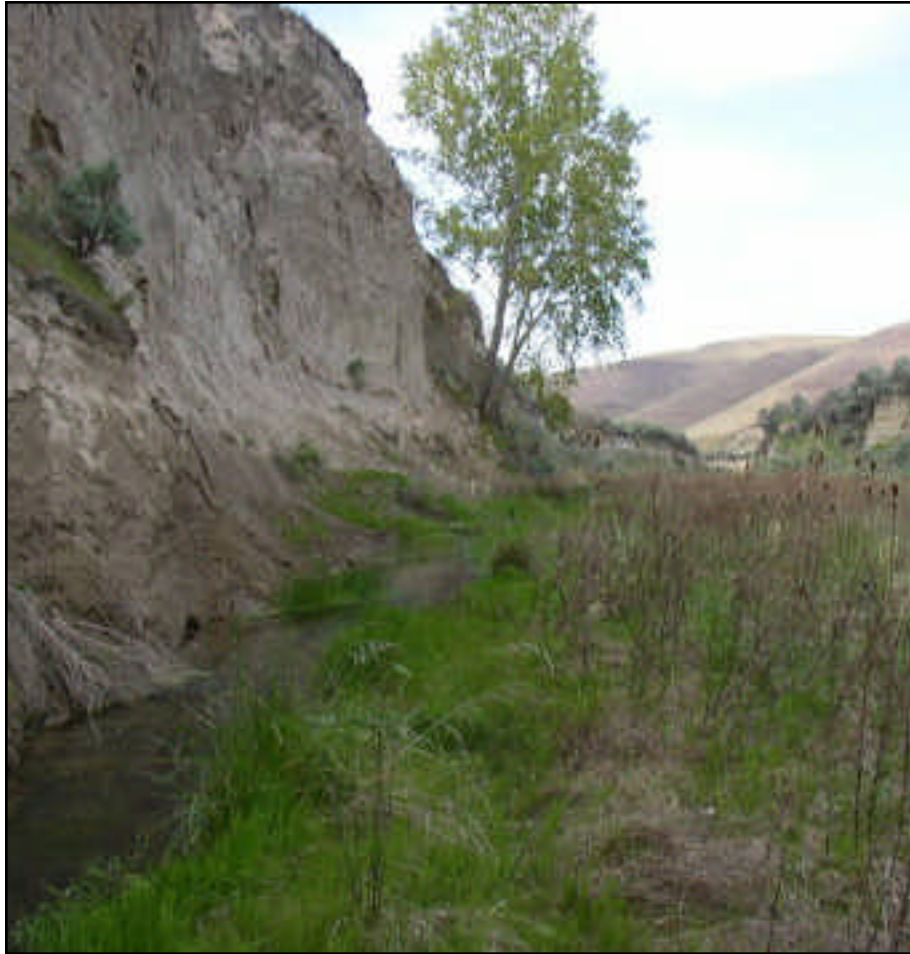
**Left: Section of Lower Hay Creek that is in CREP. This photo is at the same location as the photo on page 35, but this photo was taken on 4/03.**

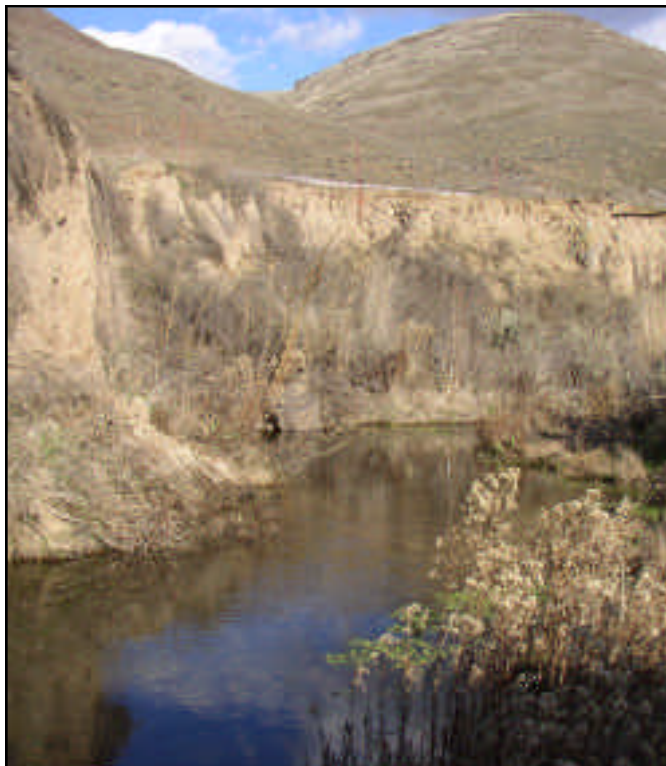
**Lower left: This is also on a section of CREP where the stream is beginning to pool up. 2/03**

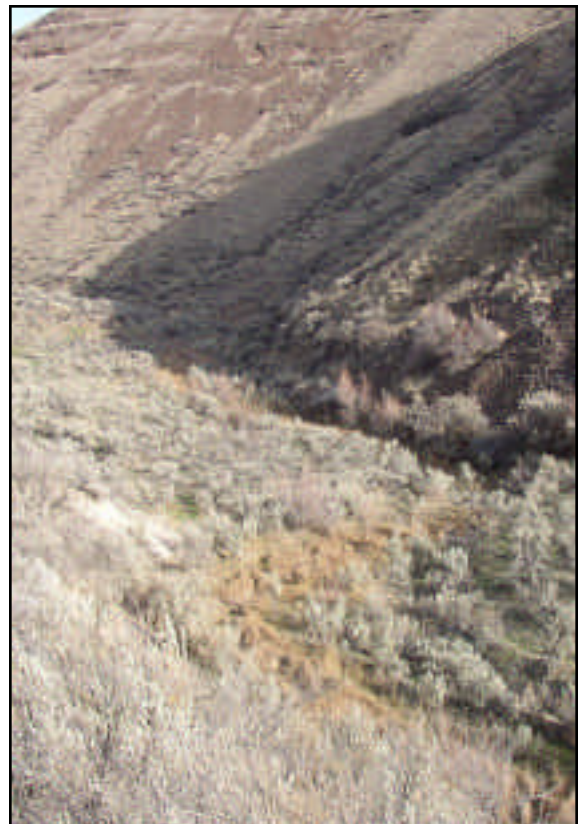
**Lower right: A shot looking down on Six Mile. Note willow colonies. 12/02**

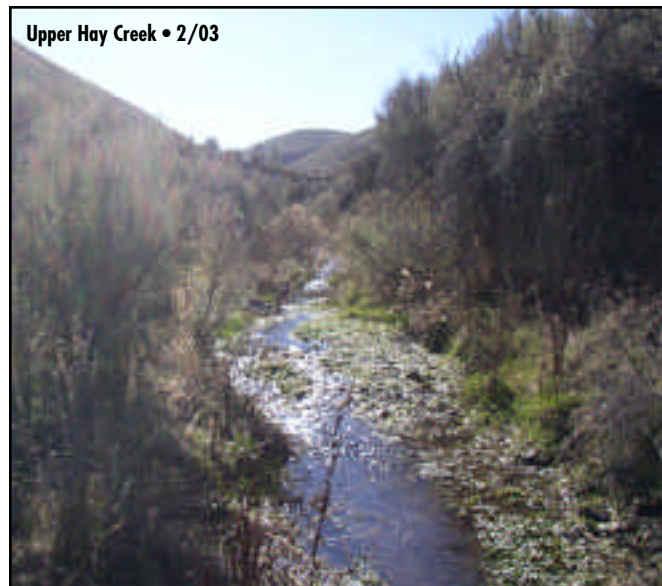
Field observations in the Hay Creek watersheds showed certain sections having a lack of riparian vegetation and an abundance of Big sagebrush close to the stream channel. Grazing has altered the vegetative stands, but without historical aerial color photos it is difficult to assess what the true natural state of riparian vegetation along this stream system was. Historically it was noted that pioneers had to clear the stream beds of large dense populations of sagebrush in order to plant crops. But how much riparian vegetation existed, we may never know.
