Microscopy of glazed layers formed during high temperature sliding wear at 750°C

I. A. Inman^a, S. Datta^{a*}, H.L. Du^a, J.S. Burnell-Gray^a and Q. Luo^b

Abstract

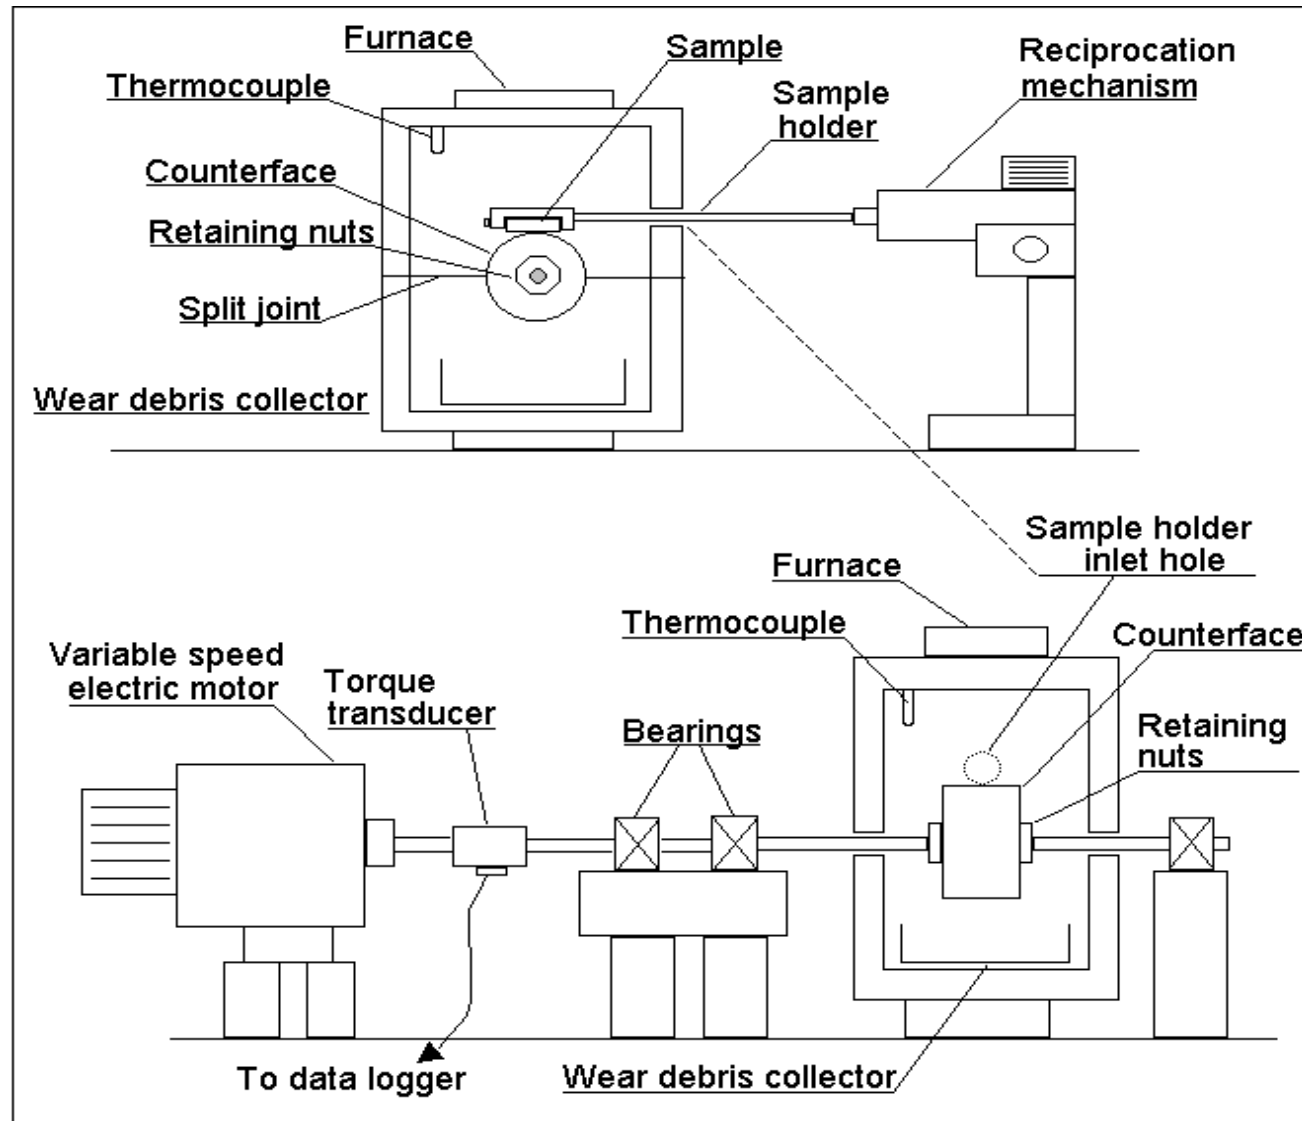
Fig. 1. Reciprocating high temperature block-on-cylinder wear rig, as used in the experimental programme

All high temperature wear tests were carried out on a high temperature reciprocating wear rig in open air, as illustrated in Figure 1. Details of the high temperature wear machine used have been described previously [1,2]. Basically the machine was a block-on-cylinder arrangement (the cylinder being the counterface and the block being the sample). A variable speed electric motor rotated the shaft and connected counterface (Stellite 6) of diameter 50 mm and length 50 mm at various speeds. Samples of Nimonic 80A, of dimensions 5mm x 5mm x 45mm were held against the counterface using the sample arm in reciprocating motion, with reciprocation at 3 cycles per minute with a constant stroke of 12mm. The tests were carried out at a sliding speed of 0.314 ms^{-1} , (this being the speed of rotation of the counterface) under a load of 7N at various temperatures. Attention in this paper has been focussed on the situation at 750°C.

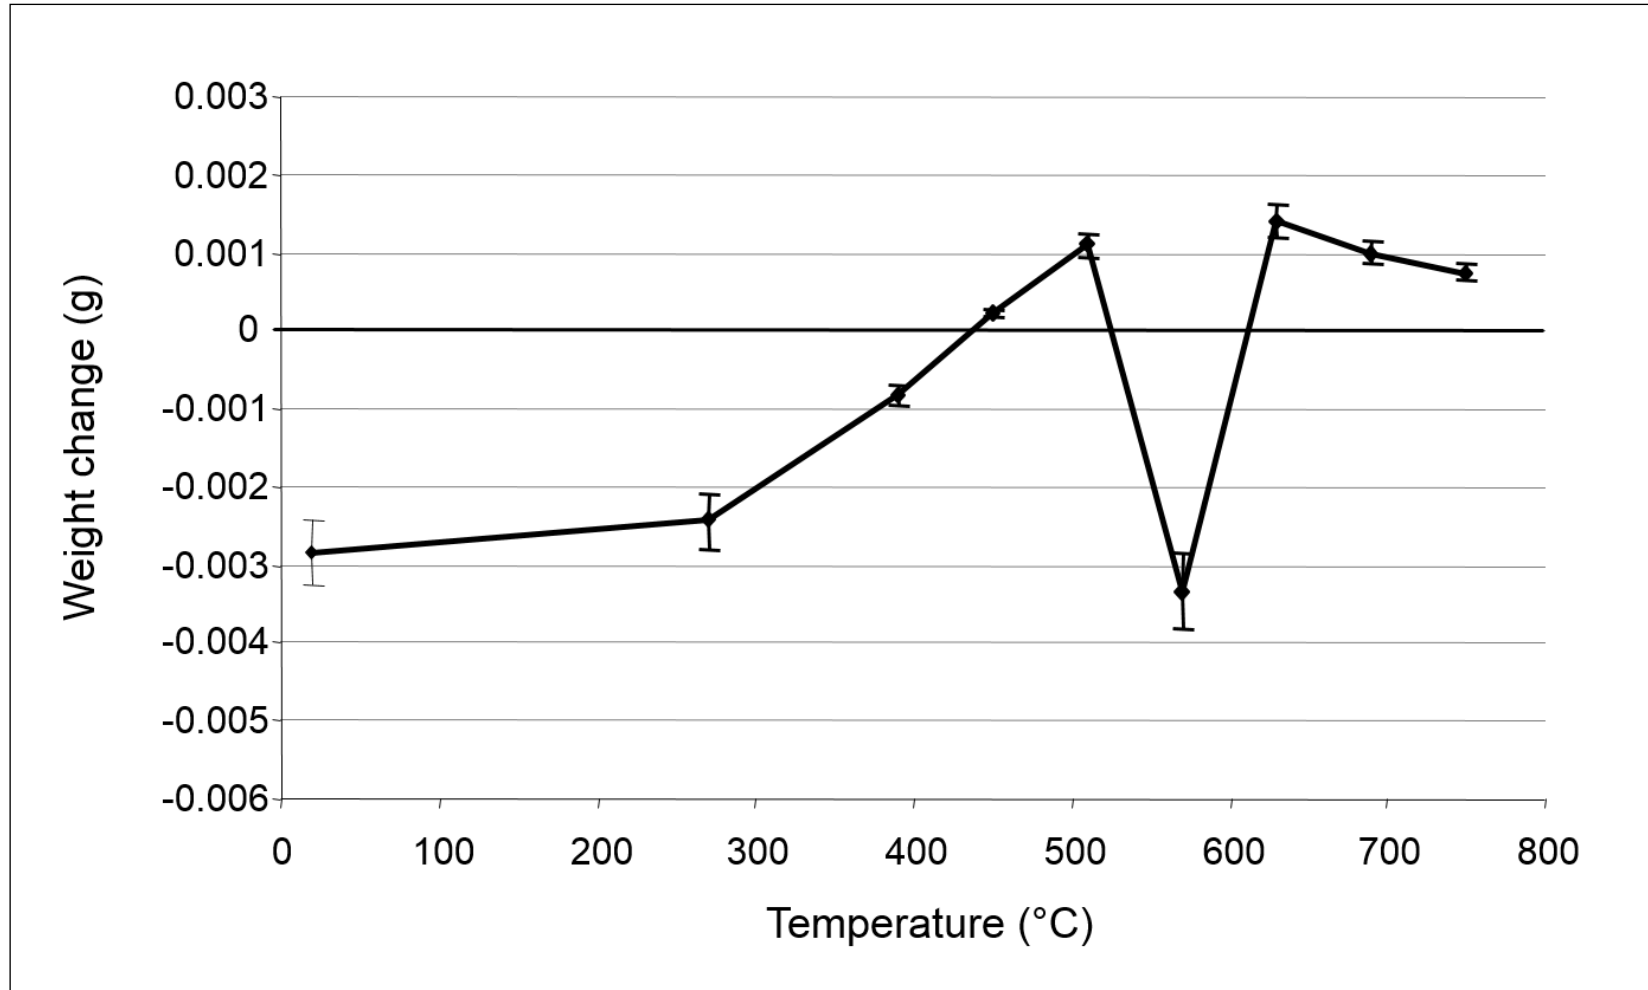
Fig. 2. Weight change vs. temperature for Nimonic 80A against Stellite 6 at 0.314 m.s⁻¹ / 750°C

Figure 2 displays the wear data on Nimonic 80A/Stellite 6 system as a function of temperature under a load of 7N at 0.314 m/s¹ for total sliding distance of 4522 m. Weight changes were extremely low for all temperatures, with the largest mean change being 0.002(4) g at 270°C. Slight gains were observed for all test temperatures between 450°C and 750°C, with the maxima in mean values at 510°C and 630°C of 0.001(1) g and 0.001(4) g respectively. The wear data at 570°C shows a departure from the general trend. Repeated experiments confirmed the data at 570°C needing further attention. This paper focuses attention on the situation at 750°C.

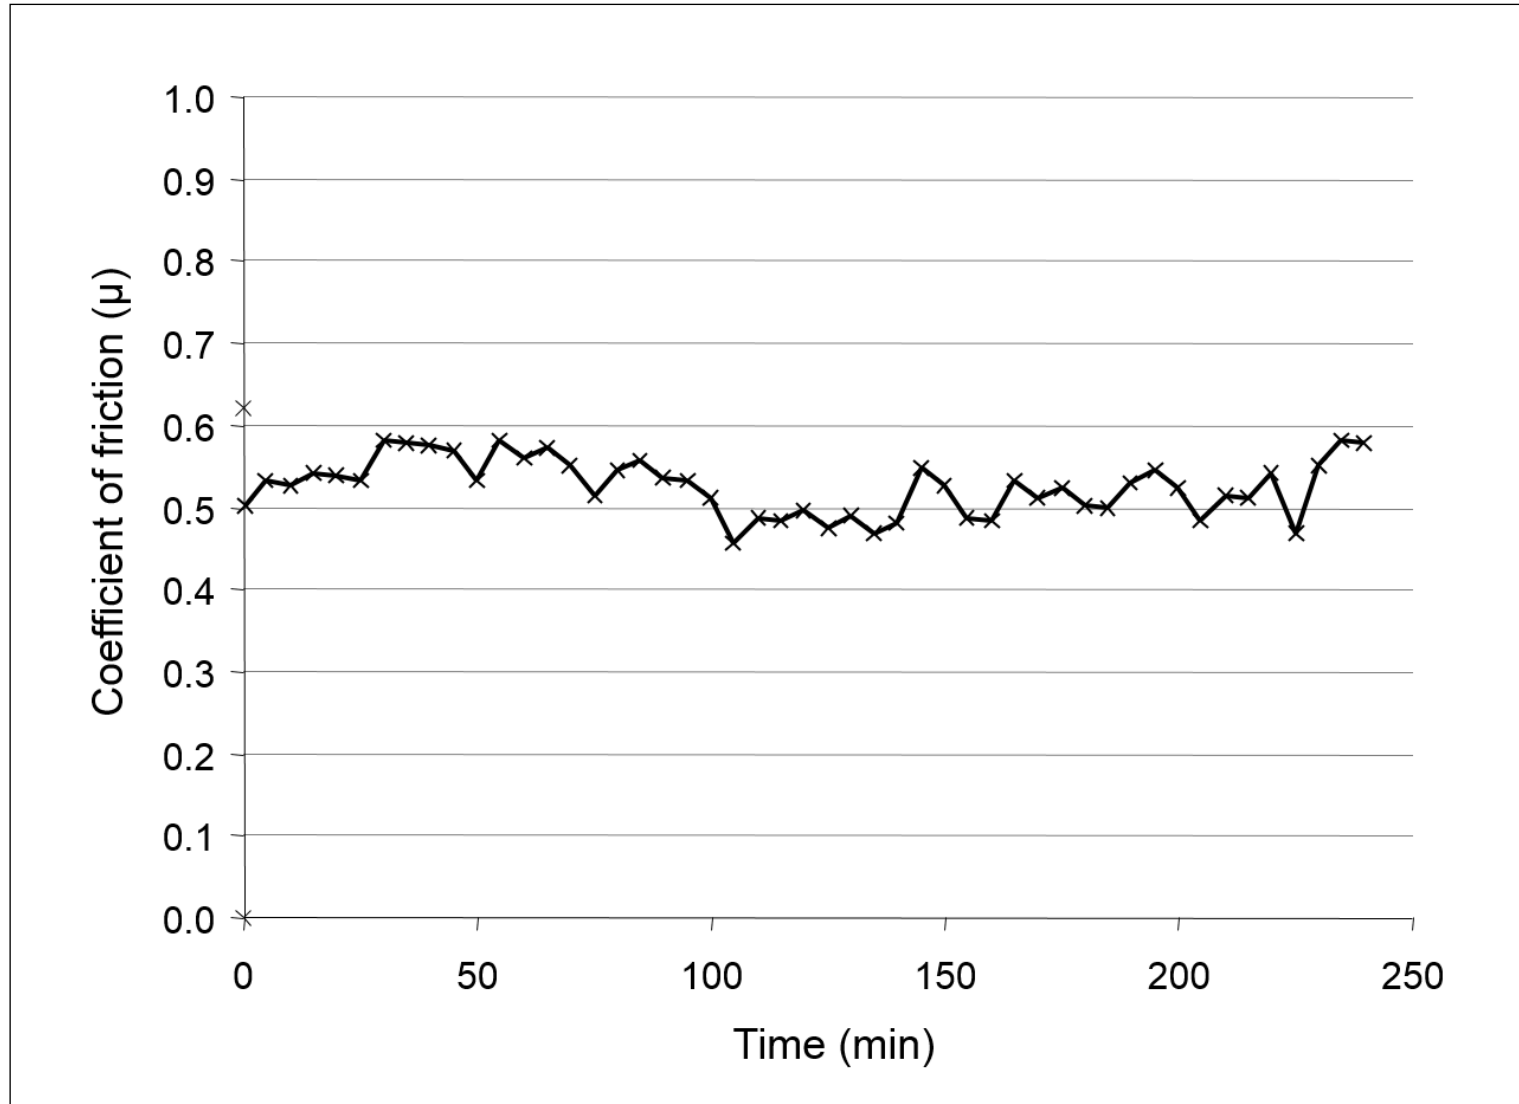
Fig. 3. Coefficient of friction vs. time for Nimonic 80A vs. Stellite 6 at $0.314 \text{ m.s}^{-1} / 750^{\circ}\text{C}$

The coefficient of friction values measured during each of the tests showed an initial period of rapid change, before in many cases settling down into a ‘steady state’ situation with reduced variation. The measured friction coefficients in Figure 3 show no significant changes with time after an initial peak at the very beginning of testing. This indicates that the onset of the formation of a glaze layer was virtually almost immediate giving, the lack of variation indicating a “steady state” in the values of the friction coefficients due to the presence of the glaze on the worn surface.

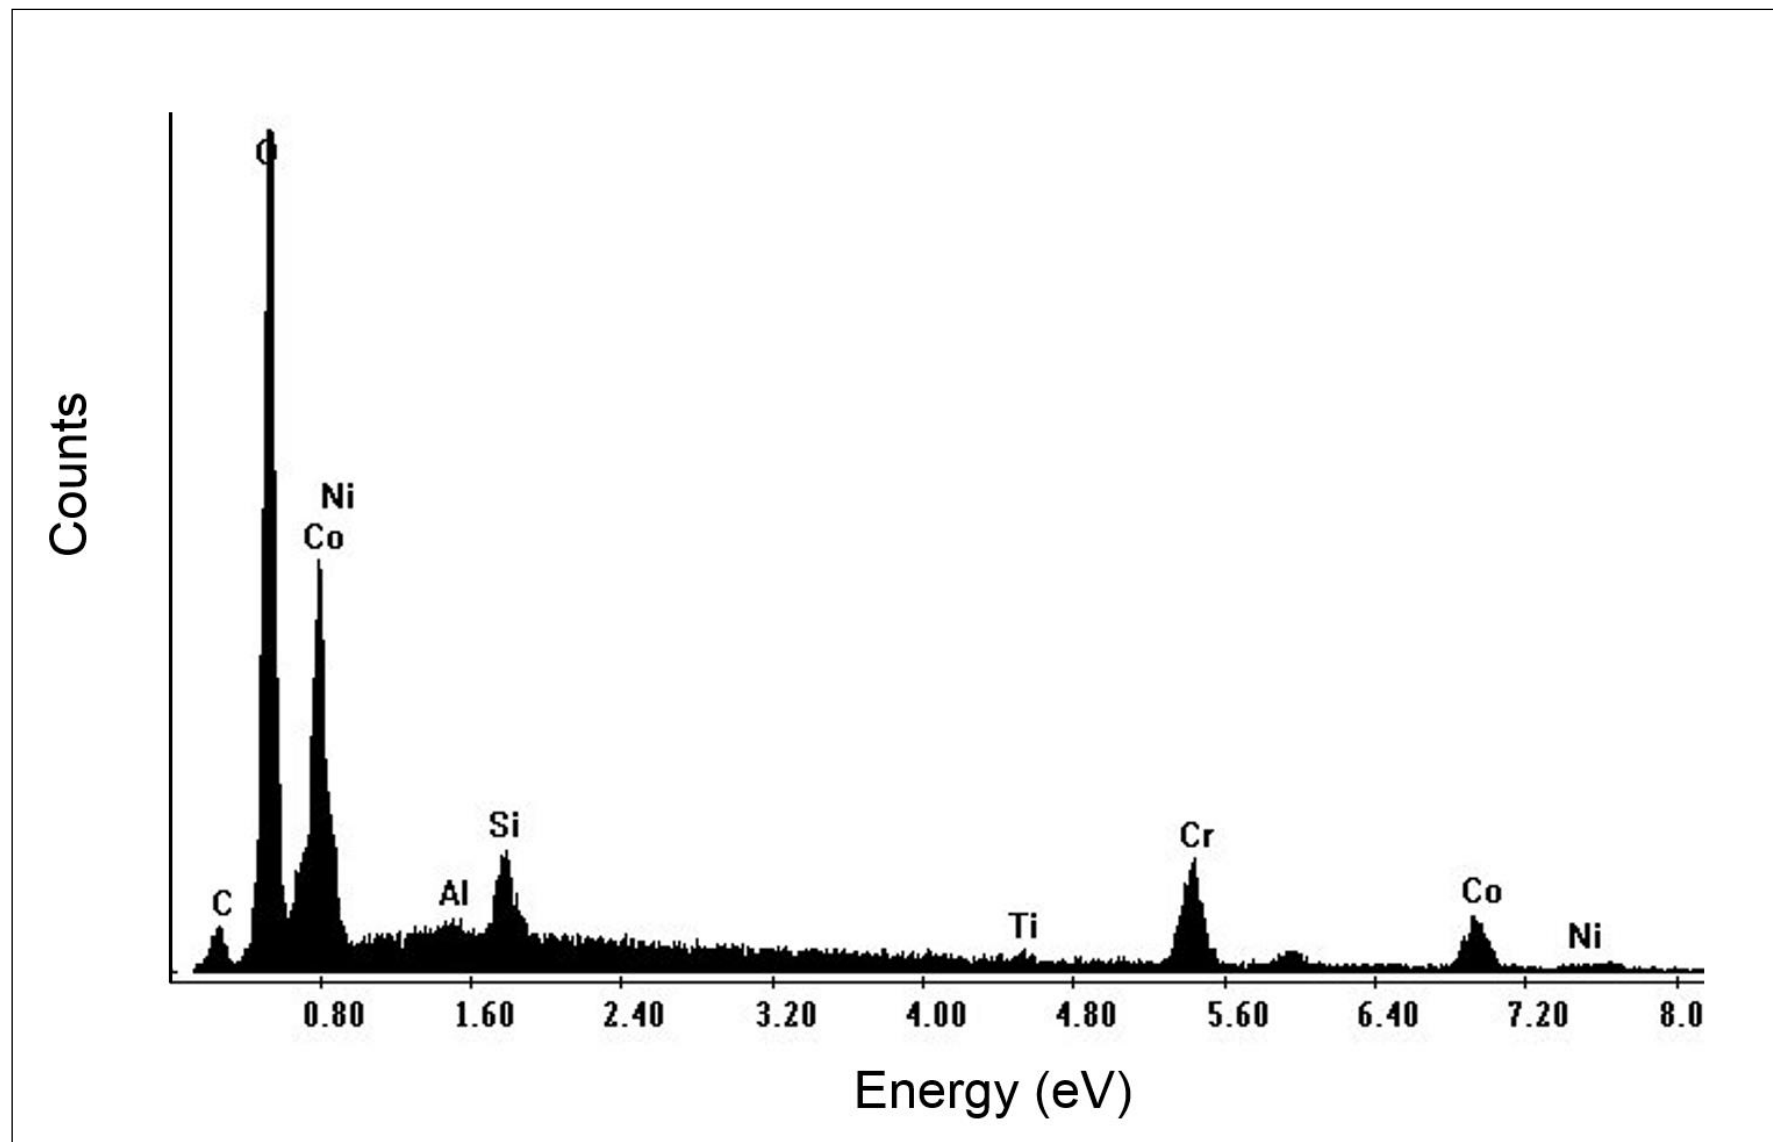
Fig. 4. EDX surface spectrum for Nimonic 80A vs. Stellite 6 at $0.314 \text{ m.s}^{-1} / 750^\circ\text{C}$

The spectrum by EDX analysis of the surface generated under sliding wear at 750°C for 4 hours, shown in Figure 4, reveals the dominant presence of Co, Ni, Cr and O on the glaze surface. Quantification of the results averagely gives Co = 34.2, Cr = 36.2, Ni = 16.7, Si = 3.8 and Fe = 1.3 (%at). However, the presence of these elements was also confirmed by TEM EDS which showed some location-to-location variation. The dominant phases identified by XRD included CoCr₂O₄ and Ni_{2.9}Cr_{0.7}Fe_{0.36} (Figure 5).

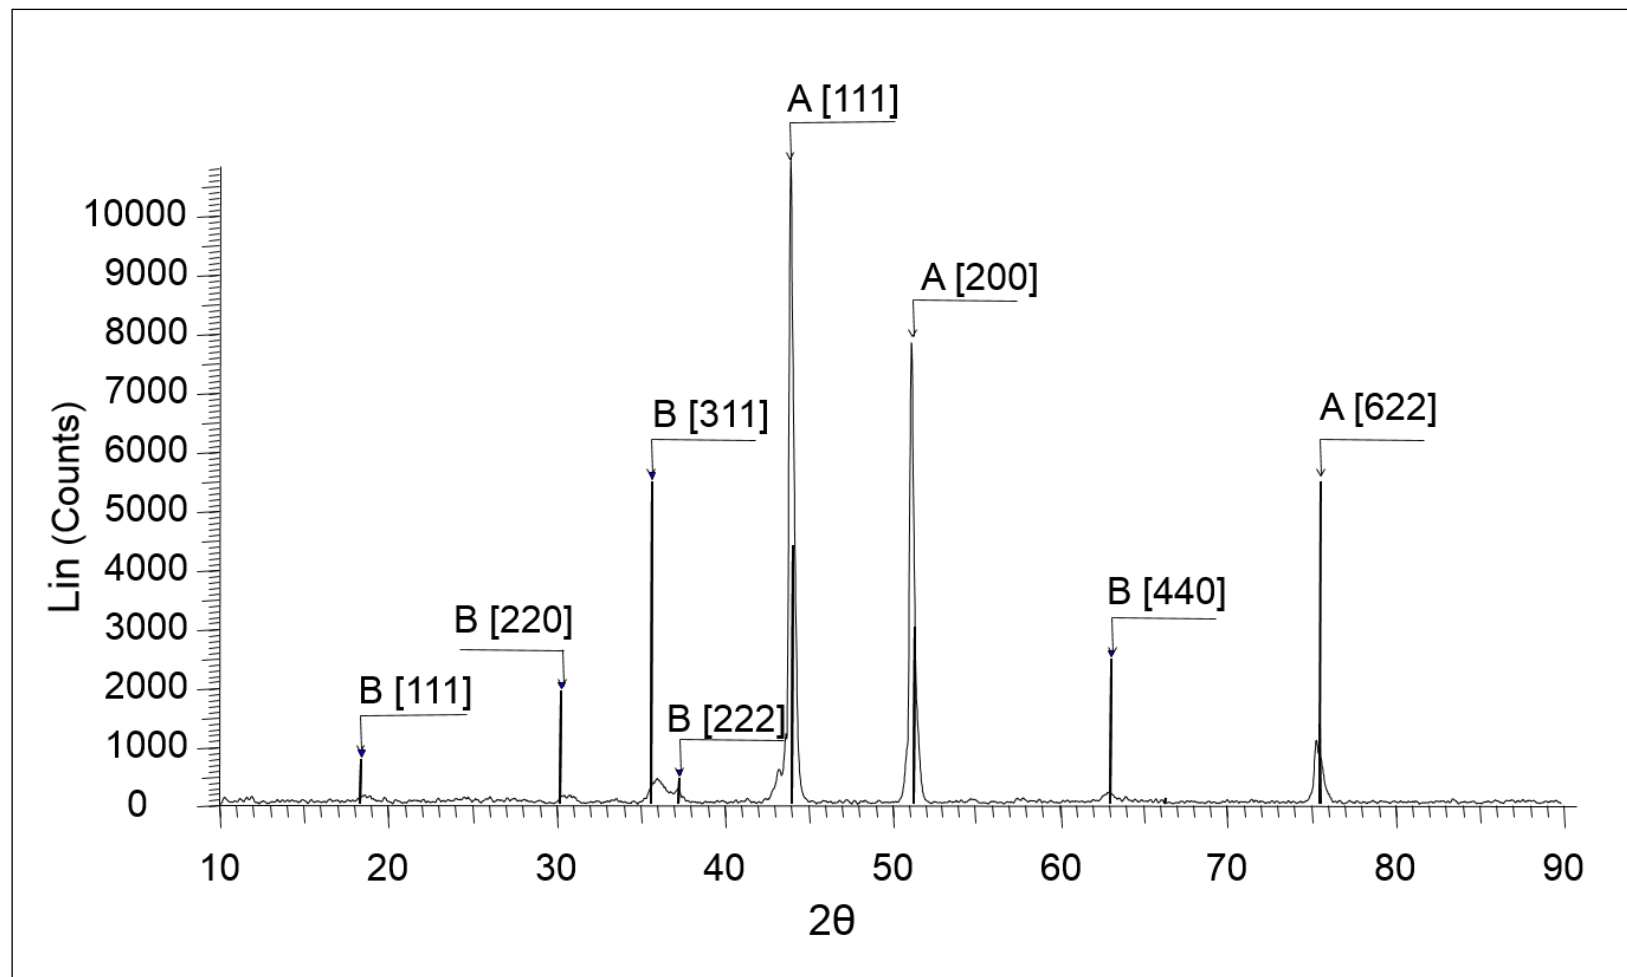
Fig. 5. XRD pattern for Nimonic 80A vs. Stellite 6 at $0.314 \text{ m}\cdot\text{s}^{-1} / 750^\circ\text{C}$: (A) $\text{Ni}_{2.9}\text{Cr}_{0.7}\text{Fe}_{0.36}$; (B) CoCr_2O_4 .

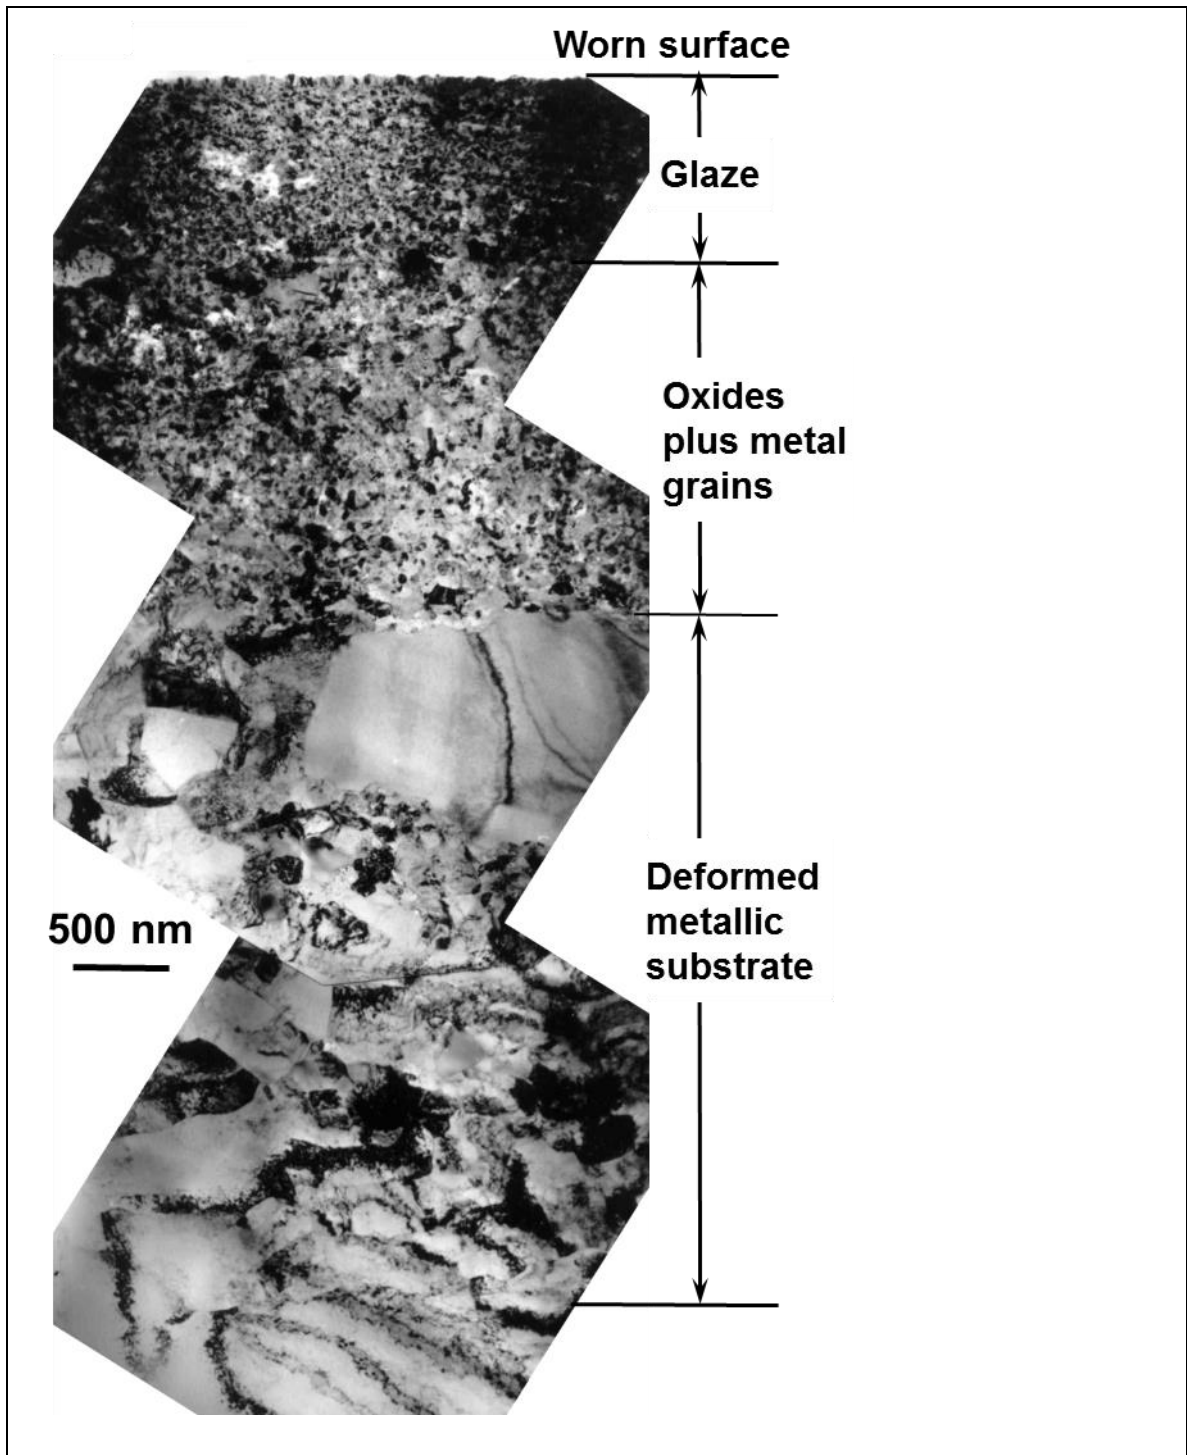
Fig. 6. TEM bright field image: wear-induced polycrystalline glaze layer and deformation of substrate ($0.314 \text{ m}\cdot\text{s}^{-1}$, 750°C)

Figure 6 illustrates a cross-sectional composite transmission electron micrograph of the surface formed during wear test at 750°C. The micrograph demonstrates the presence of the surface layer (glazed surface), the deformed substrate and the glazed layer/substrate interface. The wear-affected region (total thickness ~3 μm) consisted of three layers – the top most layer (the glaze layer) showed the presence of uniform grain structure of size 5 to 15 nm; some of the grains displaying contrast – the dislocation density in this area was low. The interfacial layer consisted of grains of size 10-20 nm and had a higher dislocation density. The layer just beneath the interfacial layer showed subsurface deformation and the presence of elongated grains. The structure of the glazed layer and the selected analysis diffraction (SAD) pattern are separately presented in Figure 7. The SAD pattern consisted of spots arranged in concentric circles

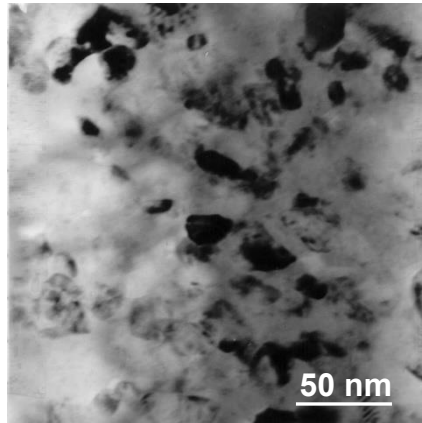
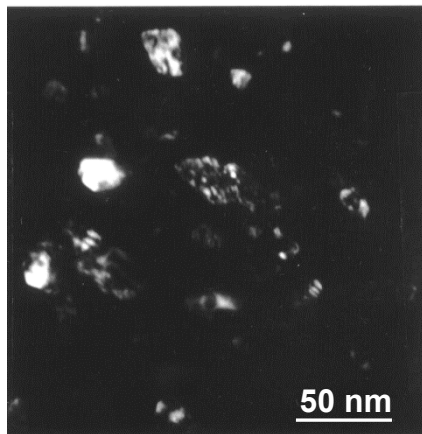
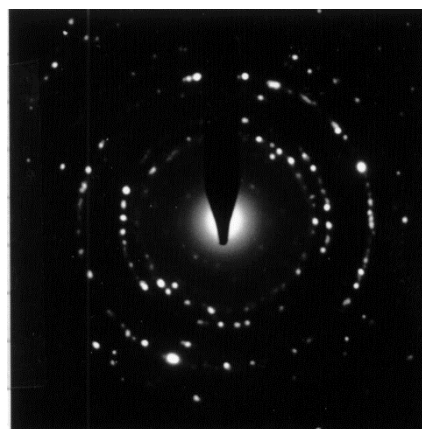
Fig. 7. TEM morphological and structural details of glaze layer: (a) bright field image; (b) dark field image; and (c) selected area diffraction (0.314 m.s^{-1} , 750°C)

indicating the presence of small grains with high angle boundaries, multiple boundaries and large misorientations (formation of misorientated lattice-fragmentation). The poorly defined irregular boundaries indicate non-equilibrium high energy configuration. The indexed SAD pattern also revealed the presence of oxides of Ni, Cr and Co (indexing not shown here). The dark field images further elaborate on the grain structure of the glazer layer.

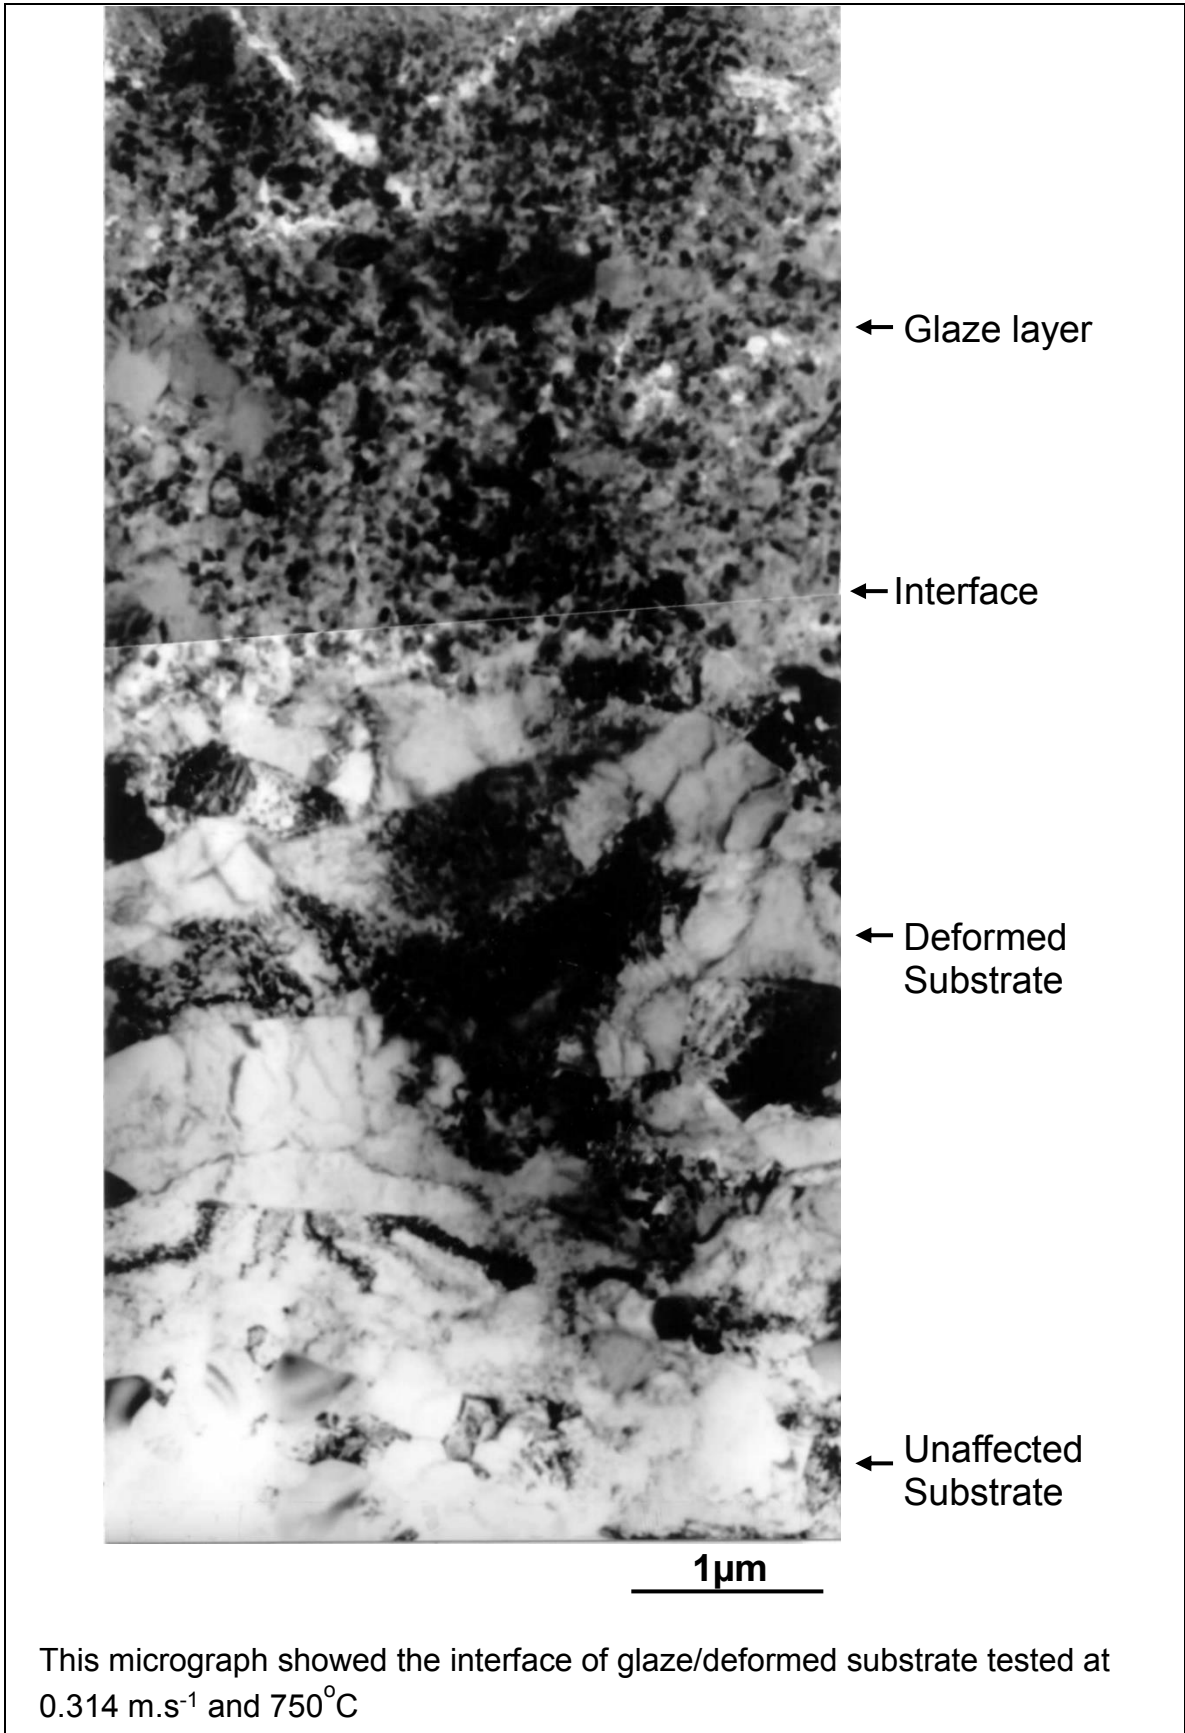
Fig. 8. TEM image showing interface of glaze layer/deformed substrate

The occurrence of sub-surface deformation is illustrated in Figure 8. Dislocations have been observed in the deformed substrate. These dislocations were present as networks inside the deformed (elongated) grains. It was evidenced that shearing deformation took place in the substrate as a response to the sliding process.

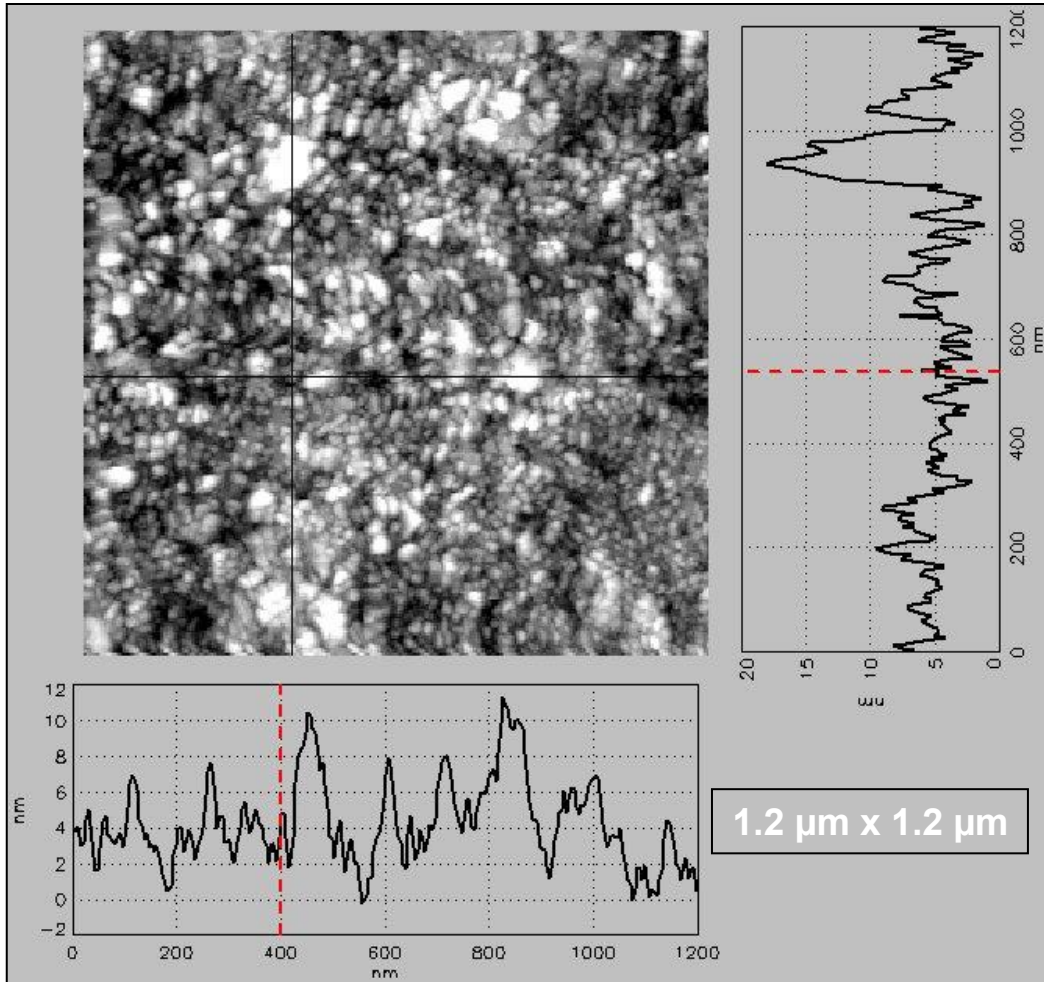
Fig. 9. STM surface line profile results on glaze layer formed on Nimonic 80A at 750°C (0.314 m.s^{-1})
