# SERVICE BULLETIN ML 0010

Date : 31 August 1999  
Game : Happy Hobos  
Subject : Excessive Guiding Ring Wear

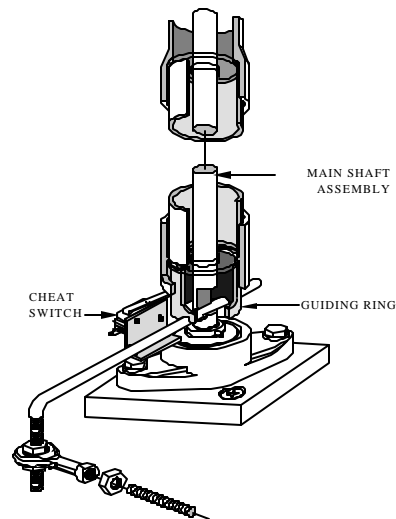
: Prolonged Activation of the Cheat Detection Mechanism is resulting in excessive wearing to the Guiding Ring and Main Shaft Assembly. This is resulting in the Cheat Switch not activating and also in the collapse of the Movement Mechanism

Mark the location of the notch in the old Guiding Ring on the Plastic Pipe. Remove the Head Stop bracket and slide the Head Assembly out of the machine. Remove the retaining screw and old Guiding Ring, you may have to heat the pipe to help loosen it.

Insert the New Nylon Guiding Ring and align the notch with the mark you made on the plastic pipe. Drill a small pilot hole at the retaining screw hole and fit a self-tapping screw. It may be advisable to place a second retaining screw 90 degrees from the first.

Reassemble the head in the machine and check Cheat Detection mechanism for correct function. For details on adjusting Cheat Detection Mechanism, please refer to page 20 of your Service Manual.
