Model Sportage [AL]
Group Fuel System(14)
Number KT2006050901

Service Campaign: 1996-2002 Sportage Fuel Tank Inspection (SC059)

Date Thursday, May 11, 2006
Area N. America

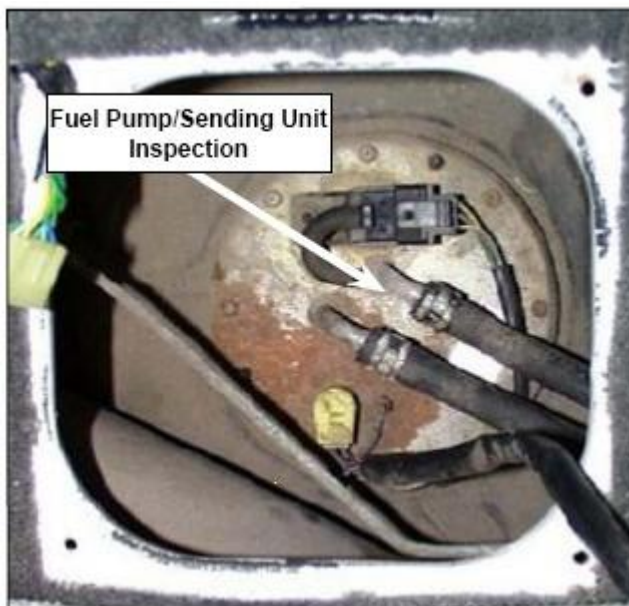
Lift up the right rear seat cushion and raise the carpet access section. Loosen and remove the four (4) screws holding the fuel pump cover plate and move plate to the side to obtain access to the area below. Inspect the fuel sending unit area which can be observed through the opening.

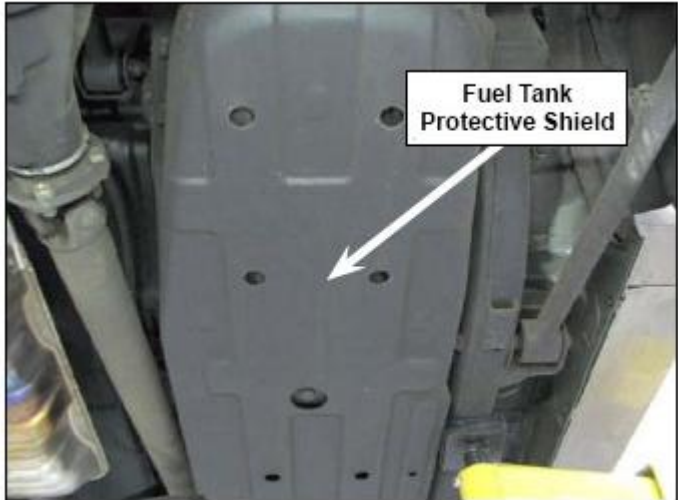
| <p>Note any impact or abrasive damage to the protective shield in Location "A" on the inspection sheet.</p> | |

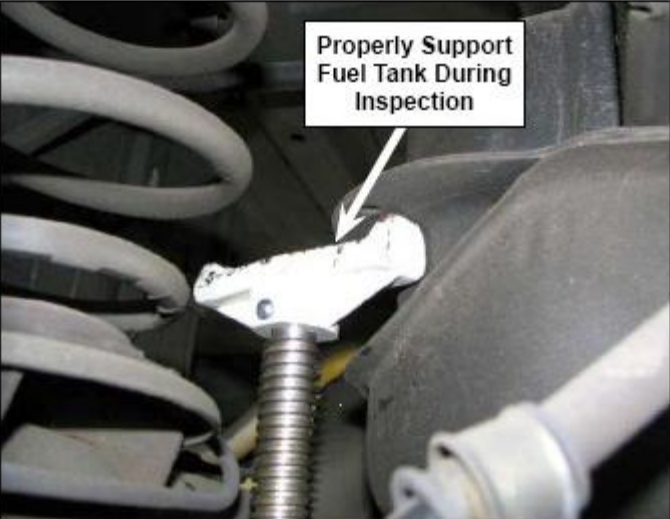
| <p>3. Support the rear of the fuel tank with a jack stand as shown.</p> | |

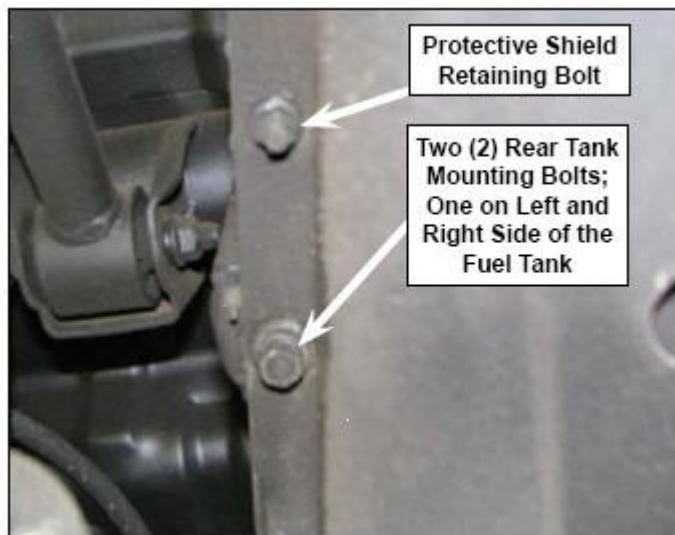
| <p>4. Loosen and remove the two bolts that secure the rear of the fuel tank to the frame.</p> | |

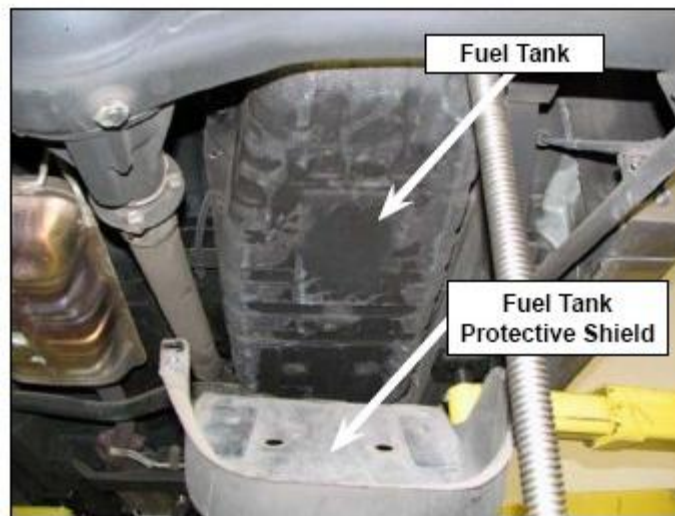
5. Loosen and remove the bolt and nut that secure the rear of the protective shield to the fuel tank.

6. Lower the rear of the shield by gently bending it down just enough to obtain visual access to the entire bottom of the tank.

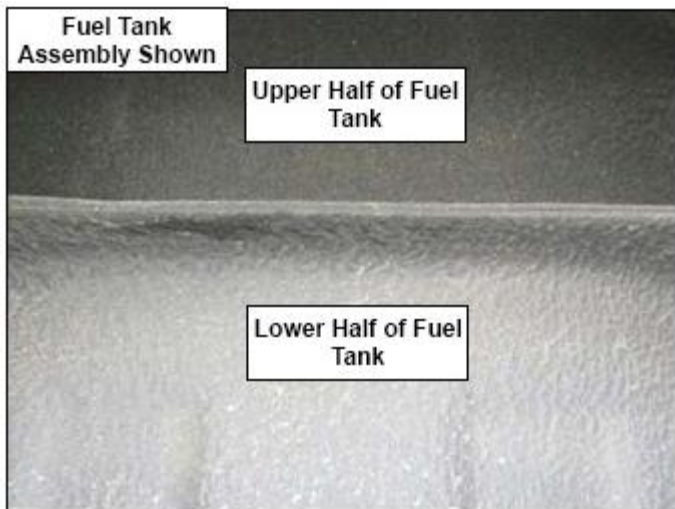
7. Check the lower and upper halves of the tank for impact damage, including dents and abrasions.

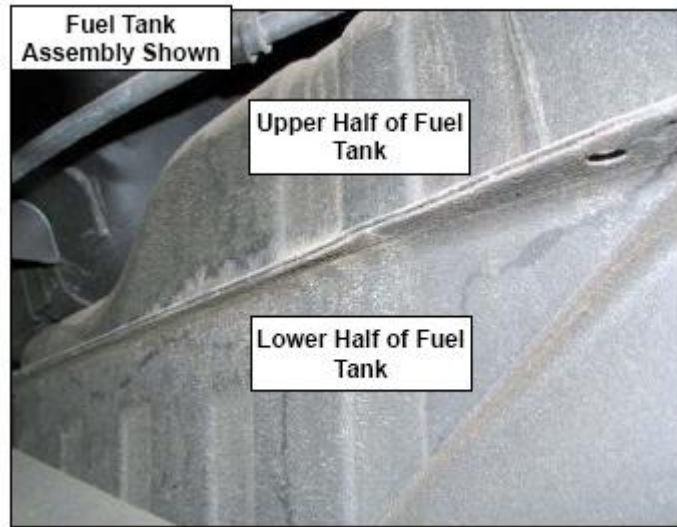
8. Note any such damage on the form in location "A".

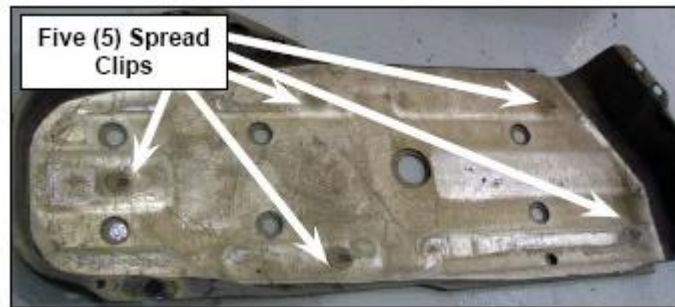
9. Inspect the inside of the protective shield and note if there is an aluminum coated glass-wool insulation pad held in place by spread clips (5); note presence or absence of pad on Inspection Sheet in Location "B".

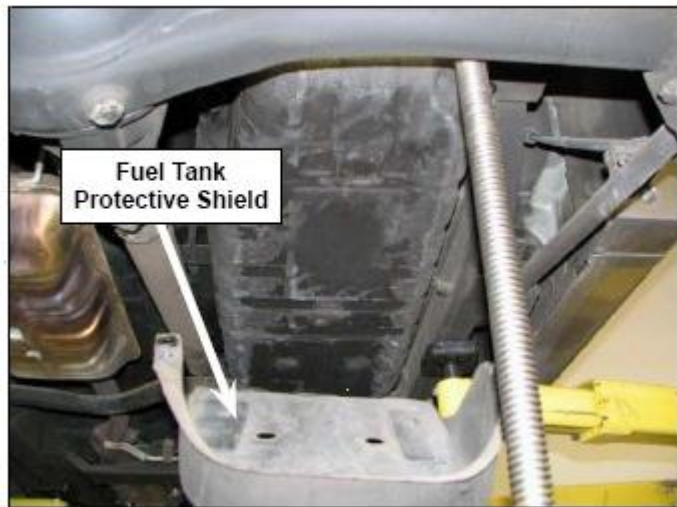
10. Check for disruptions to the integrity of the under body coating on the bottom half of the tank.

11. Note such disruptions on the Inspection Sheet in Location "B" and identify any apparent cause of the coating disruption. Identify whether corrosion is present on the fuel tank and provide a rating for the corrosion level:

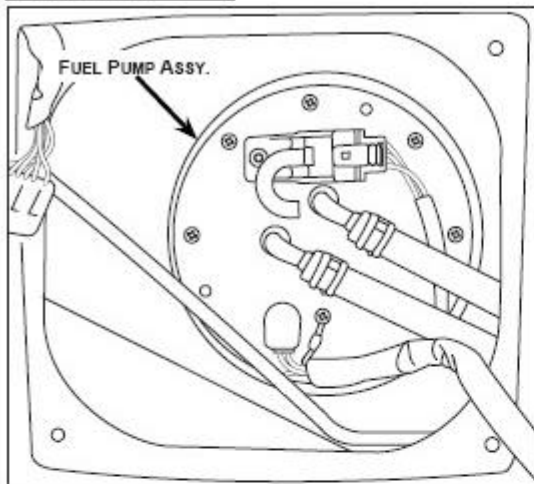
Location A

- Check for displaced or deteriorated hoses and lines, cracked or split plastic fittings.
- Check for fuel leaks due to corrosion of fuel pump/sending unit mounting screws.

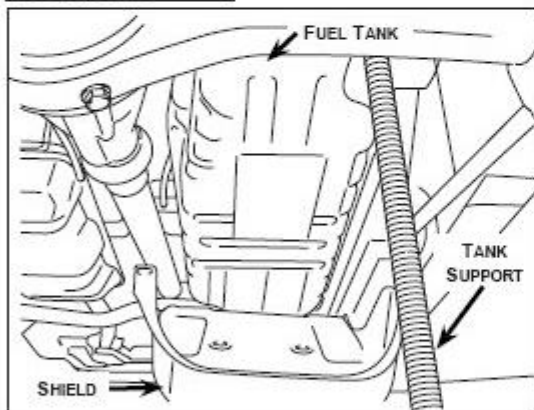
Location B

- A: Corrosion of retaining tabs on shield
- B: Surface: corrosion of metal under coating
- C: Superficial: some limited change to the metal's surface layer only
- D: Moderate: rust alteration to the metal but no rusting through
- E: Deep corrosion: corroded area may be damp but no indication of fuel leakage
- F: No hole apparent, but fuel is visible
- G: Hole / Perforation visible

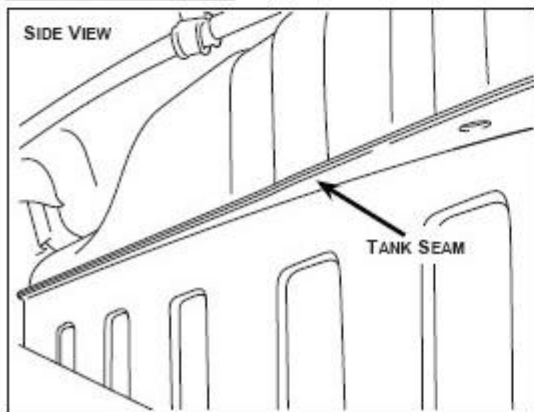
Location C

Check the seam between the upper and lower halves of the fuel tank for loss of integrity and presence of fuel.
