Rattle or Wind Noise From a Front Door Panel

(Supersedes 01-048, Rattle From a Front Door Panel, dated July 2001)

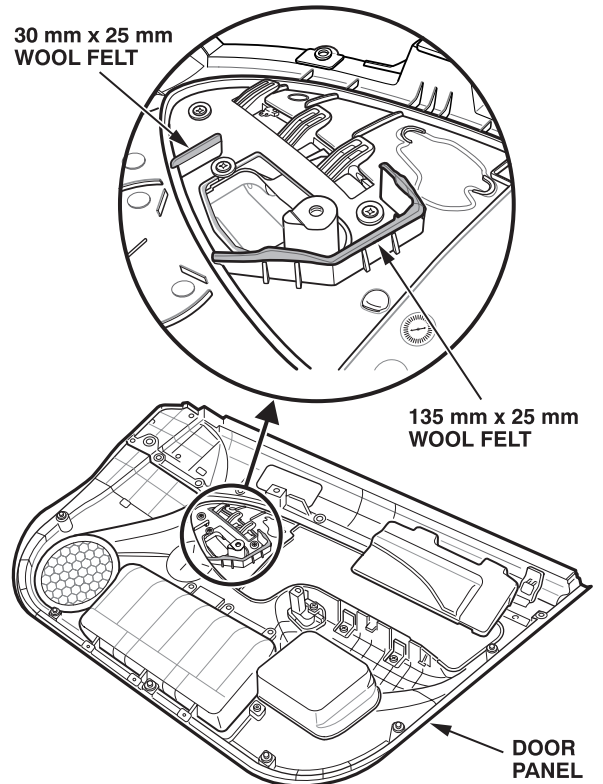
Rattle — Friction between the ribs on the door panel and the door skin.

1. Remove the affected door panel. Refer to section the 2001 Civic Shop Manual.
2. Cut two pieces of wool felt: one 135 mm x 25 mm and one 30 mm x 25 mm.
3. Apply the pieces of wool felt to the ribs as shown.

Apply wool felt to the ribs on the door panel and EPT Foam 10T to the top rear edge of the affected door(s).

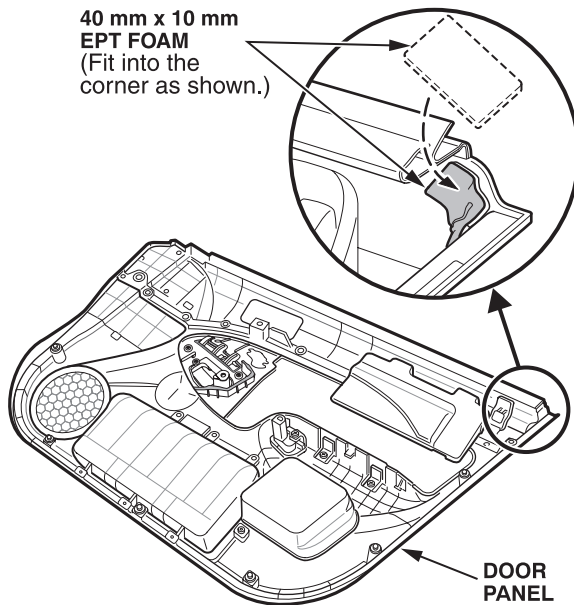
Wind noise — A gap at the top rear edge of the door panel.

- Cut a 10 mm x 40 mm piece of EPT Foam 10T. Apply it to the top rear edge of the door panel.
