Safety Recall: Civic Fuel Fill Hose Clamps

Safety Recall: Civic Fuel Hose Clamps

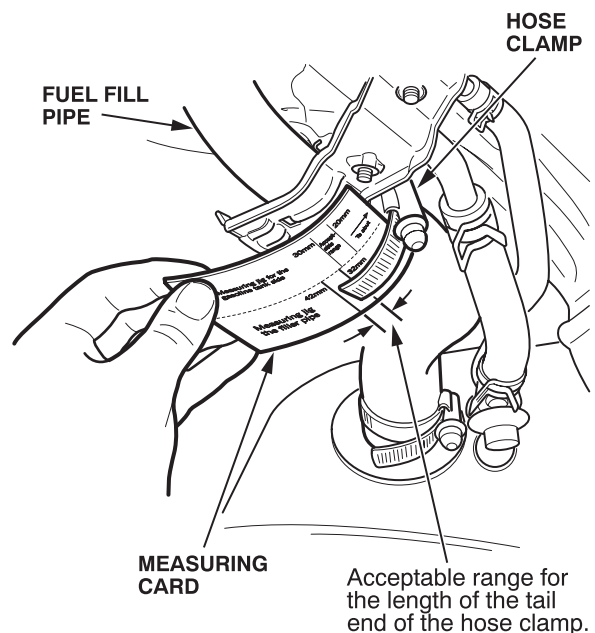
1. Raise the vehicle on a hoist.
2. Remove the fuel fill pipe cover.
3. Insert the card under the tail of the hose clamp that is around the fuel fill pipe.

- If the tail of the hose clamp reaches the acceptable range on the card (32 to 42 mm) or extends past the range, the hose clamp is properly tightened. Go to step 5.
- If the tail of the hose clamp does not reach the acceptable range, go to step 4.

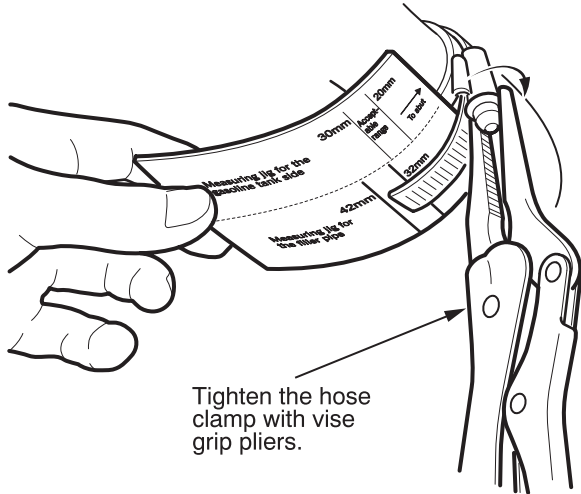
- Use a pair of vise grip pliers to tighten the hose clamp until the end of the tail reaches the acceptable range.

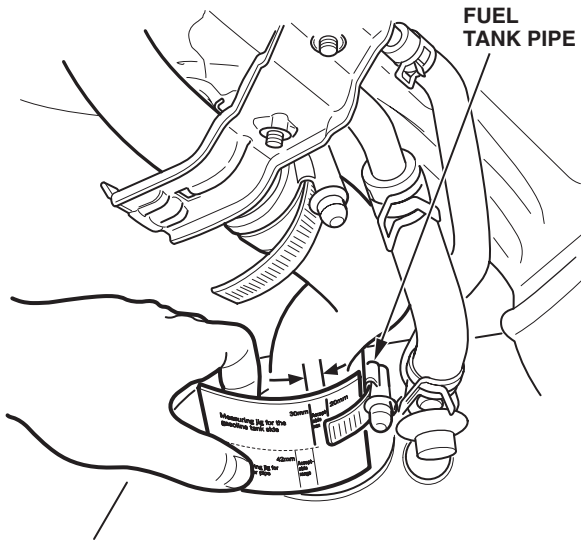
- Insert the supplied card under the tail of the hose clamp that is around the fuel tank pipe.

- If the tail of the hose clamp reaches the acceptable range on the card (20 to 30 mm) or extends past the range, the hose clamp is properly tightened. Go to step 7.
 - If the tail of the hose clamp does not reach the acceptable range, go to step 6.
- Use a pair of vise grip pliers to tighten the hose clamp until the end of the tail reaches the acceptable range.
 - Reinstall the fuel fill pipe cover.
 - Lower the vehicle.
 - Center-punch a completion mark above the last character of the engine compartment VIN.
