Rear Seat-Back Lock Is Hard to Turn

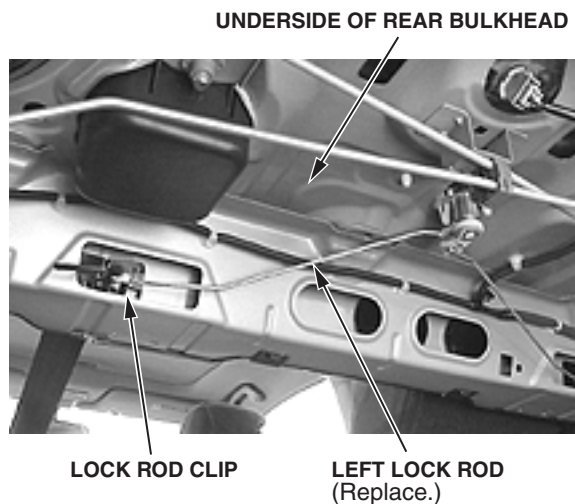
1. Open the trunk.
2. Pull the left rear seat handle to release the seat-back.
3. Rotate the lock rod clip; remove and discard the lock rod.

4. Install the new lock rod.
5. Reinstall the lock rod clip.
6. Lock and unlock the seat-back three or four times to make sure the lock works well.
