Applies To: **2001–03 Civic DX, EX, HX, LX – ALL**
September 16, 2003

Cracked Air Cleaner Case

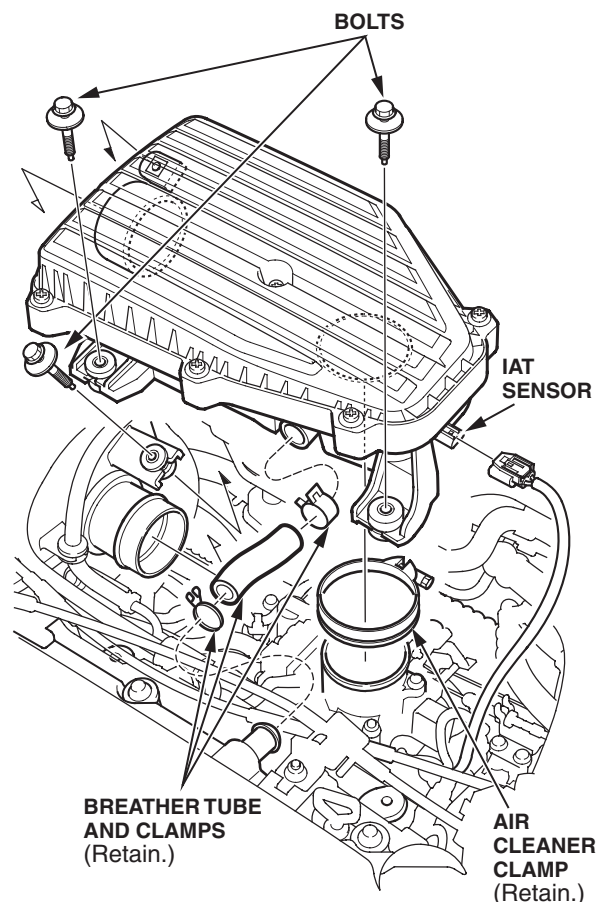
1. Disconnect the connector from the IAT sensor.

2. Remove the three assembly mounting bolts.
3. Loosen the clamp holding the air cleaner to the throttle body. Remove the air cleaner assembly.
4. Remove the breather tube and clamp from the old air cleaner case.
5. Install the breather tube and clamp to the new air cleaner case, then install the air cleaner case on the vehicle.
6. Install the air cleaner element. If you are not able to reuse the original element because you cannot separate the cover from the case, install a new element.
7. Install the new air cleaner cover, and reconnect the IAT sensor.
