# Texas Professional Home Inspections

**Concerning:** **103 Easy St. Yellow Rose, Texas**  
(Address or Other Identification of Inspected Property)

**By:** **Mike Wilkinson #6552** **6/7/2005**  
(Name and License Number of Inspector) (Date)

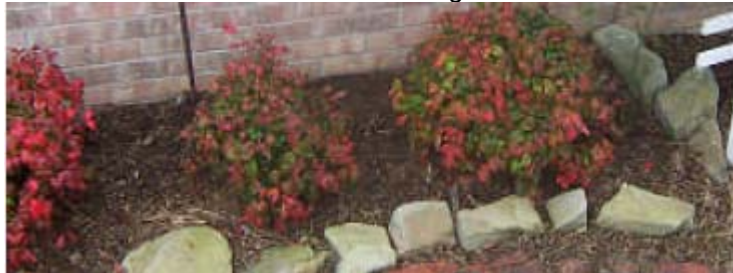
Comments: Soil is too high in some areas around the foundation there should be at least 6 inches of foundation showing at all times.

Proper drainage is critical to the future performance of the foundation. If for any reason water standing near the foundation for an extended time, (more than 24 hours) drainage corrections will be necessary.

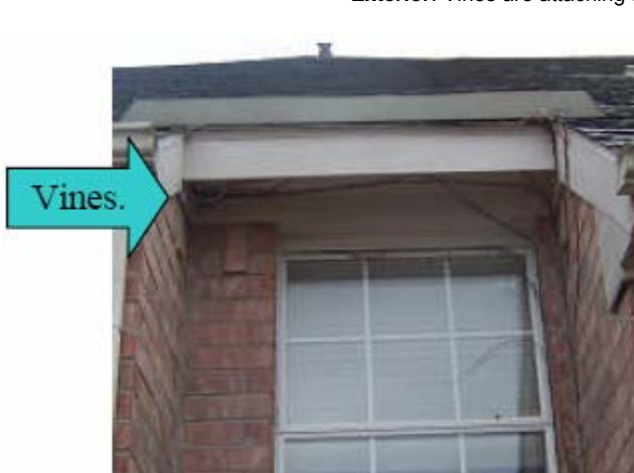
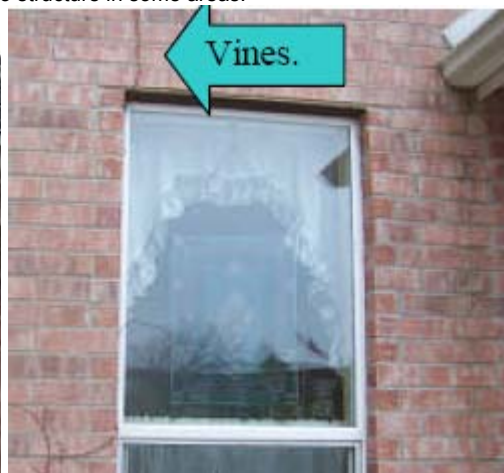
**Exterior:** Vines are attaching to structure in some areas.

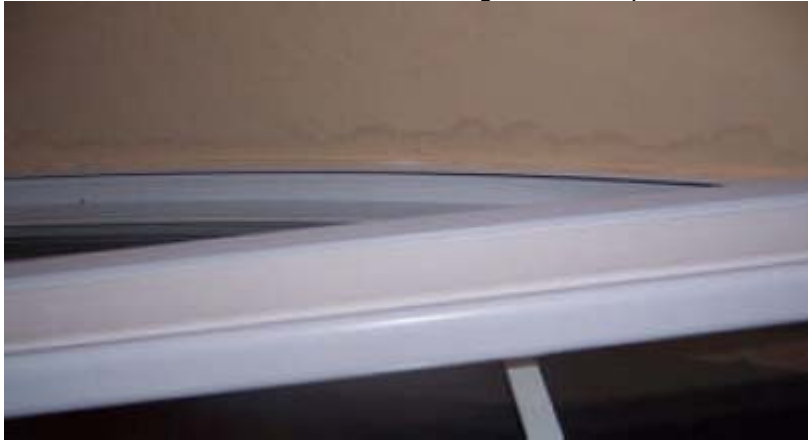
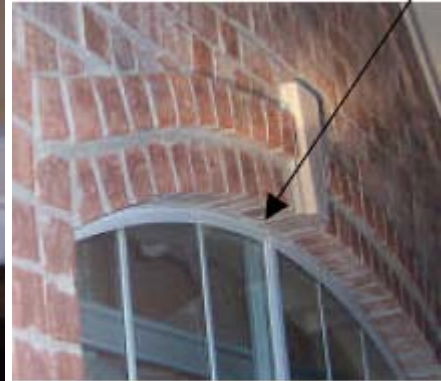
Comments: Signs of water penetration in upstairs office window at arch area.

**With any reference of water penetration, or stain noted in this report it is recommended that a qualified professional perform a professional mold/mildew analysis. It should be noted that mold/mildew investigations are not included in this report.**

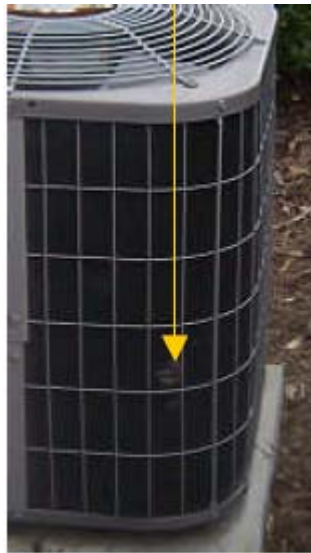
Comments: Some fins are bent on outside unit.

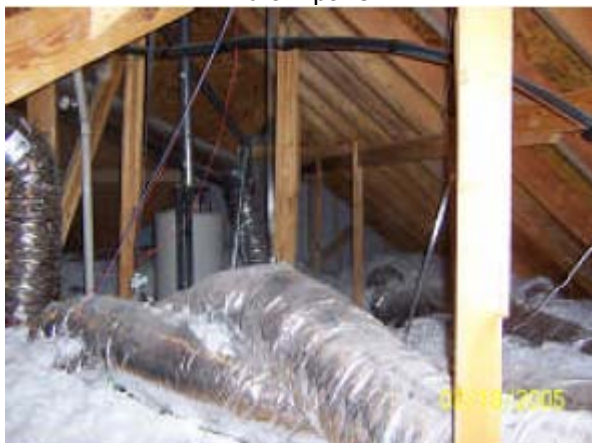
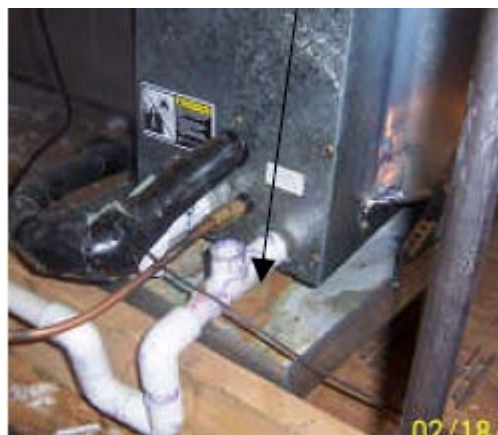
Comments: Flexible air ducts are not supported every 4 feet in the attic. The 2 units in the upstairs attic need new filters and signs of rust in the secondary drain pans.

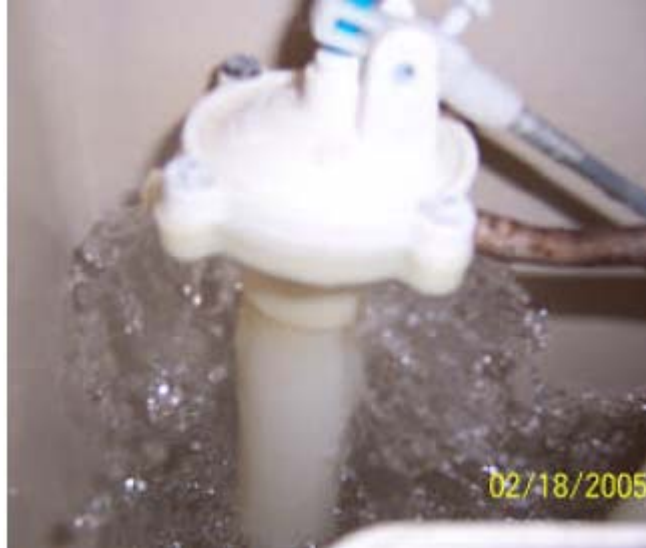
*Comments: Hall bathroom right of kitchen the toilet valve seal is leaking. Master bathroom toilet valve seal is leaking.*

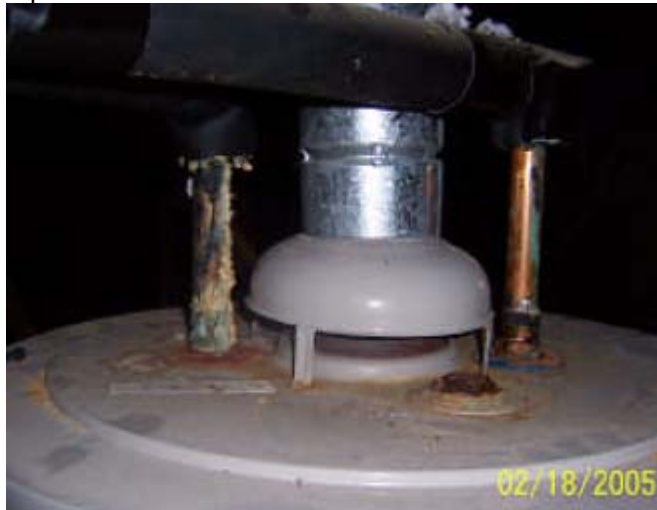
*Comments: First attic access at top of stairway water heater has signs of rust and corrosion on hot water outlet. Both burner compartments have signs of rust present. Recommend a licensed plumber to determine and evaluate necessary repairs.*
