**Land Drainage Consultancy Ltd.**

## **CHERRY BURTON VILLAGE**

### **Flooding of Village**

**Prepared for Cherry Burton Parish Council  
By Jenny Lambert BSc (Hons) Dip Ag Eng  
November 26<sup>th</sup> 2008 (Version 2)**

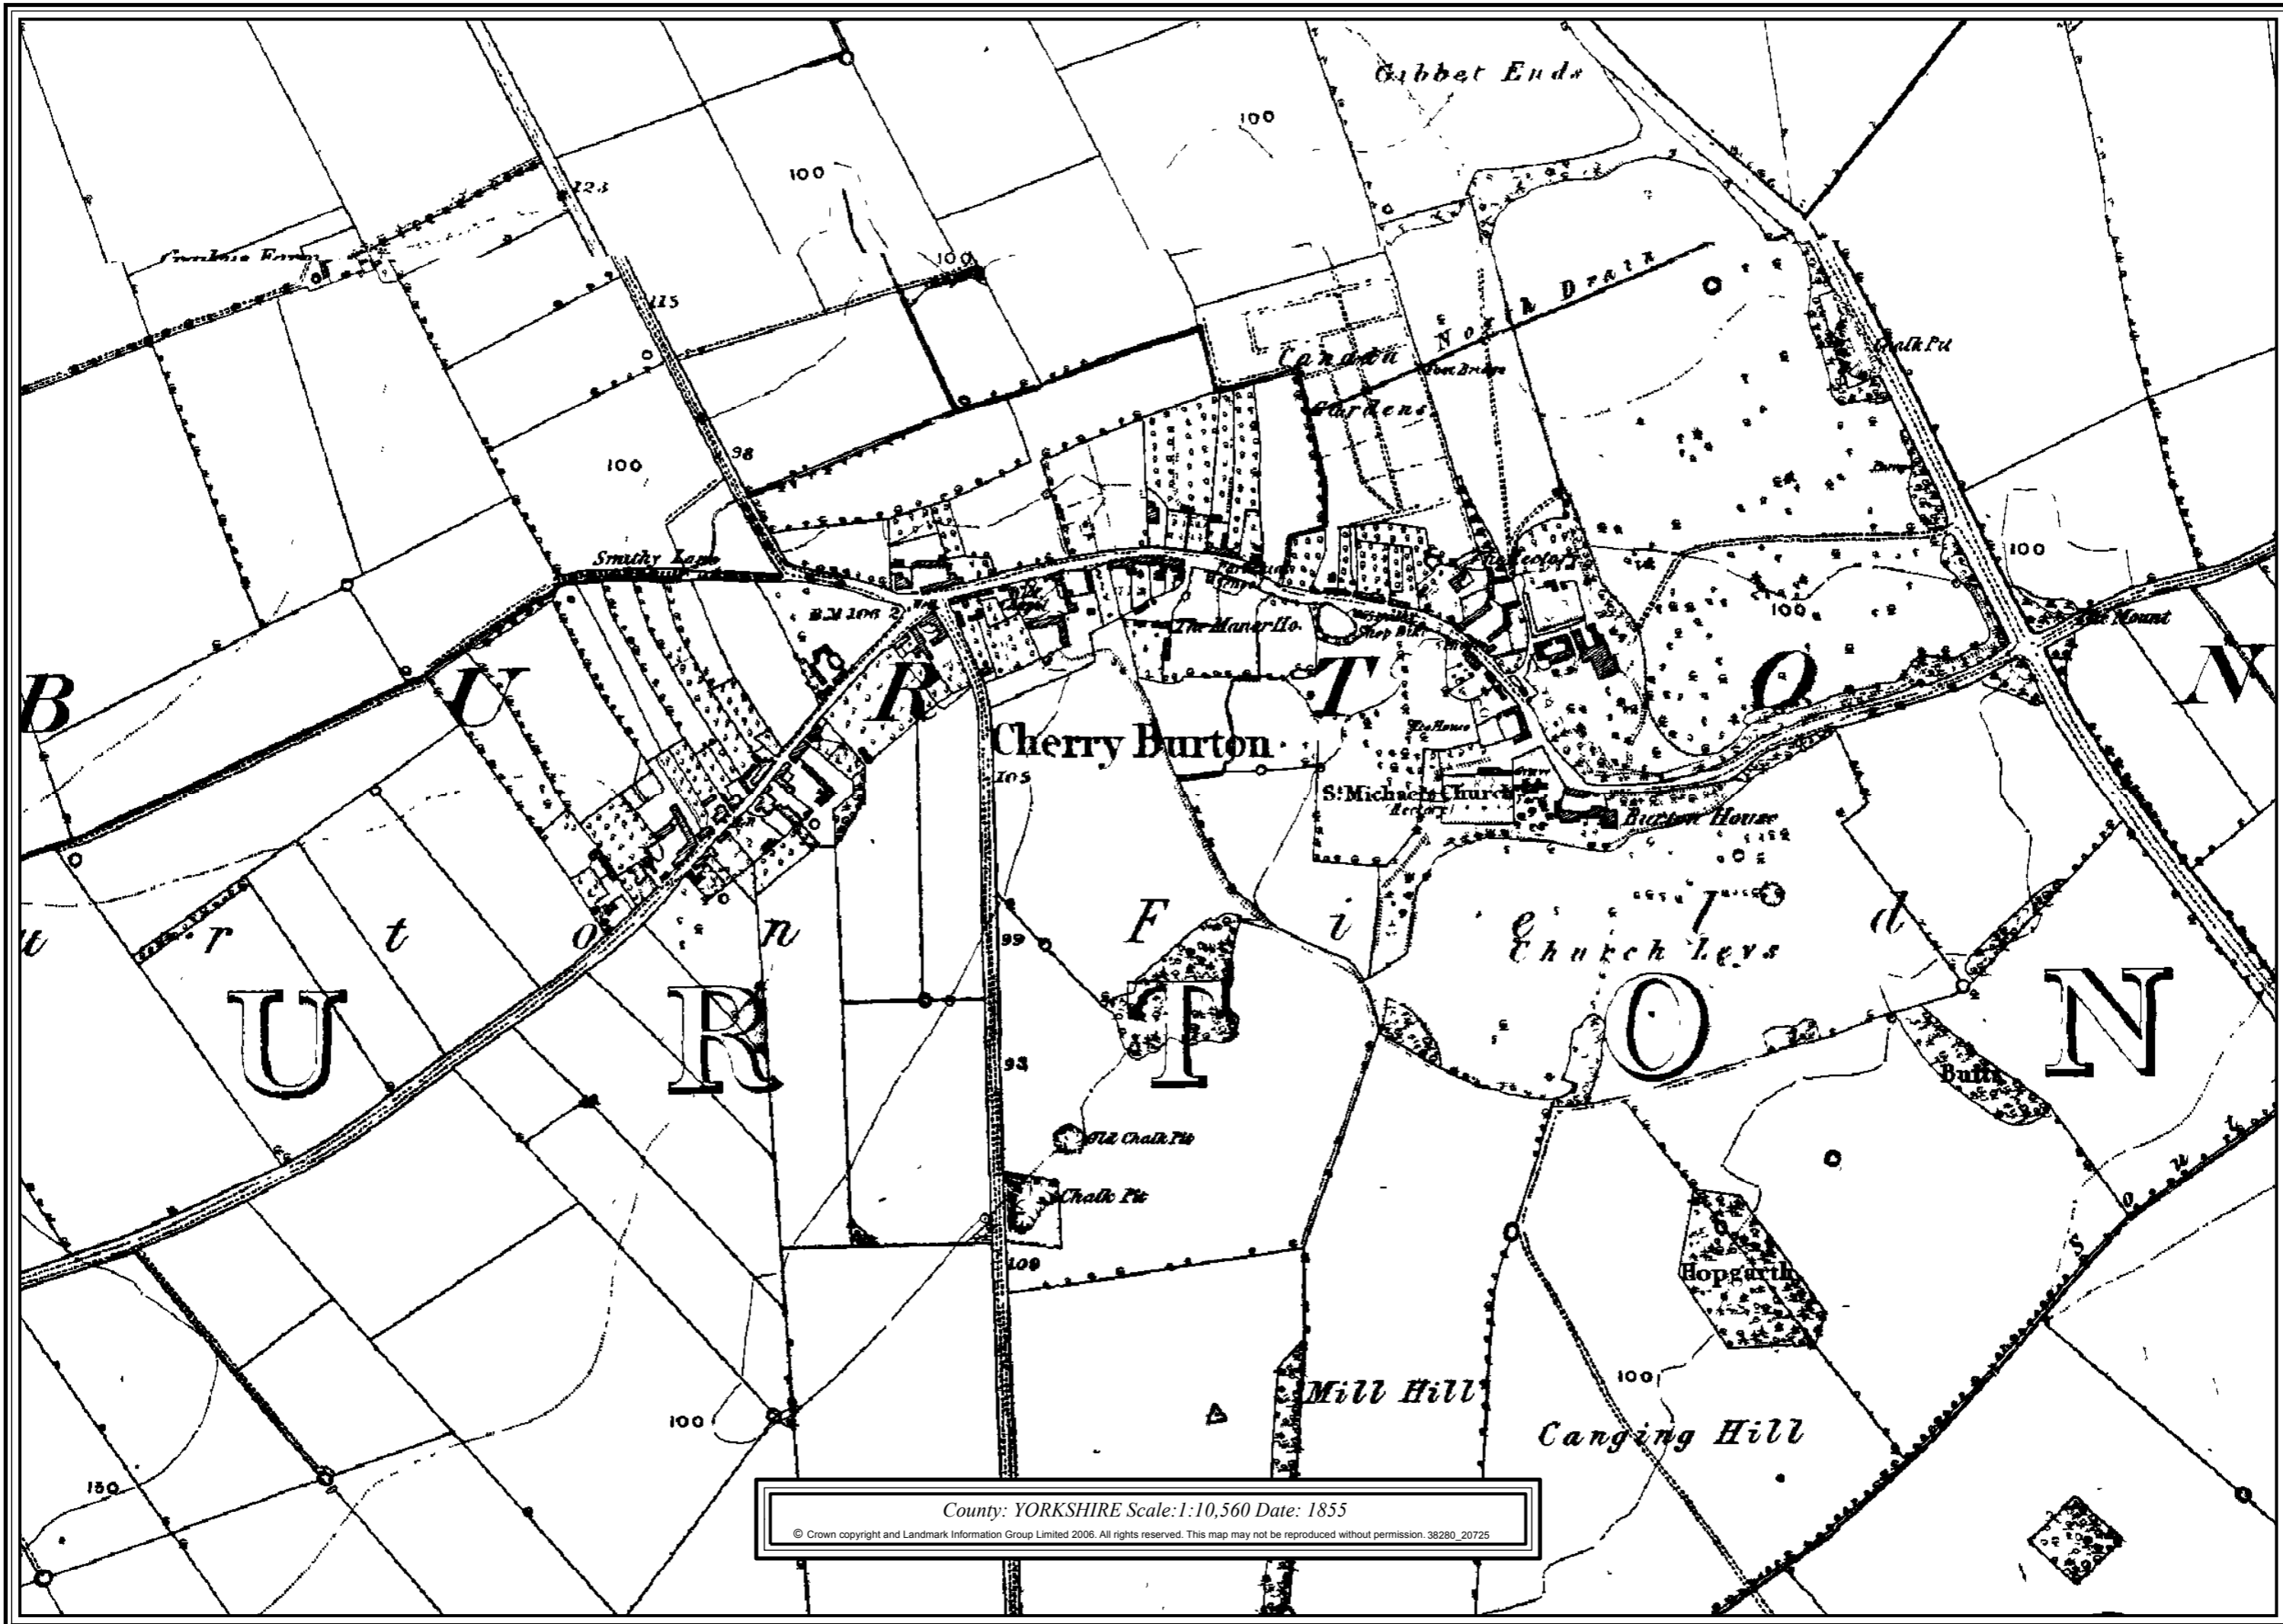
Former ditch section A- H has been replaced with a 600mm dia pipe with the exception of a short section from E, through the garden of 122 Canada Drive which is recorded as a 150mm dia pipe.  
 Former ditch section K-I has been replaced with a 900mm dia pipe.  
 Former ditch section K-M has been realigned and replaced with a 150mm di pipe from The Meadows to the school and then a 225mm dia pipe from the school to point K
