TECHNICAL BULLETIN INDEX
Sorted by Bulletin Number

All the 2000 Mods You Wanted — But Were Afraid to Ask For

Tandy 2000 Orphans

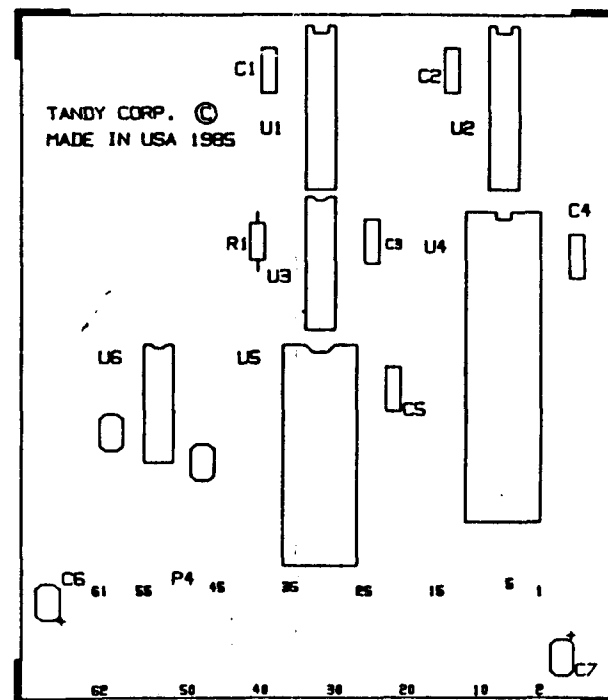
Tandy 2000 8087 Numeric Coprocessor Component Layout

The iAPX 8087 identifies numeric instructions by monitoring the bus activity of the 80186 CPU. Two sets of status lines (S0* - S2* identify the type of bus cycle, and QS0 - QS1 identify queue operations) inform the 8087 of the bus cycle being run as well as the status of the CPU's internal queue (the 80186 maintains a queue up to six bytes long from which opcodes are fetched). A certain class of instruction codes (ESCAPE opcodes) have been reserved for the numeric coprocessor extension. In response to an ESC opcode, the 80186 computes the EA (Effective Address) identified by the opcode, and does a single memory read from that address. The 8087 decodes the ESC instruction tandem with the 80186 and (if necessary) grabs both the data and the address generated by the CPU. If further bytes need to be fetched to complete the instruction, the 8087 informs the 80186 of its status by outputting BUSY (active high while doing a numeric operation). The CPU has an instruction (WAIT, no operands) that waits for its TEST* (active low) to go active before it continues. All 86 family assemblers insert a WAIT instruction before floating point instructions unless explicitly directed not to do so. That way, the CPU does not embark on a new numeric instruction before the last one has completed its execution. Interface between the 8087 and the 80186 is performed by the 82188. This device provides system READY synchronization, converts the RQ/GTn* bus master control convention of the 8087 to the HOLD/HDLA convention of the 80186, synchronizes the QSn* lines of the 80186 to the 8087, and provides RD*, WR*, and ALE strobes by decoding the S0* - S2* status lines that are common to both the 80186 and the 8087.

Additional logic on the circuit board regenerates the MCS0* and MCS1* (Memory Chip Select 0 and 1, active low in 00000H - 1FFFFH for MCS0* and in 20000H - 3FFFFH for MCS1*) that is generated by the 80186 so that the 8087 may access these areas also. In order for the 8087 to properly track accesses to the UCS* (Upper Chip Select, active low in F8000H - FFFFFH), SRDY (Synchronous Ready, active high) must be held inactive to maintain the appearance of a three wait state access (the 80186 is programmed by the boot ROM to run a three wait state access to this area).
