BAD VIBRATIONS

The First Part of One Chevy Fan's Quest for Smoothness

Finally...the End of One Chevy Fan's Quest for Smoothness

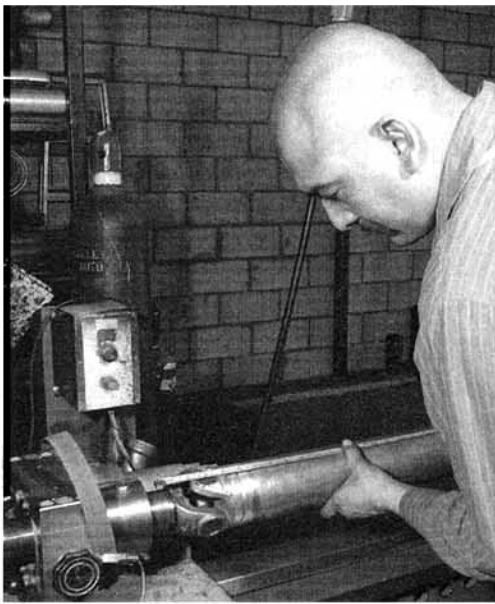
The measurements customers make are transferred to the driveshaft fabrication process. Here, Inland's Tom Aragon verifies the length of our new shaft just before he fires up the welder.

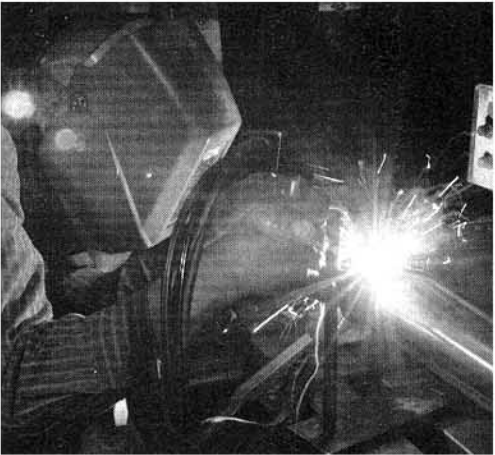
Aragon heliarc welds driveshafts on a machine specially designed and built by Inland Driveline.

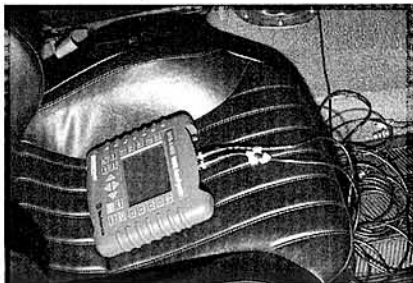
The Vetronix MTS 4100 is wired for road test use in the Malibu. When this image was recorded last June, the 4100 was still in the final stages of development. Since then, it was introduced to the market and promptly named to the Motor Magazine "Top 20 Tools" list for 2002. One nice thing about this device is its ergonomics. You hold it securely with two hands, using your thumbs to push buttons at the side and along the bottom of the screen.
