**USGA GREEN SECTION  
TURF ADVISORY SERVICE VISIT REPORT**

**LAKE WILDWOOD GOLF CLUB**

**Penn Valley, California**

**August 7, 2008**

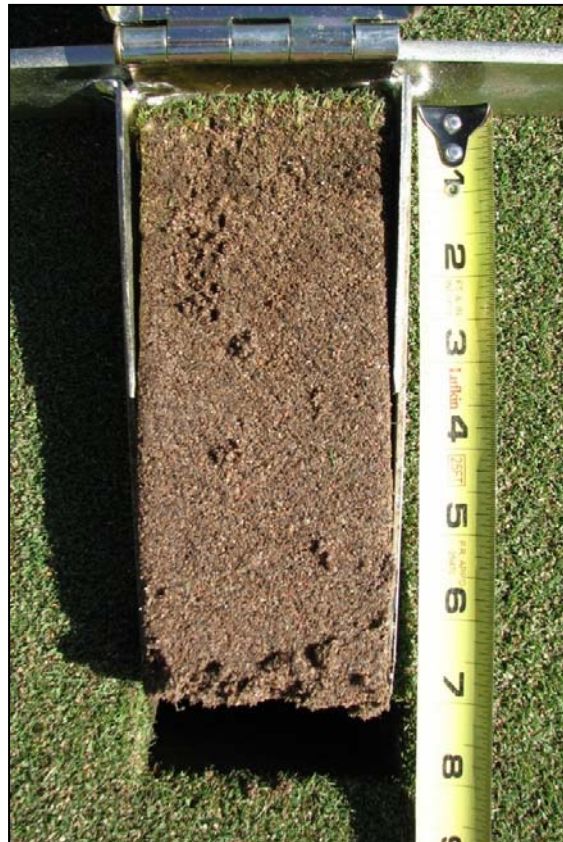
*This soil profile sample taken from a golf course in Arizona is a good example of healthy bentgrass grown on a well-constructed USGA sand profile. The sample shows approximately 1-in. of thatch and organic matter development. A healthy profile is better able to withstand traffic, encourage root growth, and tolerate a deep, infrequent watering regime.*

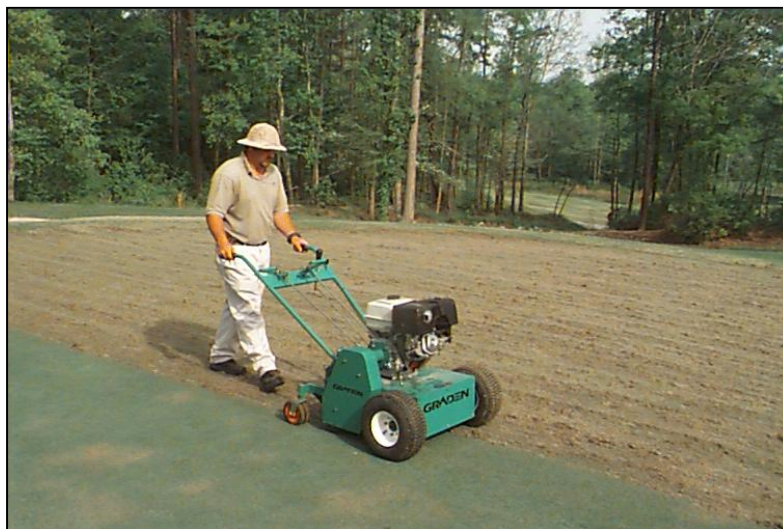
*The Graden vertical mower has been used successfully by a number of courses to remove excess organic matter in the surface of greens and help with the incorporation of sand topdressing.*

Another effective procedure is to use a dethatching machine, such as the *Ryan Mat-a-way* or *Graden* dethatcher to remove additional organic matter and aid in the mixing of sand topdressing into the upper portion of the soil profile. Dethatching and light sand topdressing can be scheduled on a monthly basis during the active growing season for improved results.
