ServiceNews

March 2002

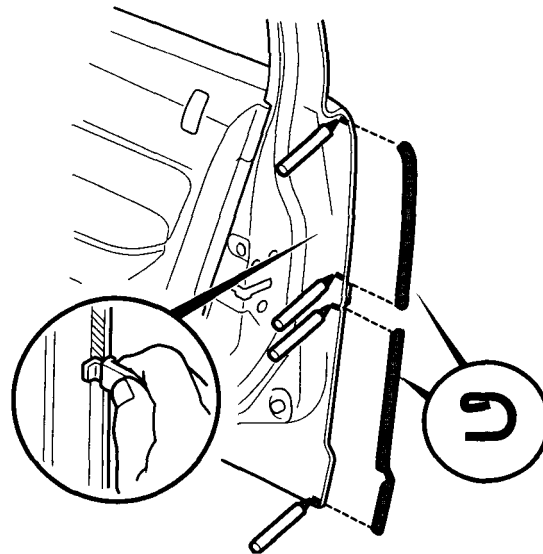
Door Edge Guards Fall Off: '01-02 Civic

When installing accessory door edge guards on a '01-02 Civic, make sure you follow step 4 of the appropriate installation instruction *to the letter*. Trim the sealer from the door with the hem sealant cutting tool. If you *don't* trim the sealer, the door edge guard *doesn't* fully seat when you install it. Over time, it could detach itself from the door and fall off.
