**EXPERIENCE WITH DOUBLE HULL TANKERS  
AN OWNER'S VIEWPOINT**

**BERGESEN D.Y. ASA**

**TANKER STRUCTURE CO-OPERATIVE FORUM**

**TOKYO, OCTOBER 2000**

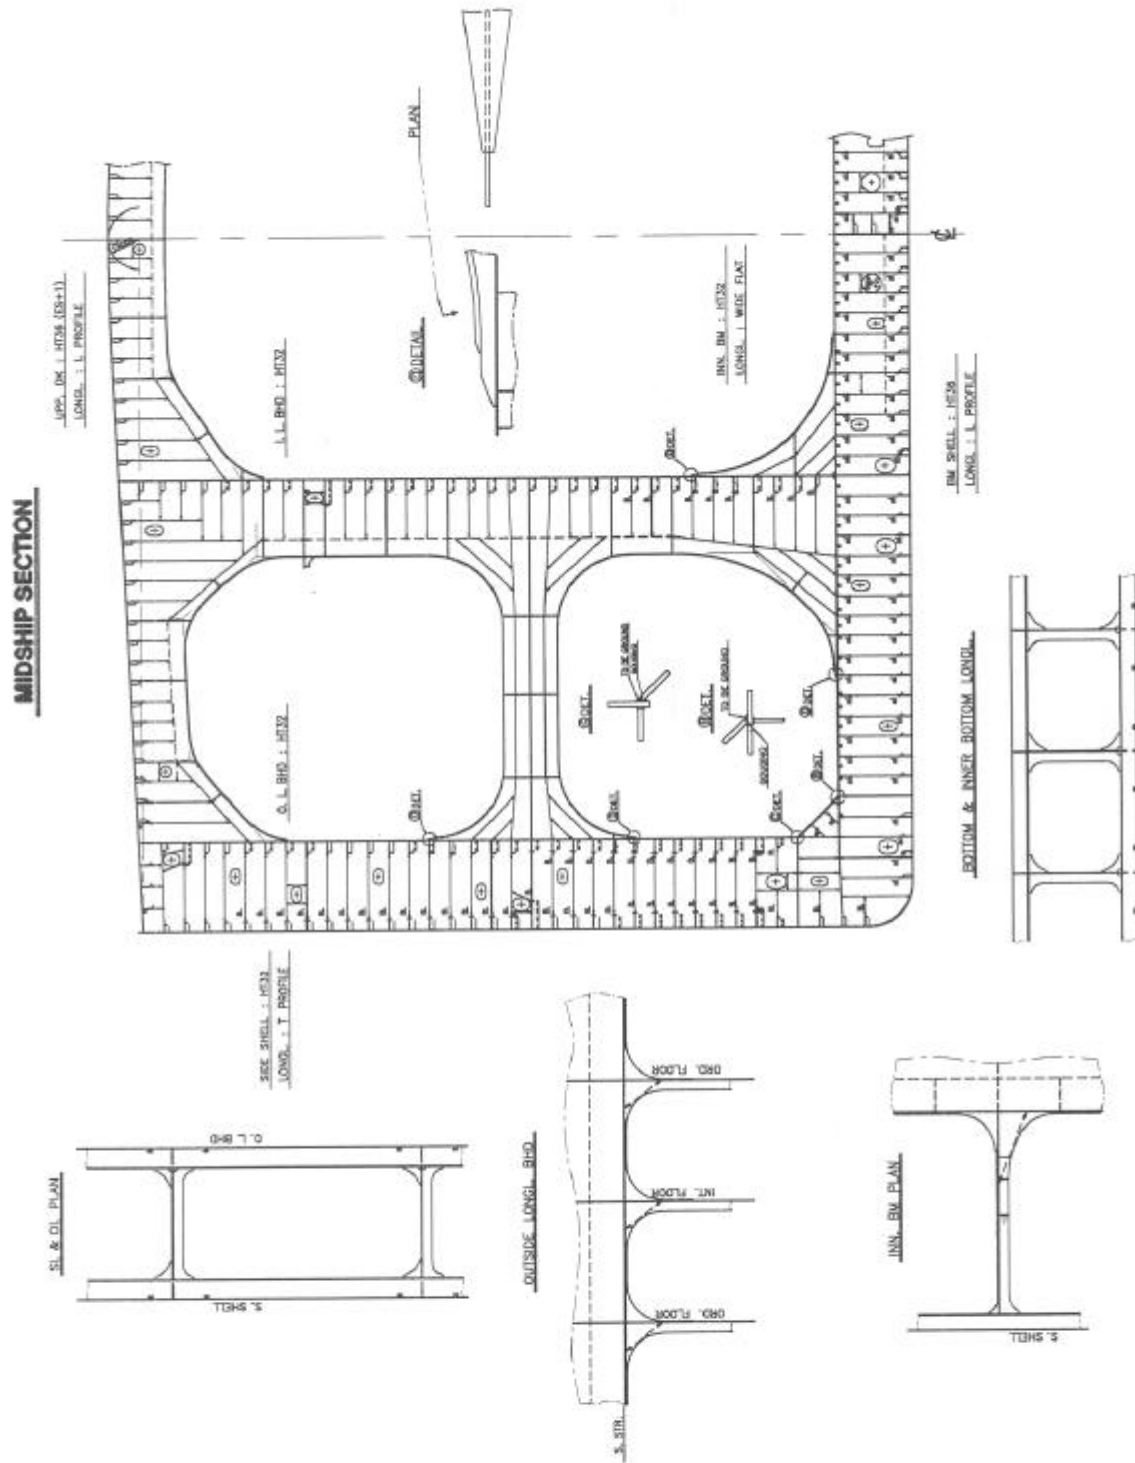
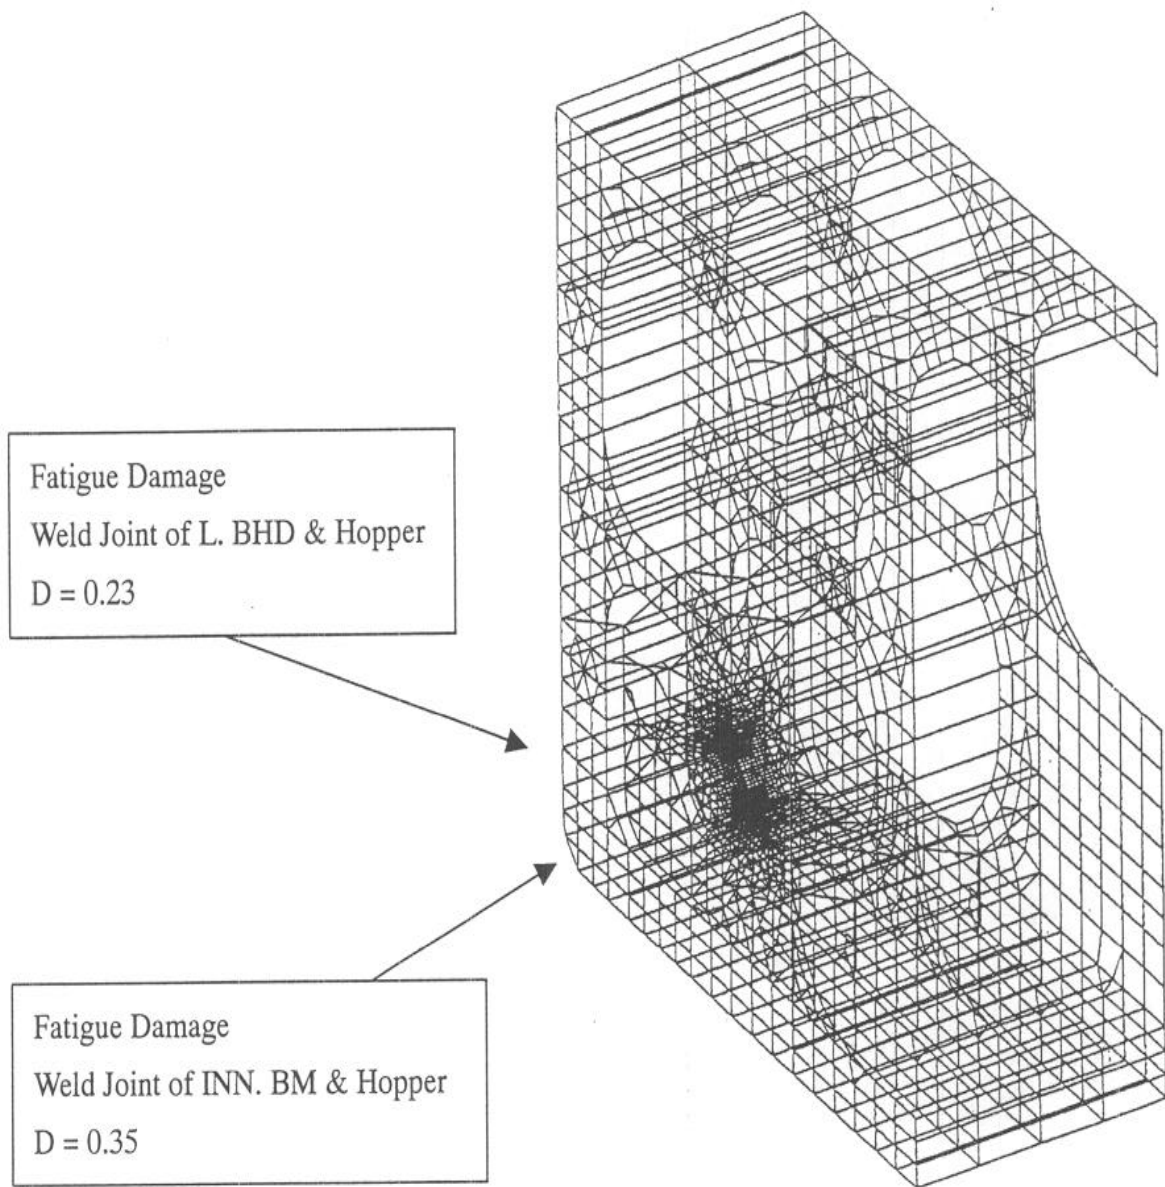
Figure 1

- HT-36 steel to be used in deck and bottom structures only with one mm added steel in the deck plating – Fig 1.
- T-profiles to be used in the side longitudinals .

- Partial horizontal stringers to be arranged in the water ballast tanks at the transverse bulkheads
- Double brackets to be fitted on the side longitudinal and in the DB structure - Fig 1.

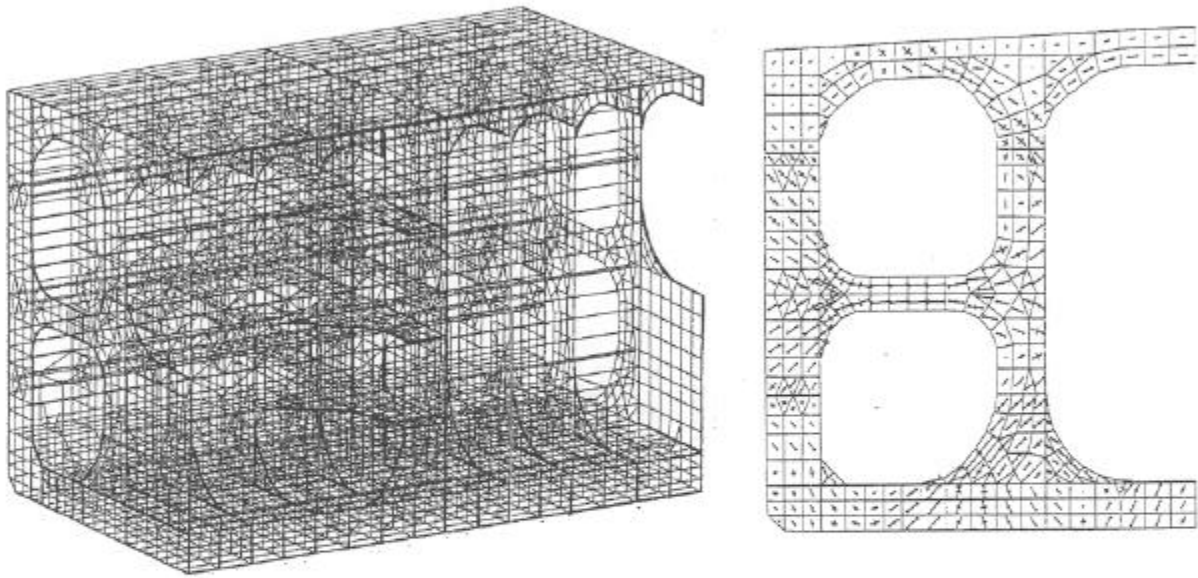
Fig. 2 Fatigue Strength Assessment

- Fatigue calculations to be performed to give an acceptable life time of the side longitudinals for world wide operation – Fig. 2.
- FEM analysis to be carried out on certain structures - Fig 3 & Fig 4.

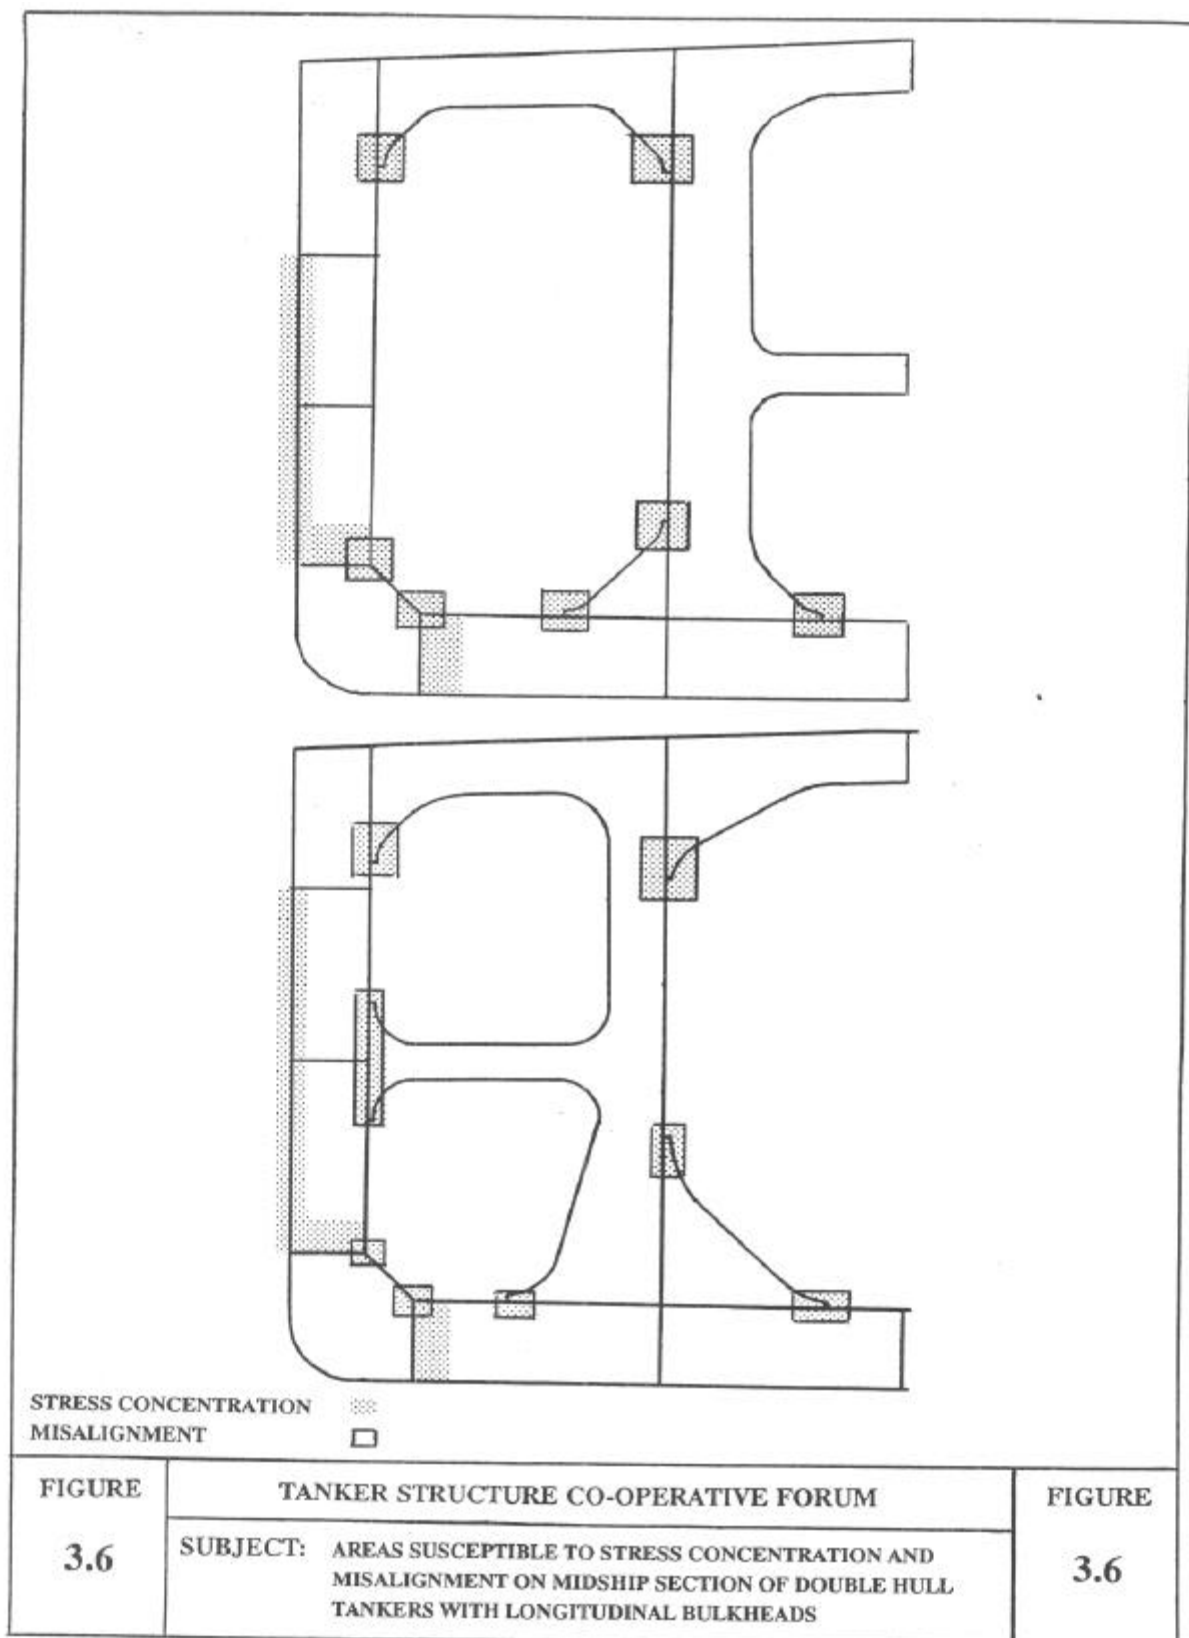
A school example where high stresses will cause cracks is the juncture of hopper plate to the inner bottom plate as shown in Fig. 1. The cracks shown in the bottom plating and in the floor below will not occur if proper attention is paid to those details as shown on the sketches taken from our VLCCs. Both increased plate thicknesses as well as avoiding the scallops are of importance. This is shown in Fig. 4 of the Manual.
