**Report on the Result of Field Inspection  
conducted on  
April 19-23, 2004 in the Province of  
Zamboanga del Sur**

# **Social Sector Projects**

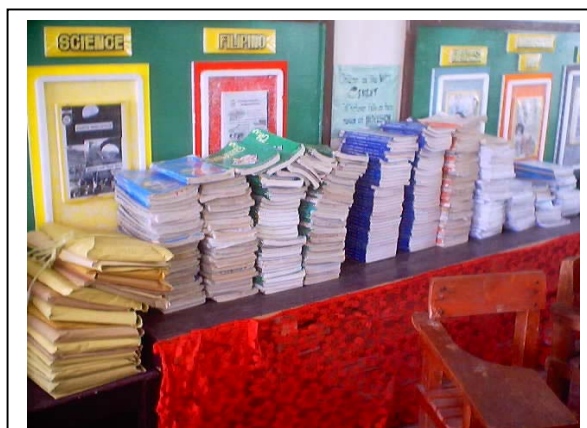
**Books Provided by TEEP**

2. It was also observed that contractor used only plain GI sheet instead of corrugated sheet.
3. The three (3) newly constructed comfort rooms overlapped adjacent property line.
4. The school principal informed the group that the Grade 3 books provided by the project were inadequate while the books for Grades 1, 2 4, 5 and 6 are sufficient.

1. It is recommended that before the preparation of building plan for the repair/rehabilitation, investigation or survey of the building for repair/rehabilitation be conducted first to avoid delay in the implementation caused by changes in POW.
2. Likewise, the PMO and contractor should give a file of the revised scope of works of the said repair/rehabilitation to the school officials.
3. There is a need to verify from the PMO on whether the construction of comfort rooms is within the POW in the repair/rehabilitation of school building.
4. It is recommended that the PMO should check whether the portion of the 3 classrooms encroached the adjacent property line.

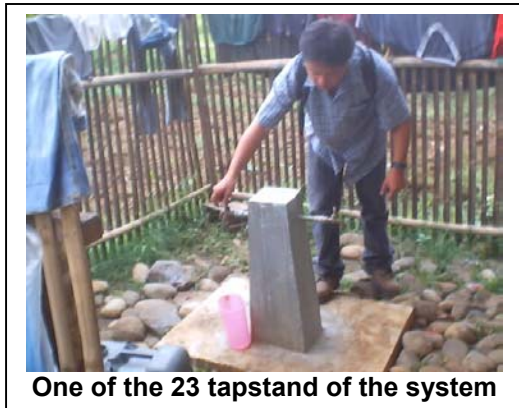
One of the 23 tapstand of the system

The LGU of Guipos implemented the construction of Level II water system. Its source is located in nearby barangay of Sikatuna, Guipos and will serve 143 household or 37% of the barangay's total household of 387. Operational last March 17, 2004, the system consists of 23 tapstands designed to serve 4-6 households per tapstand and 15 cu.m. reservoir. To ensure project sustainability, each household shall pay a monthly fee of Php 62.00 or a total annual revenue of Php106,392.00. A committee consisting of a Chairman and two (2) members was constituted

1. The community should organize a BAWASA in place of the committee. Similarly and should draft its by-laws.
2. To ensure project sustainability, the committee should to allocate funds to undertake enrichment planting in the immediate periphery of project's water source. The committee also consider planting "balete" trees to deter poaching.

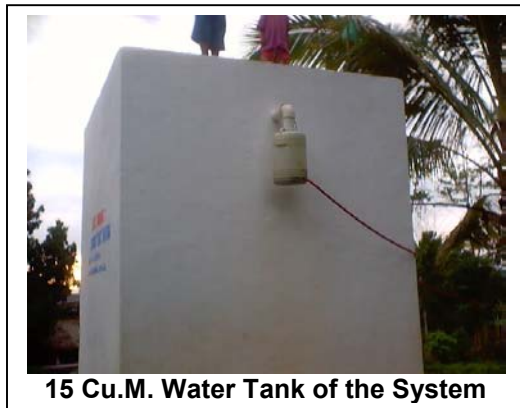
15 Cu.M. Water Tank of the System

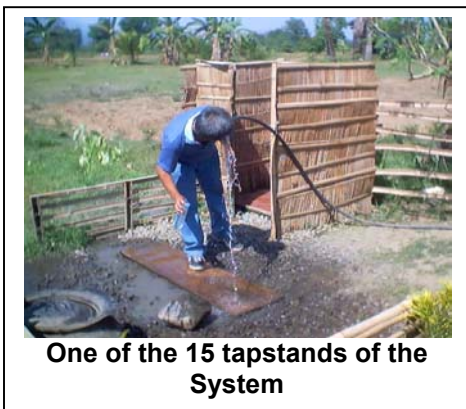
One of the 15 tapstands of the System

The level II water system project was started on October 1, 2003, completed on February 6, 2004 and turned-over to barangay last March 16, 2004. The water system will serve 67 households or 23% of the barangay's total households of 287. It consists of 15 tapstand each designed to serve 4-6 households and a reservoir with a capacity of 7 cu.m. To ensure project sustainability, each household pays a monthly fee of Php 62.00 which expected to generate annual revenue of Php 49,848.00. A committee consisting of a chairman and two (2) members was constituted from among the members of the barangay council on the recommendation of JBIC consultant.

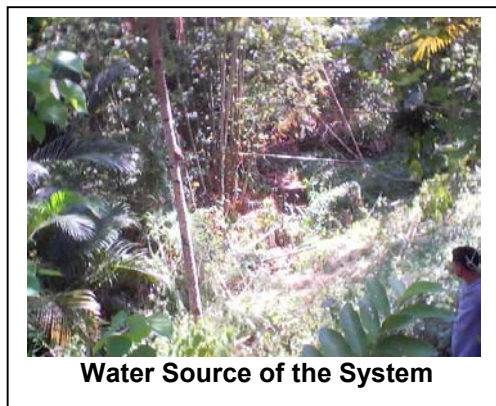
Water Source of the System

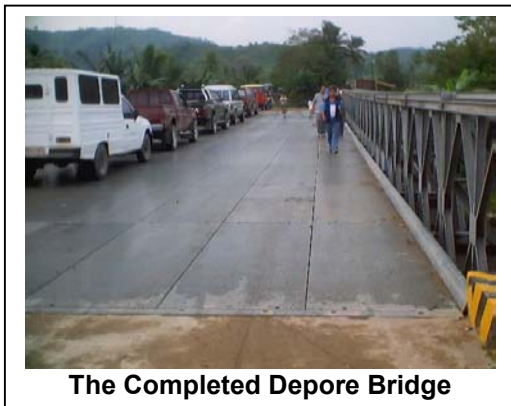
The Completed Depore Bridge

No capacity signs in both side of the approach, signs of deterioration on both approaches of the bridge since there were no flood control constructed in on the approaches and no sign of maintenance works. Concerned LGU has no complete data on the project since they were not consulted in the implementation of the projects. As a result, contractor is unknown to them.

LGU provide capacity signs in both approaches of the bridge, construct flood control in the both approaches to prevent scouring. Maintenance work should be done by LGU specially on the rusted galvanized steel. LGU concerns should be consulted prior to the implementation of the project. LGU to include bridges in their maintenance program.

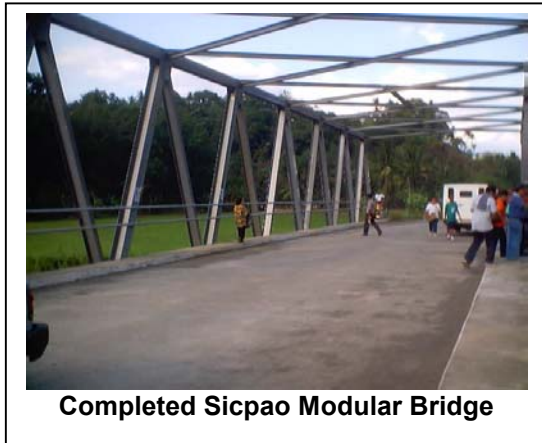
**Completed Sicpao Modular Bridge**

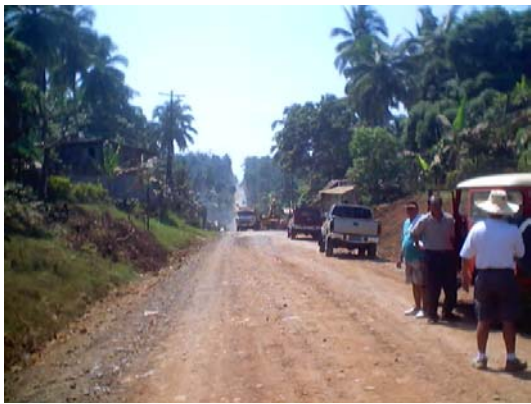
**On-going rehabilitation of Aurora – Monte Alegre Road**

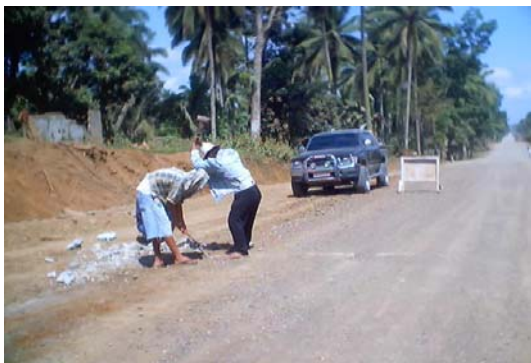
**Relocation of water pipe**

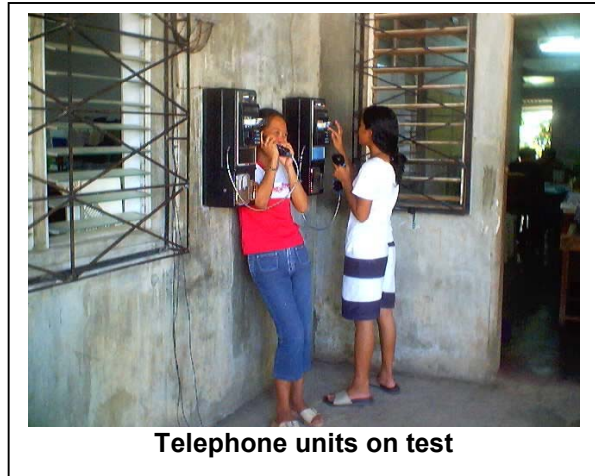
TSB project is still not yet operational. TSB-DOTC and TelOf IX personnel with the coordination of the SR Telecom (Contractor) at present is conducting Provisional Acceptance Test (PAT) in some areas in Zamboanga del Sur and part of Tungawan in Zamboanga Sibugay. PAT was started in March 2004 and to be completed in June 2004. Interconnection with the main backbone is still on going. Once the test is completed information and dissemination as well training to all barangay officials will be conducted. Accordingly some of their solar panels were stolen and some of the households residing near the repeater tap its power line to the tower for their electricity.

Telephone units on test

Fast track the interconnection of the system to the main Backbone. DOTC to formulate security measures to prevent pilferages of repeaters. Provide Manual of Operations to all barangay beneficiaries with translation in local dialects.
