# President's Bridge Program Zamboanga Sibugay

Implemented by Tulay Ng Pangulo  
sa SZOPAD Mindanao/DPWH

***Result of Monitoring  
Conducted by RPMC IX on  
March 27-28, 2006 on the  
implementation of President's  
Bridge Projects (PBP) in the  
Province of Zamboanga  
Sibugay and Zamboanga del  
Sur***

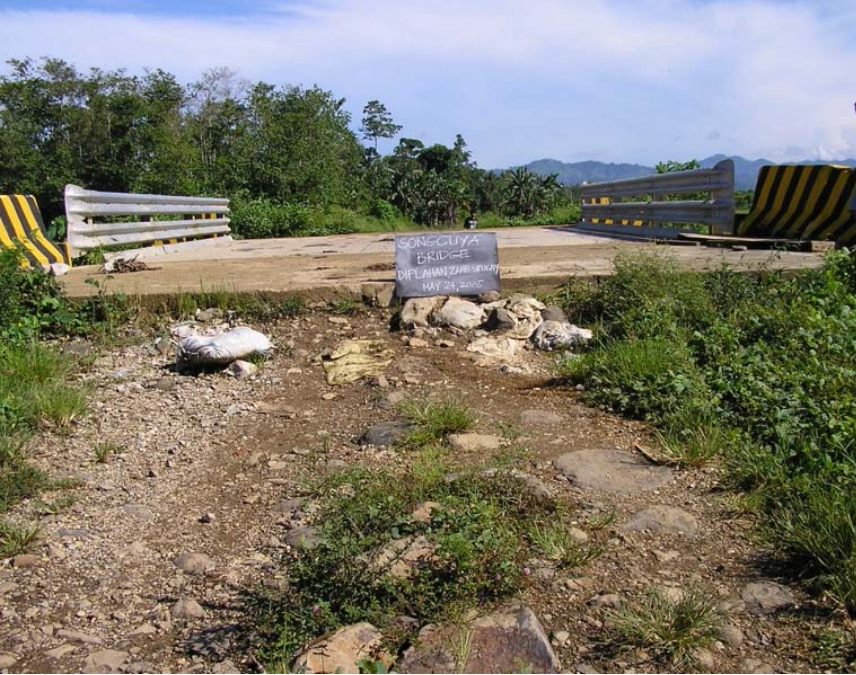
**Songcuya Bridge**

Location:  
**Diplahan, Zamboanga Sibugay**  
Project Cost: **P4,822,974.40**  
Evaluation: **No existing road. A wasted two-lane bridge leading to a small path way in the middle of a ricefield.**

- The bridge is located in the middle of the ricefield leading to a trail.
- The structure is being used as dryer of palay by nearby residents.
- Culvert pipe is also suitable for this particular project.
- Road Leading to the Bridge is unpassable. Accordingly, road to complement the bridge was already proposed in the INFRES program of DA IX.
- Lack maintenance. Grasses growing in both approaches.
- The bridge was implemented without RDC IX and PDC endorsement.

- The local government of Diplahan, Zamboanga Sibugay should maintain and upkeep the bridge to prolong its life until such time that the road to complement the bridge is implemented. Construct immediately corresponding roads
