# A Quick Evaluation of Surface Finish of Pivots

## by Bob Whiteman

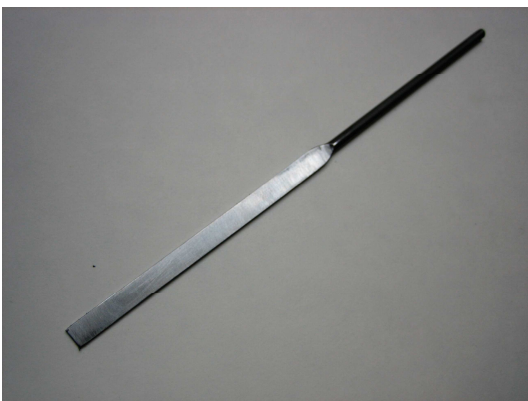
**Figure 1**

The burnishing file used was made from an old rectangular needle file with cutting teeth only on the edges. The teeth were removed completely with a simple bench grinder, taking care to keep the edges straight. All burrs were removed after grinding. The top and bottom sides were rubbed sideways across a piece of 320 grit paper to create grooves (barely visible in figures 1 and 2).

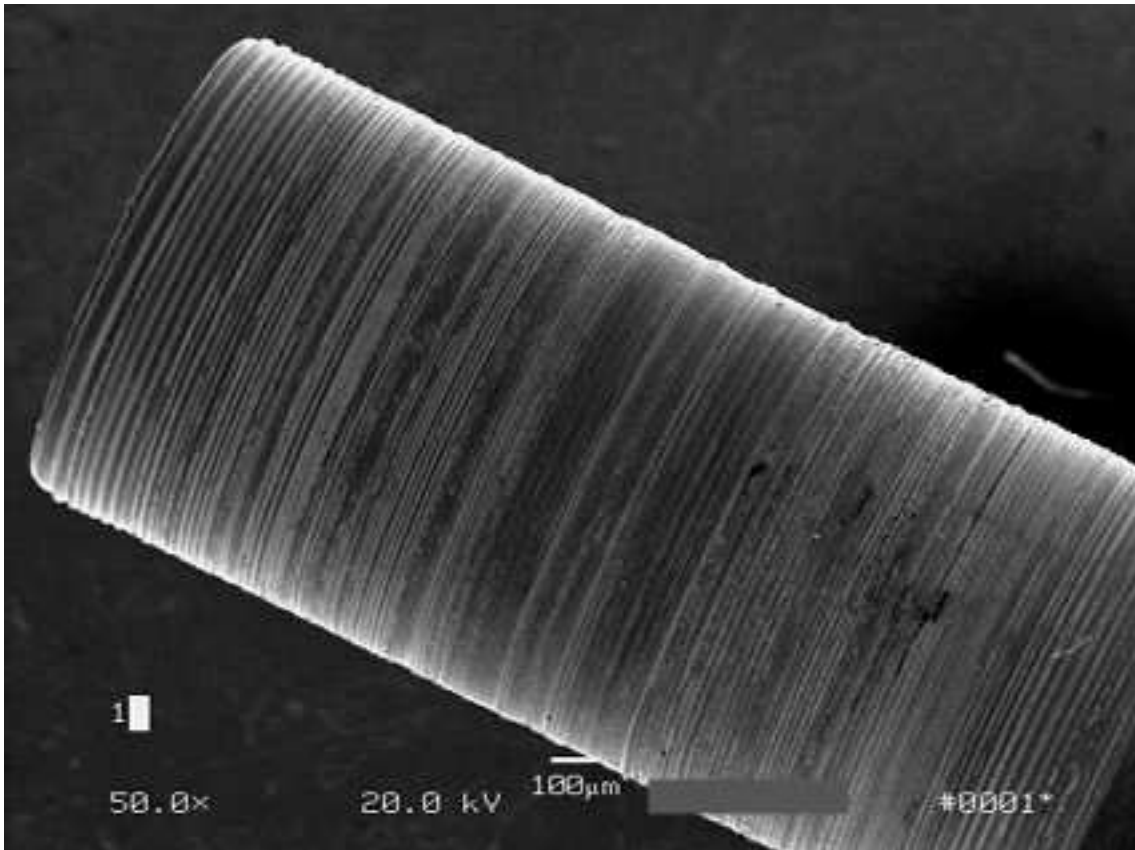
**Figure 3**

Each SEM picture is marked with the magnification level and a thin white bar indicating the 'scale', similar to what you would see on a road map. The example picture shown in Figure 3 was taken at a 50x magnification level with the scale bar indicating a distance of 100um (.004"). For this picture the short white bar would be the approximate length of the thickness of a sheet of paper. The fourth and last picture of each sample group was taken at a 1,000x magnification level with the scale bar indicating a length of 10um (.0004").

Magnification Level  
(50x)

Scale  
(100um)

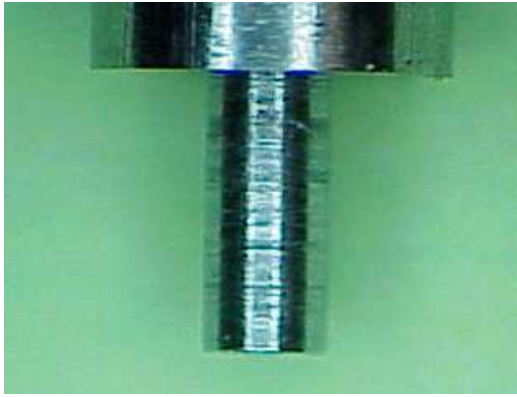
On Sample 1 you can see the scores left by the turning process and those are easily visible with the naked eye. In sample 2 the file has smoothed the surface to the point the pivot may look good without magnification.

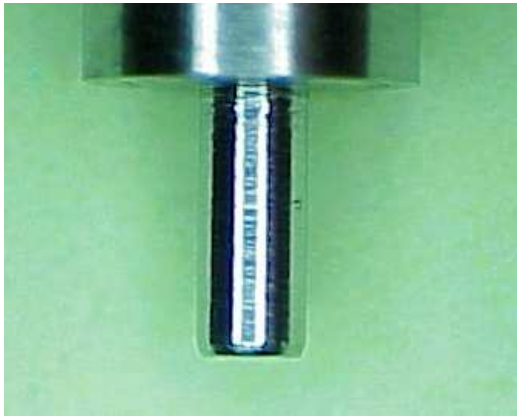
Sample 3

Sample 3, after being polished with the Cratex stick, has a nice shine and would look good to the naked eye, while Sample 4 shows some features left from the sandpaper, but still looks good.

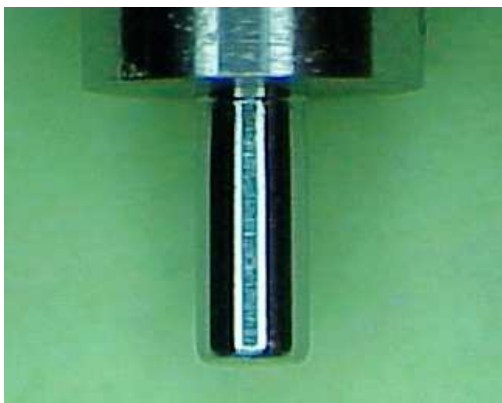
Sample 5 and 6 both look good at this point. The 1000 grit paper has done a pretty good job but SEM photos show the differences. Unfortunately the nice finish makes the photos difficult.

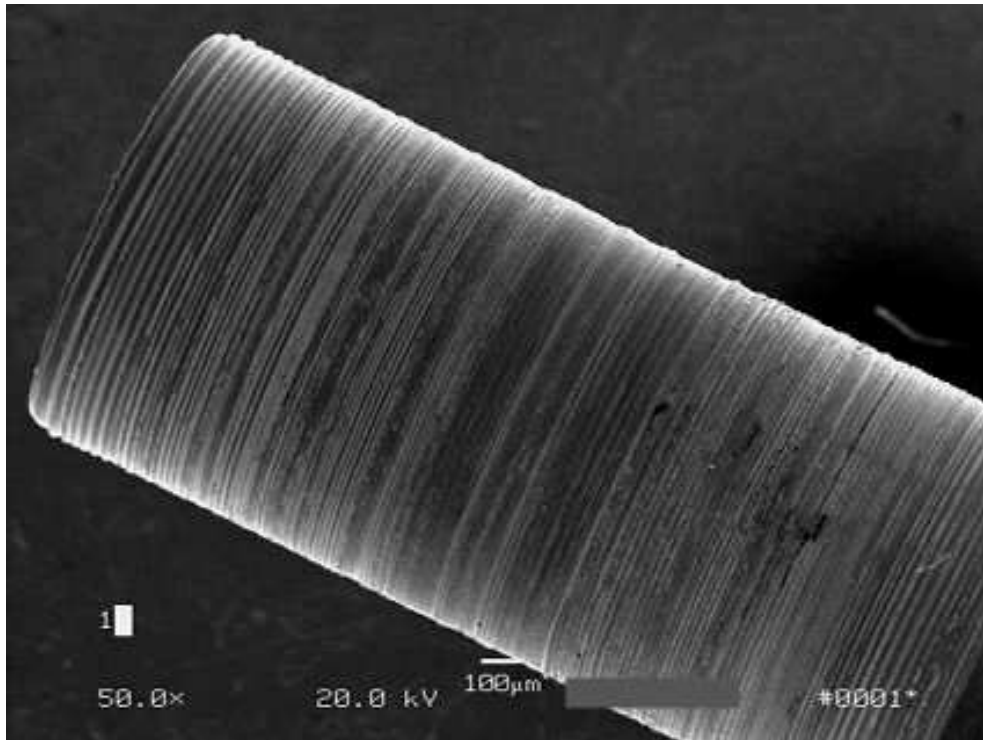
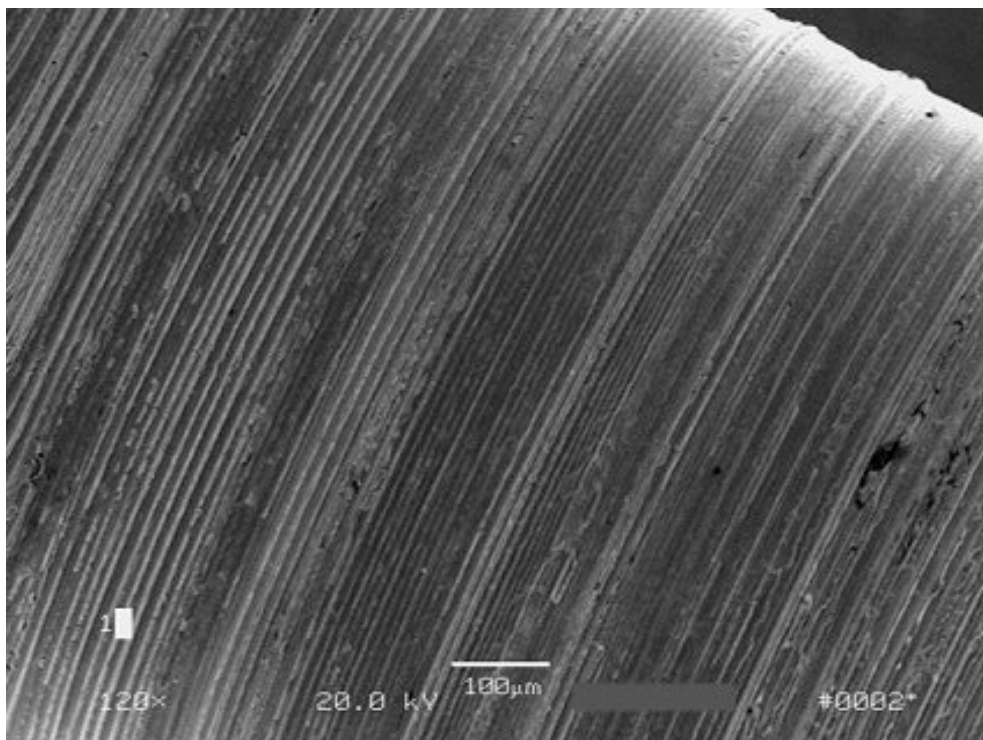
**Figure 10** – Sample 1 @50x

**Figure 11** – Sample 1 @120x

These photos show the surface of sample #1 in the “as turned condition”. This condition would represent the starting surface condition for all other samples. The scores are visible with even the slightest magnification, but the SEM photographs make the surface features very easy to see in great detail. At the lowest magnification, 50x in Fig 10, you can see this would be an extremely poor pivot.

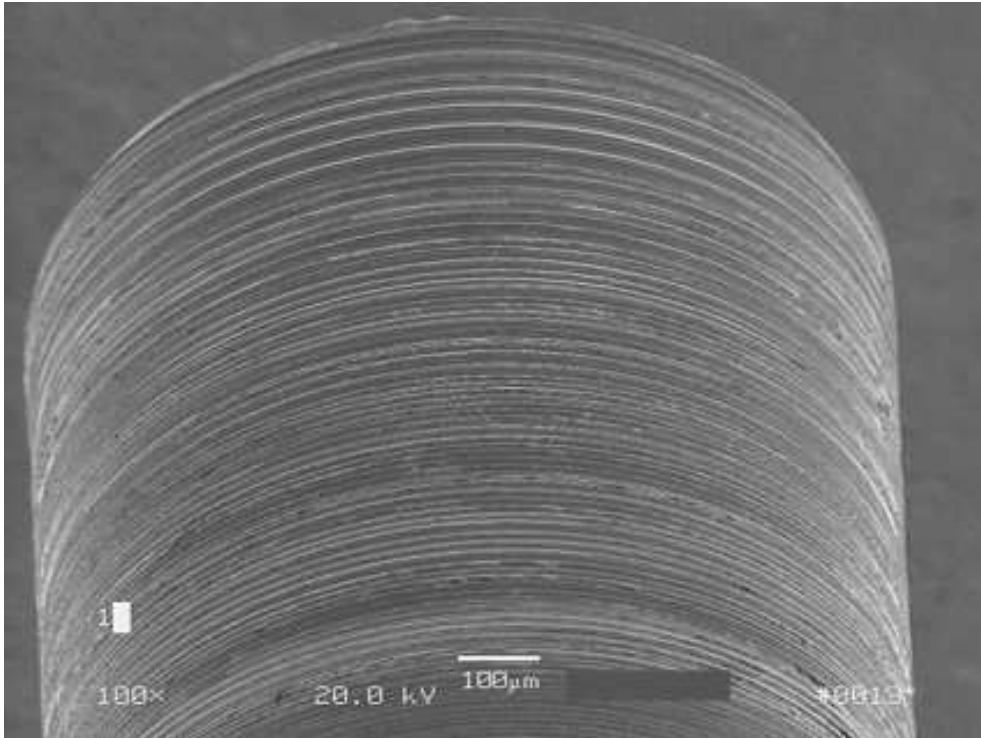
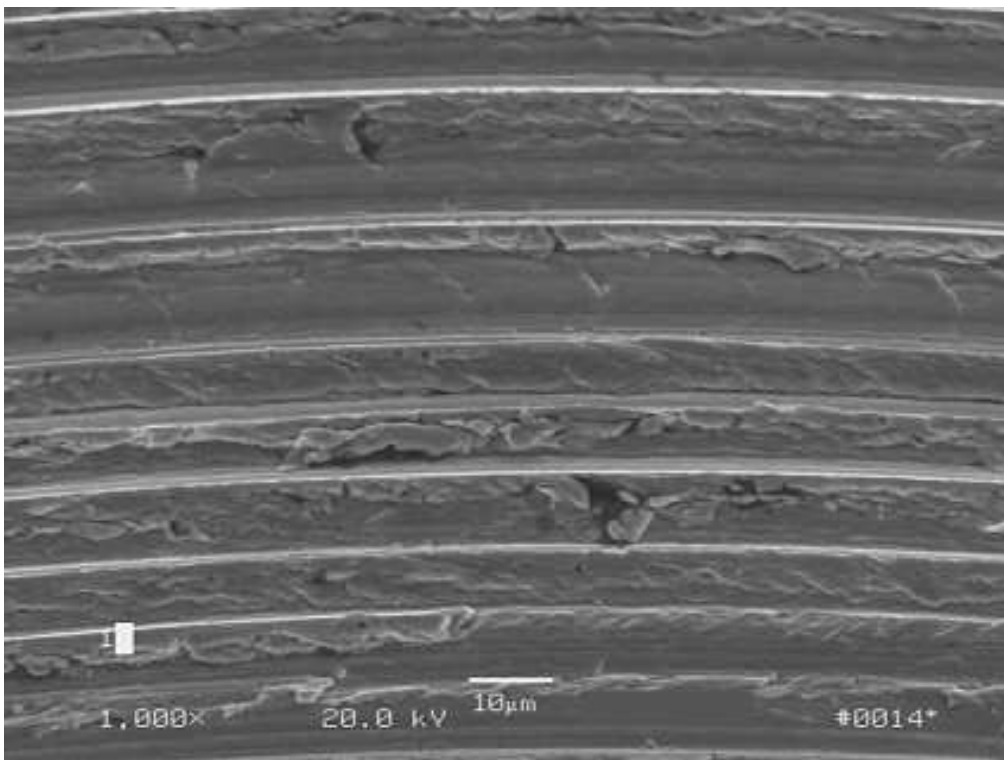
**Figure 12** – Sample 1 @100x

**Figure 13** – Sample 1 @1000x

These two figures are again of sample 1, but at higher magnification and orientation. You will see the surface details that would almost look like the surface of a record (remember those!). As shown at 1000x in figure 13 you can see the grooves created by the cutting tool and the tears and burrs present at the microscopic level. These are what you are trying to eliminate when polishing pivots (and don't forget the holes in the bushings and plates!!)

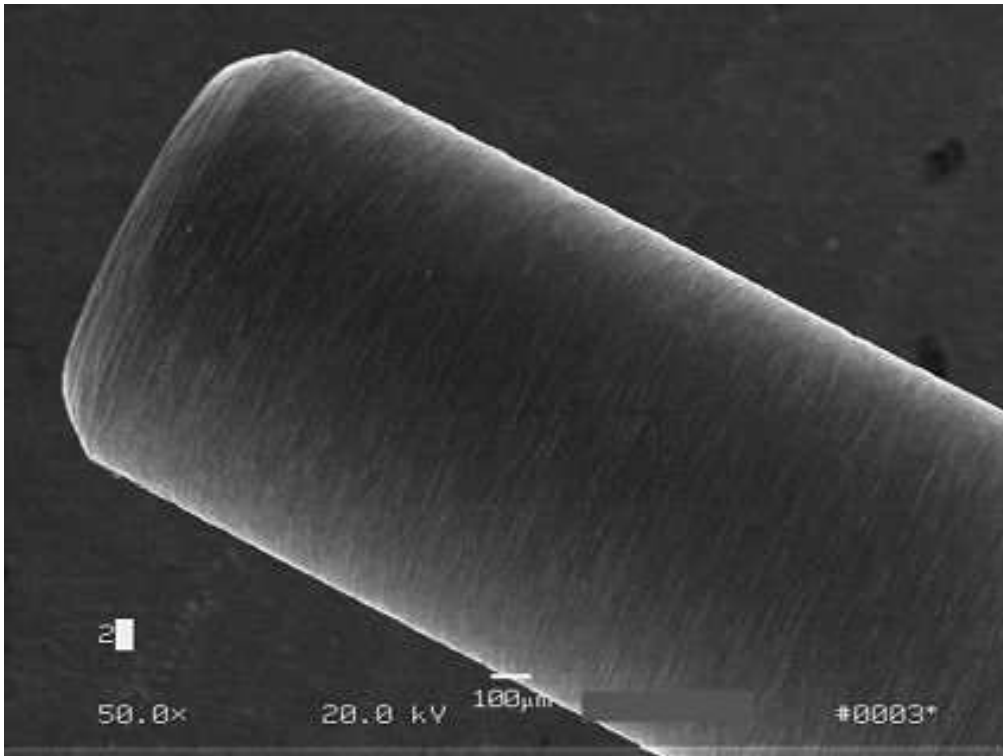
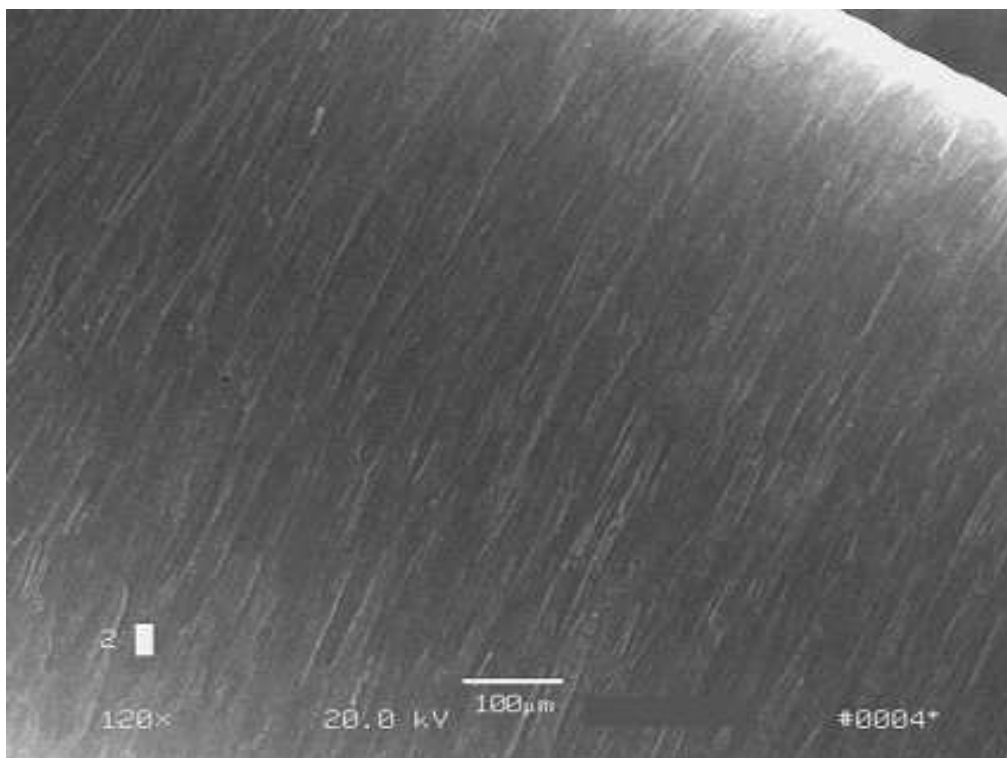
**Figure 14** – SEM Sample 2-1

**Figure 15** – SEM Sample 2-2

This sample was filed to remove the majority of the roughness that was present in the initial condition represented by sample #1; and would also be done to restore a pivot to a cylindrical shape. In these SEM photos the surface doesn't look too bad but still leaves a lot to be desired for a workable clock pivot.

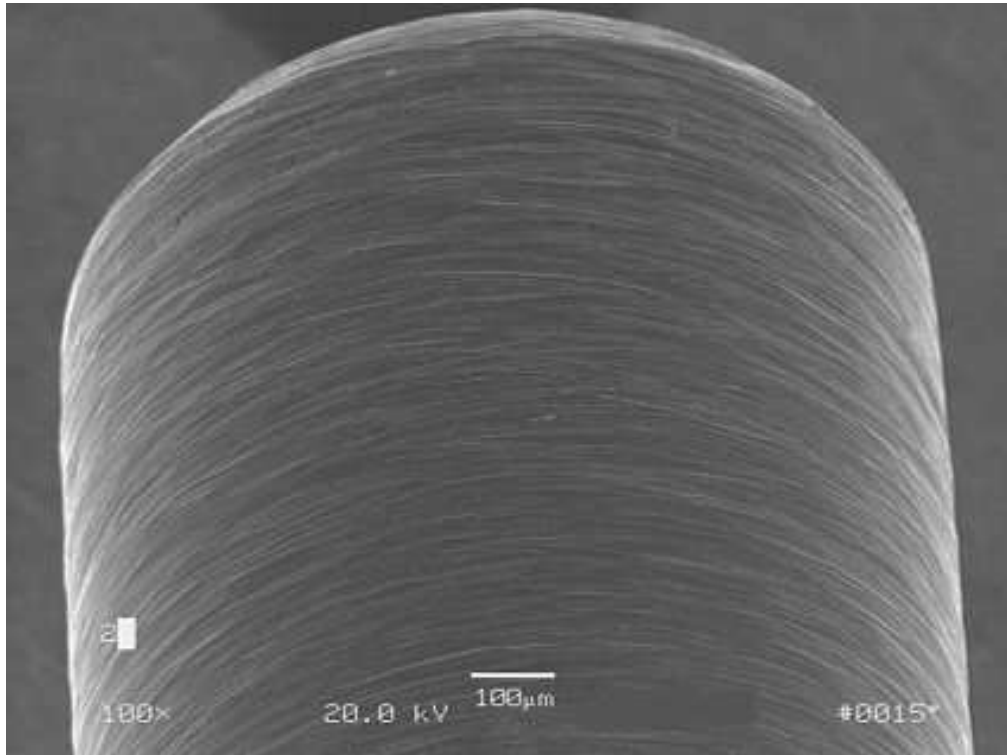
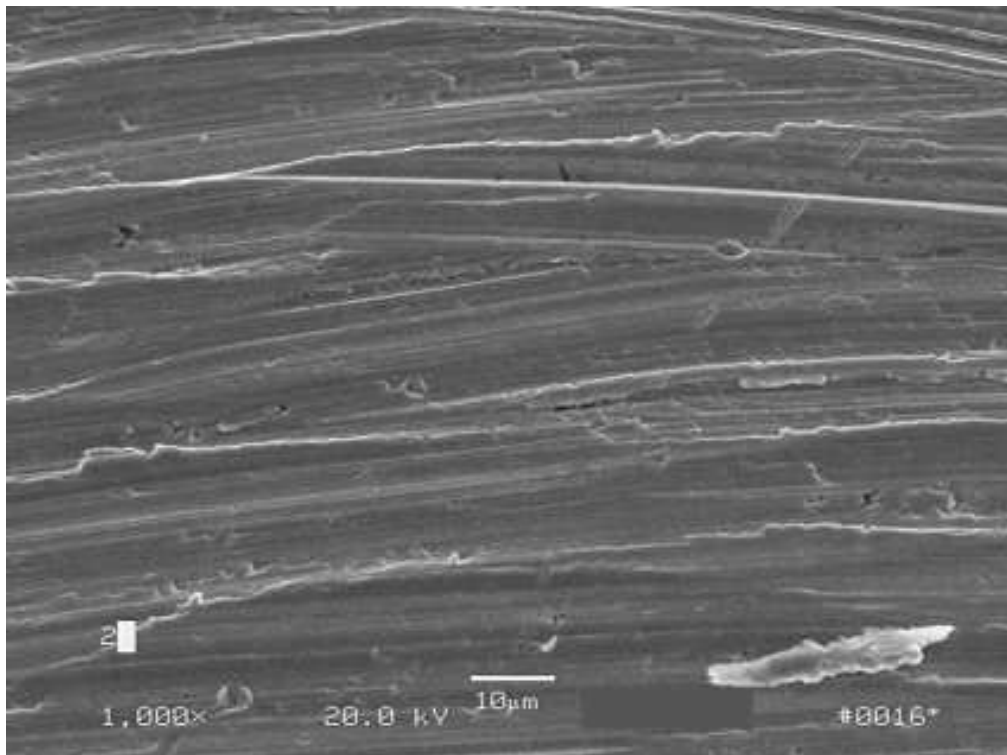
**Figure 16** – SEM Sample 2-3

**Figure 17** – SEM Sample 2-4

At the higher magnifications and orientation, it is clear that the pivot is not as good as it first appeared at the lower magnifications. There are still grooves, tears, and burrs left in the surface and the roughness is very bad. You should be able to visibly see with slight magnification that more work is required on this pivot. The remaining samples had all been filed prior to their respective process.

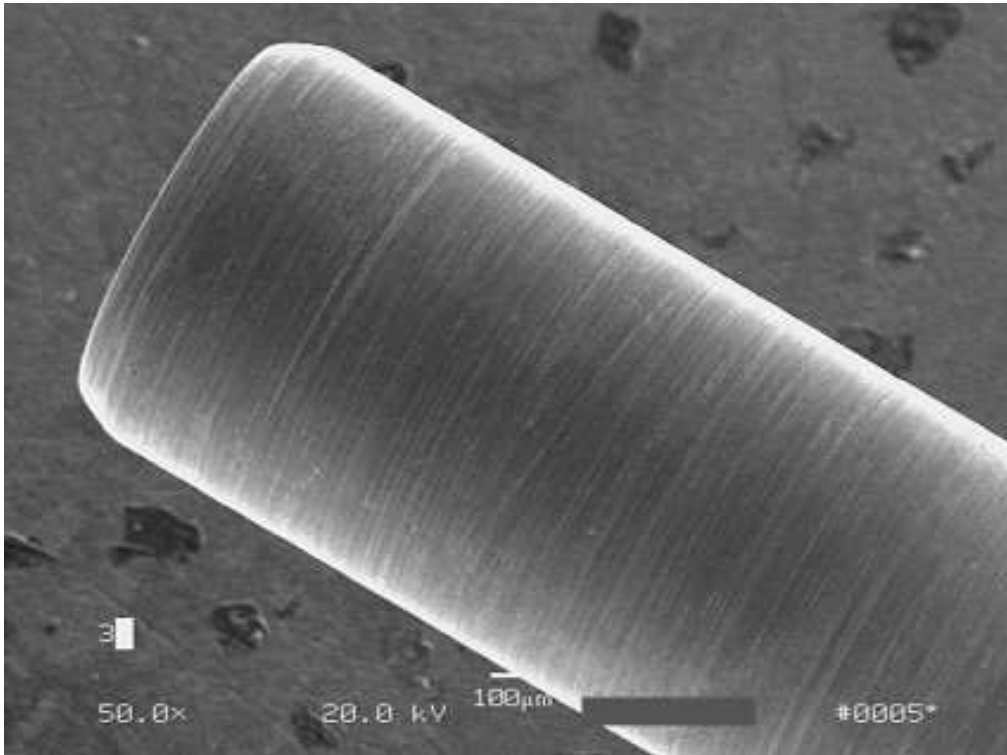
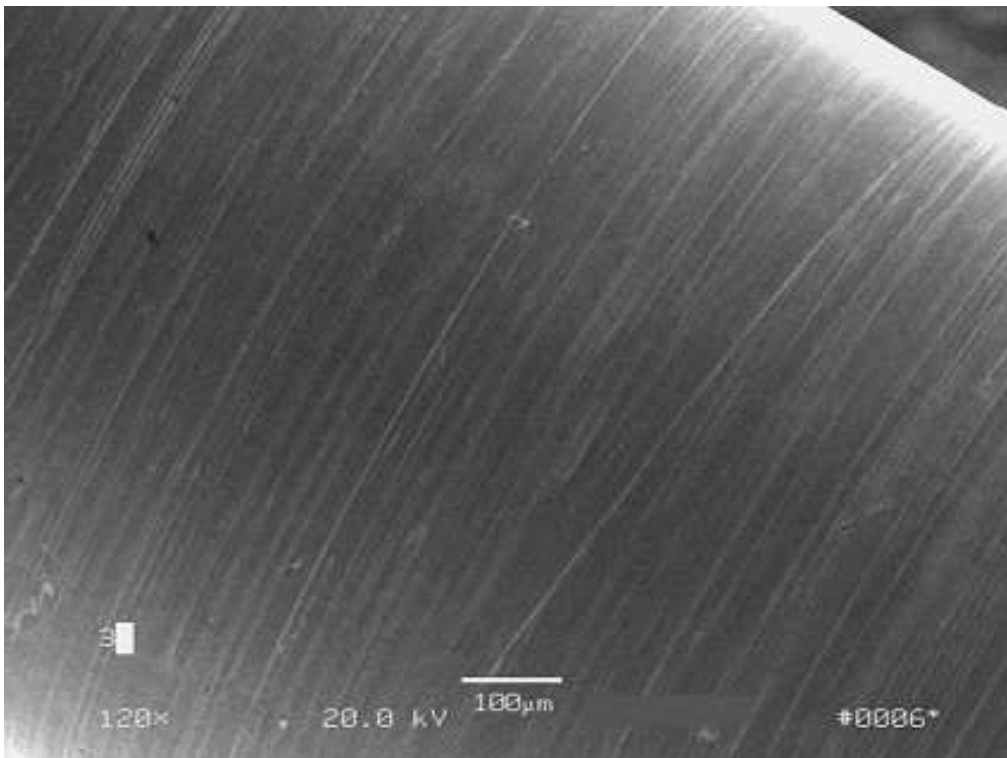
**Figure 18** – SEM Sample 3-1

**Figure 19** – SEM Sample 3-2

Sample 3 was the first sample that received a polishing operation. In these pictures the surface finish is starting to look a little better. Some grooves and features are still barely visible. The Cratex stick did tend to break the sharp edges and begin to leave a visually polished surface.

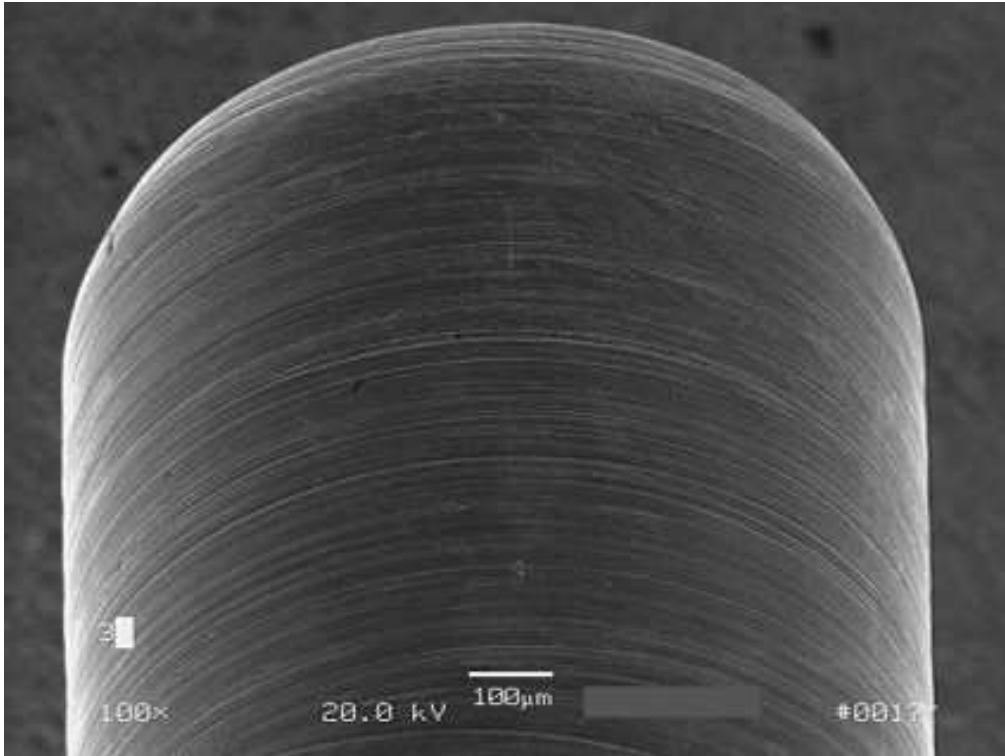
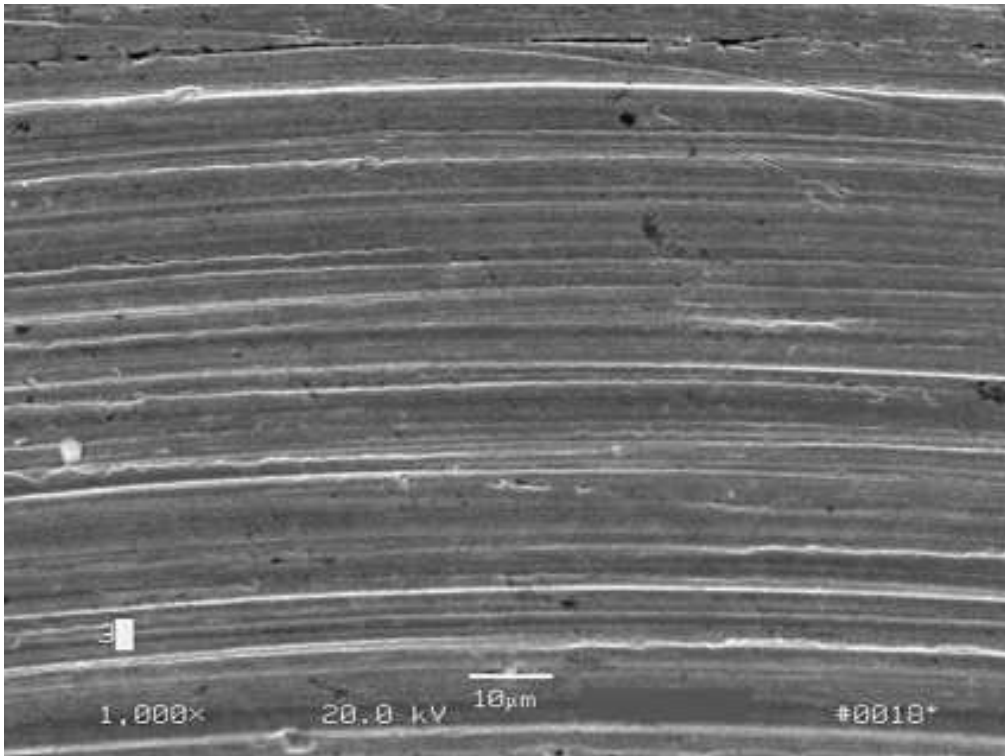
**Figure 20** – SEM Sample 3-3

**Figure 21** – SEM Sample 3-4

At the higher magnification it is clear that polishing with the Cratex stick left the grooves and only seemed to smooth the sharp edges and remove some of the burrs left from turning and filing. Polishing for a longer time may have improved the surface a little, but would still not be an acceptable finish. This would lead to rapid wear and friction in the newly bushed and burnished holes.

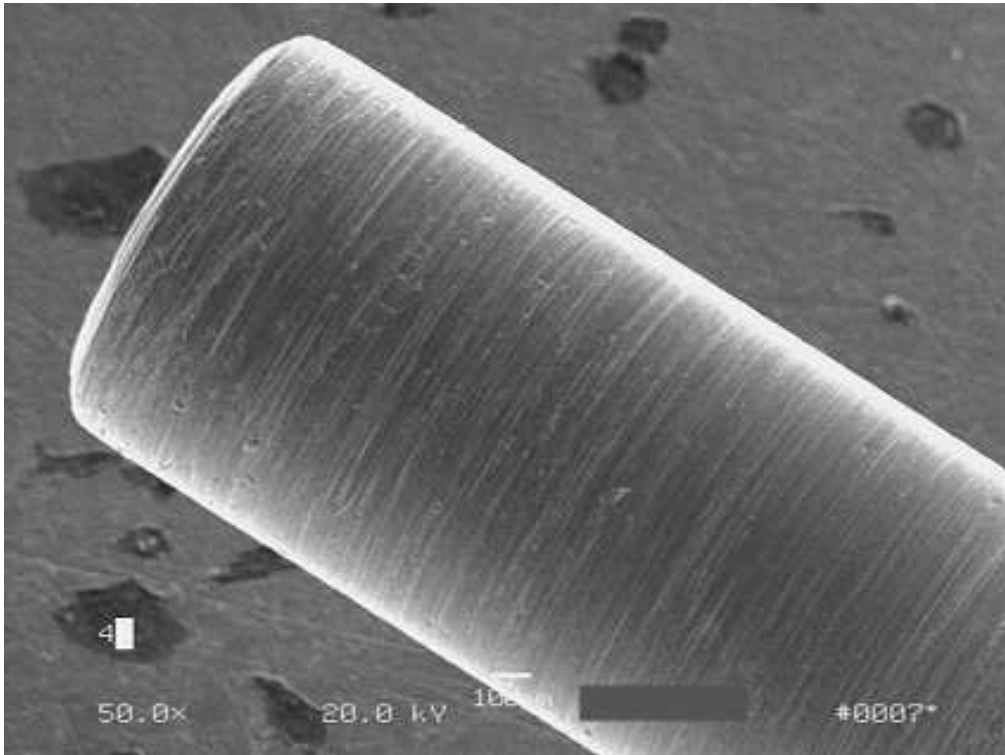
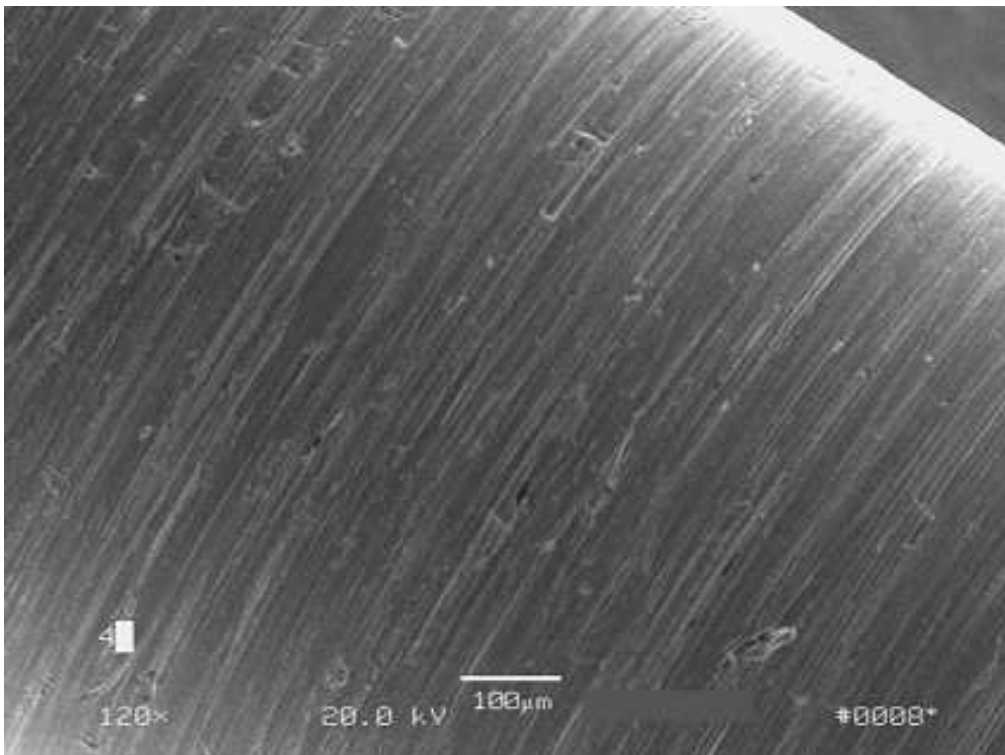
**Figure 22** – SEM Sample 4-1

**Figure 23** – SEM Sample 4-2

Sample 4 was filed and then ‘polished’ using a 320 grit paper. Visually it starts to look like a method that would produce an acceptable pivot. But at these low magnifications you can still see that we were only taking the high spots off of the previous finish. Leaving a rough surface with irregular features and traces of the original machining.

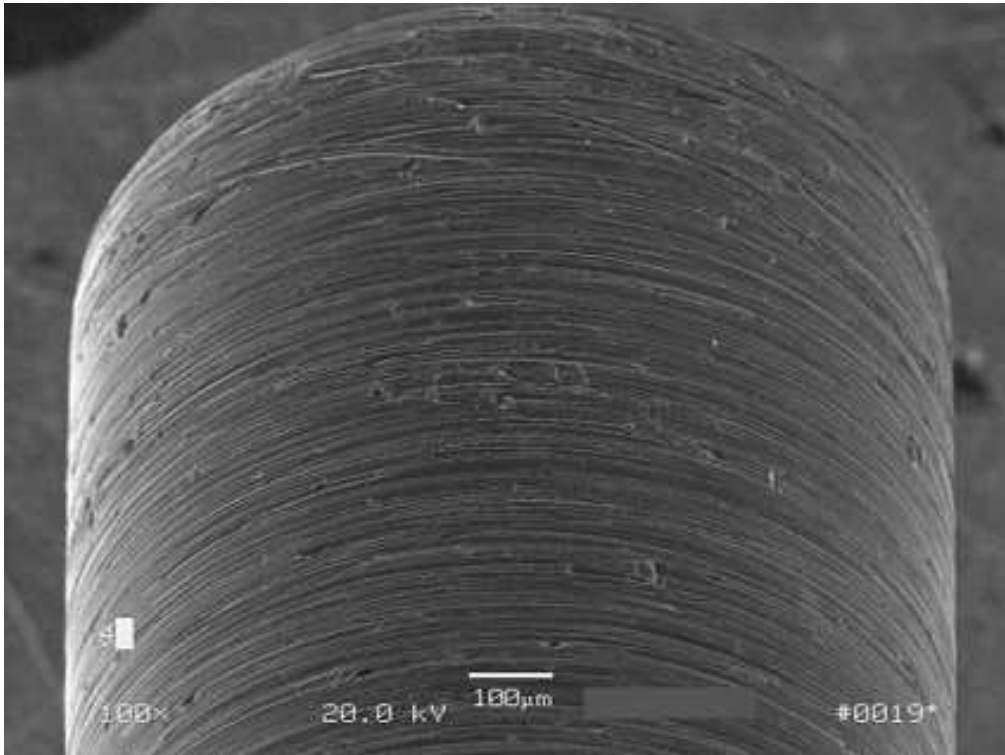
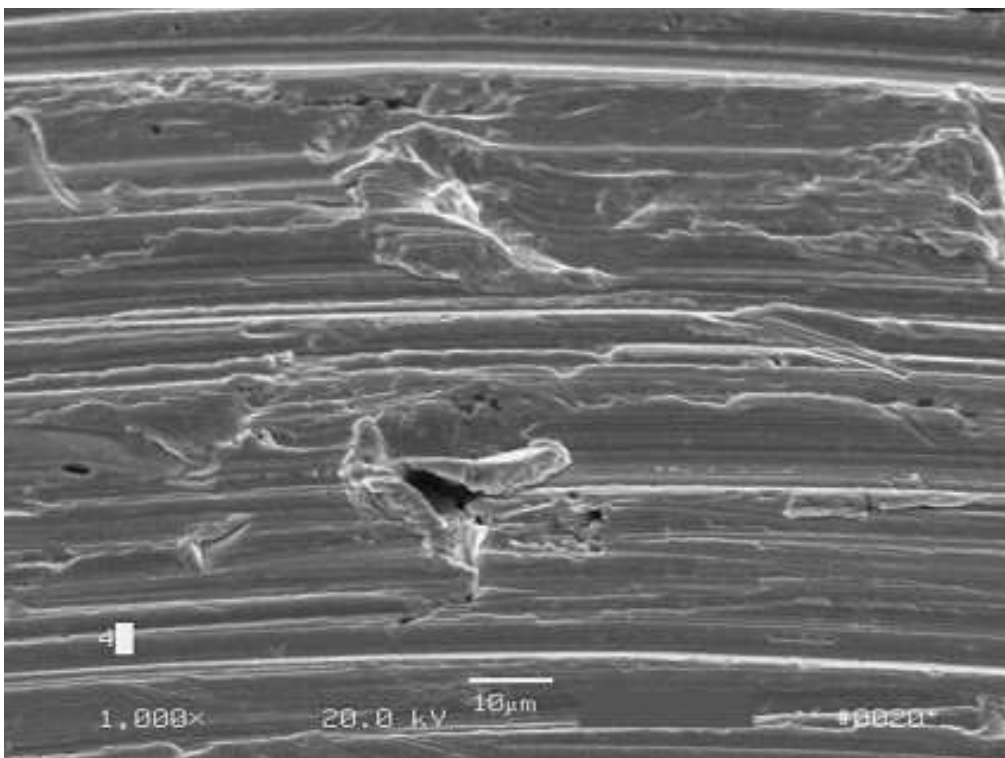
**Figure 24** – SEM Sample 4-3

**Figure 25** – SEM Sample 4-4

Again at the higher magnification it is even more apparent that resulting surface finish is really not acceptable. New features have now appeared that seem to be the result of the fine grains of abrasives working on the surface of the pivot. In some respects this even appears worse than the ‘as filed’ condition represented in Sample #2.

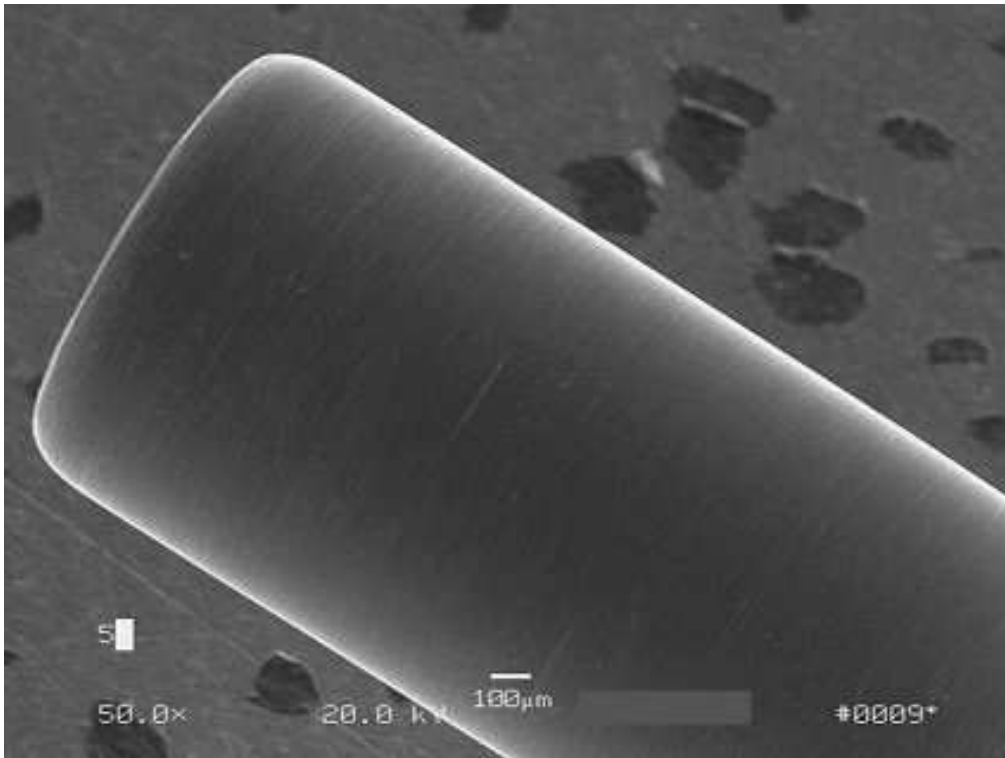
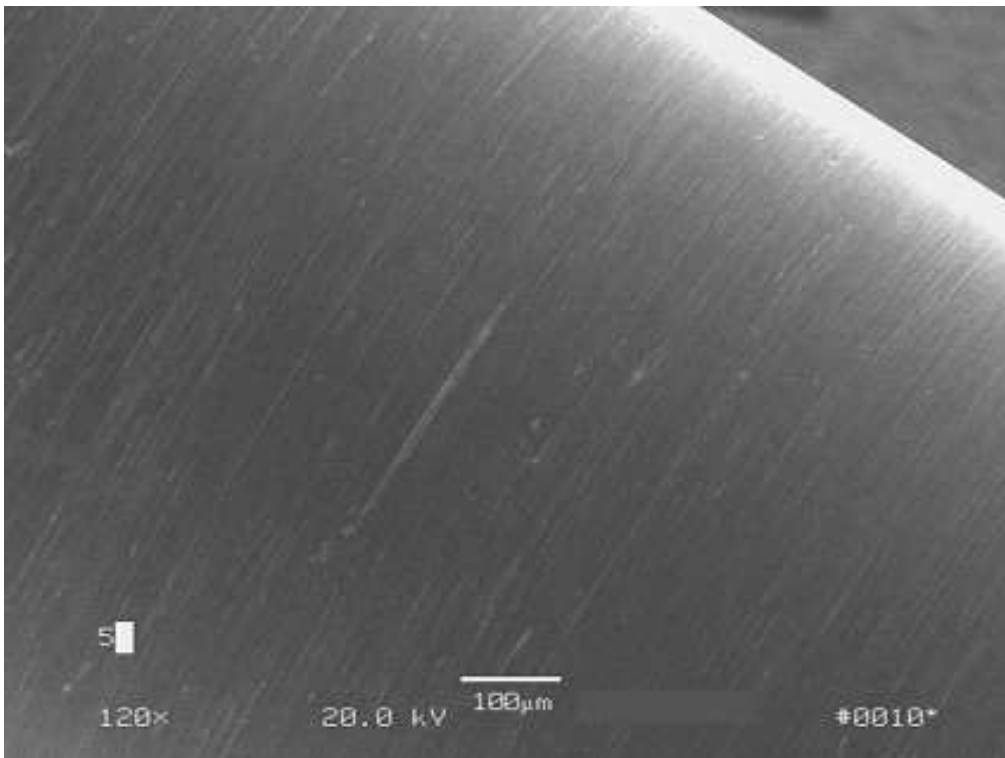
**Figure 26** – SEM Sample 5-1

**Figure 27** – SEM Sample 5-2

Sample #5 is the same as Sample #4 except the I continued to polish with an abrasive paper of a finer grit. A 1000 grit paper was used to further improve the surface left from the 320 grit polish. The finish of this pivot is probably acceptable and could be considered ready for re-assembly. The finish shown in Figure 27 shows that most surface defects have been removed and that a large bearing area is present; both desirable to reduce friction and wear.

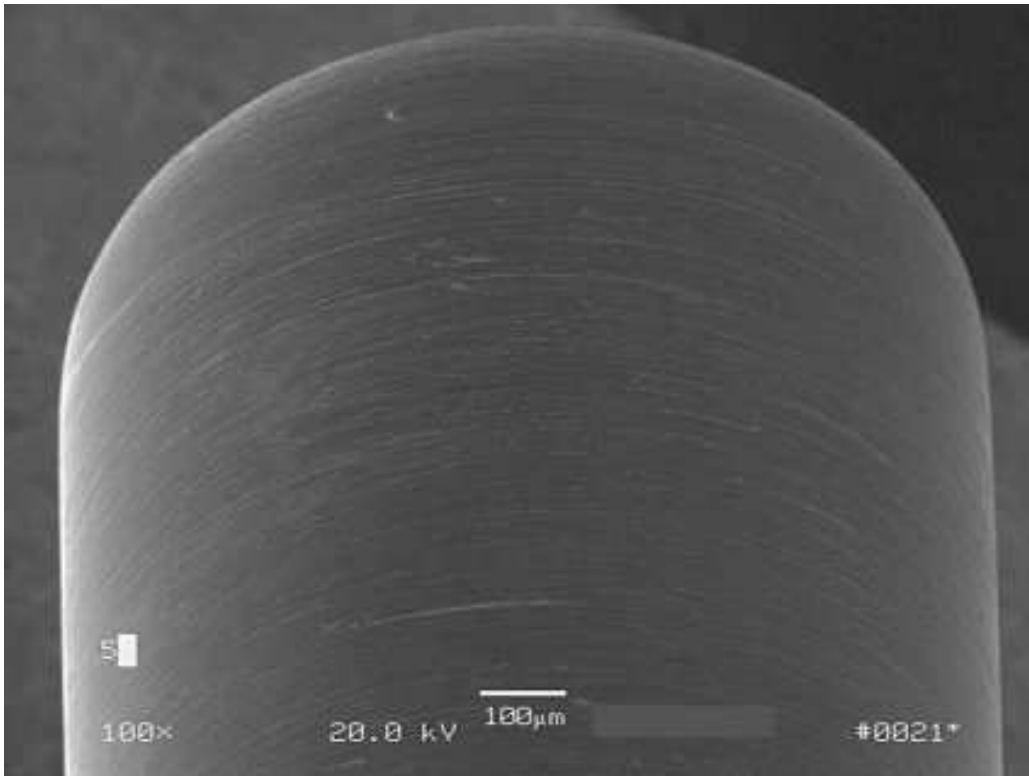
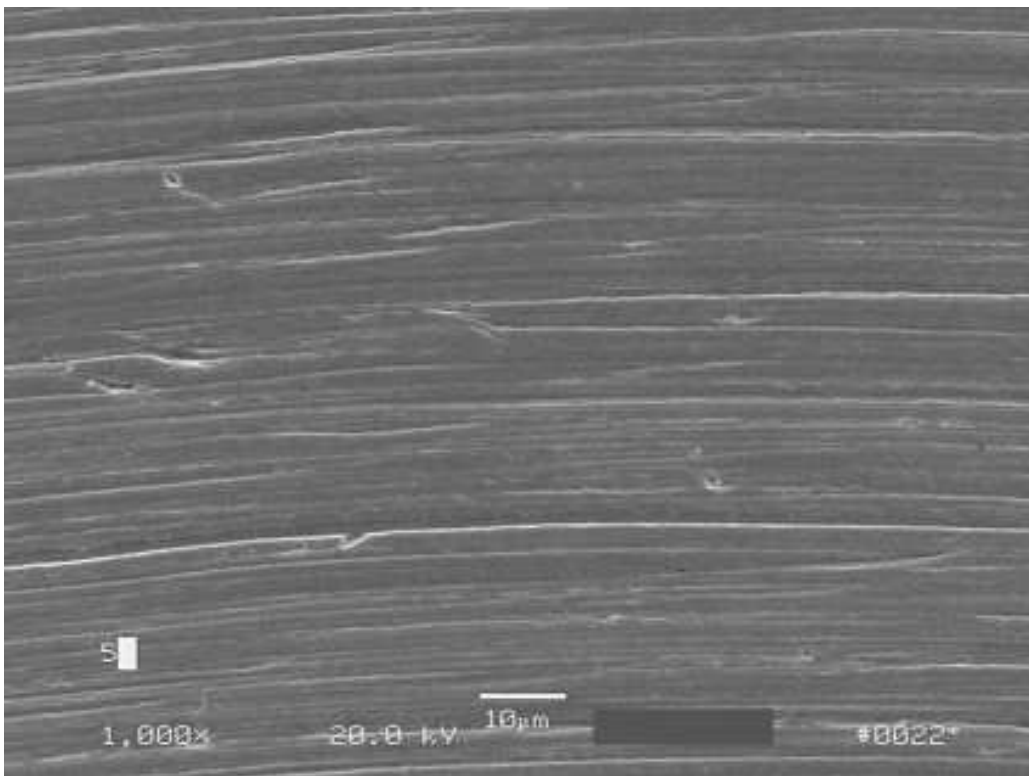
**Figure 28** – SEM Sample 5-3

**Figure 29** – SEM Sample 5-4

At the higher magnifications the surface finish does not appear too bad. Some irregularities such as scratches and tears are visible but the overall bearing surface condition is reasonable. By spending a little more time polishing, this method may result in even better conditions but was not tested.

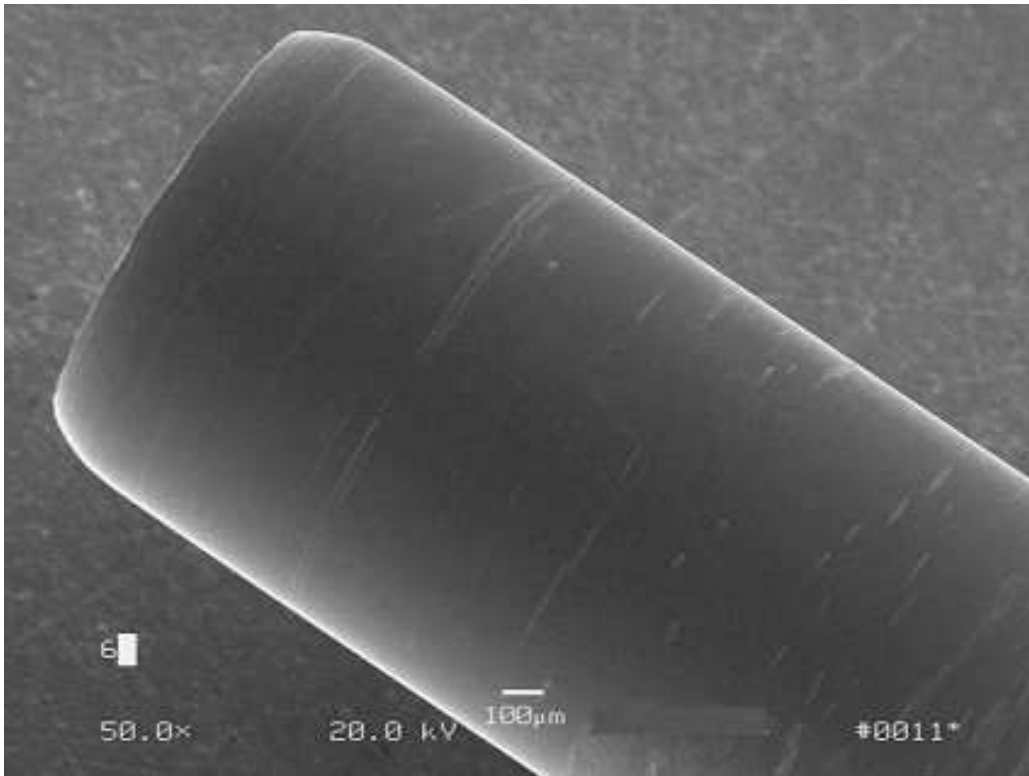
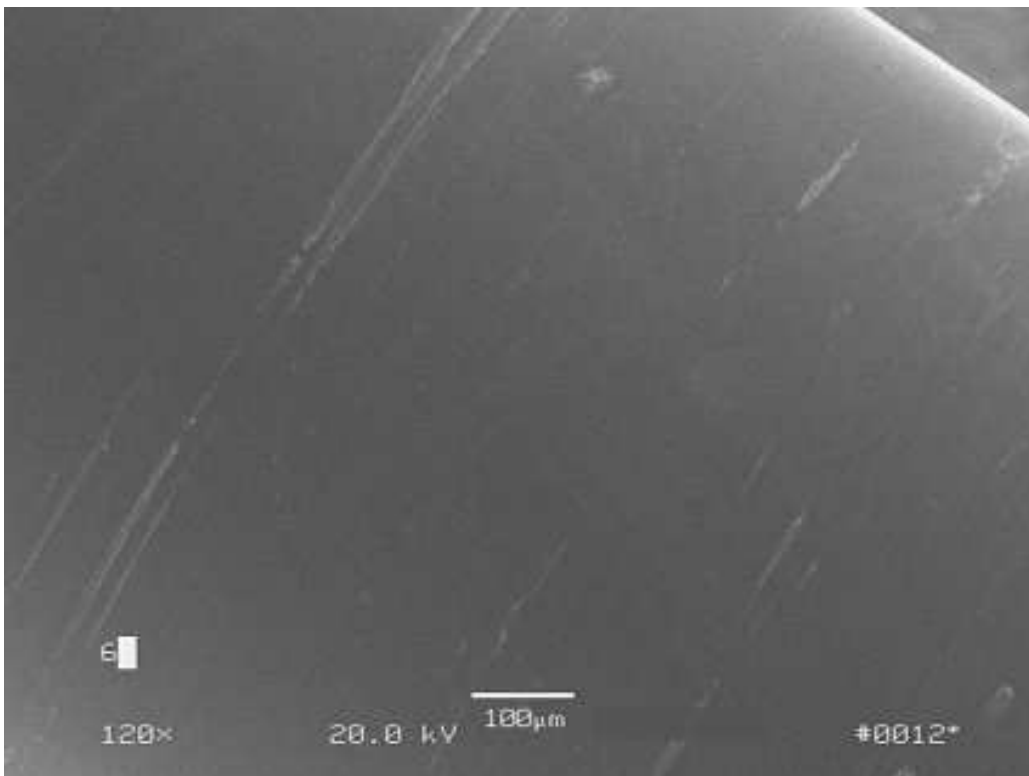
**Figure 30** - SEM Sample 6-1

**Figure 31** - SEM Sample 6-2

Sample #6 was turned, filed and burnished with a definite improvement seen. With little effort most defects were eliminated and a very smooth surface with almost the maximum bearing area produced. It is difficult to determine if the imperfections seen in these photos are remnants of the previous operations or a result of the actual burnishing.

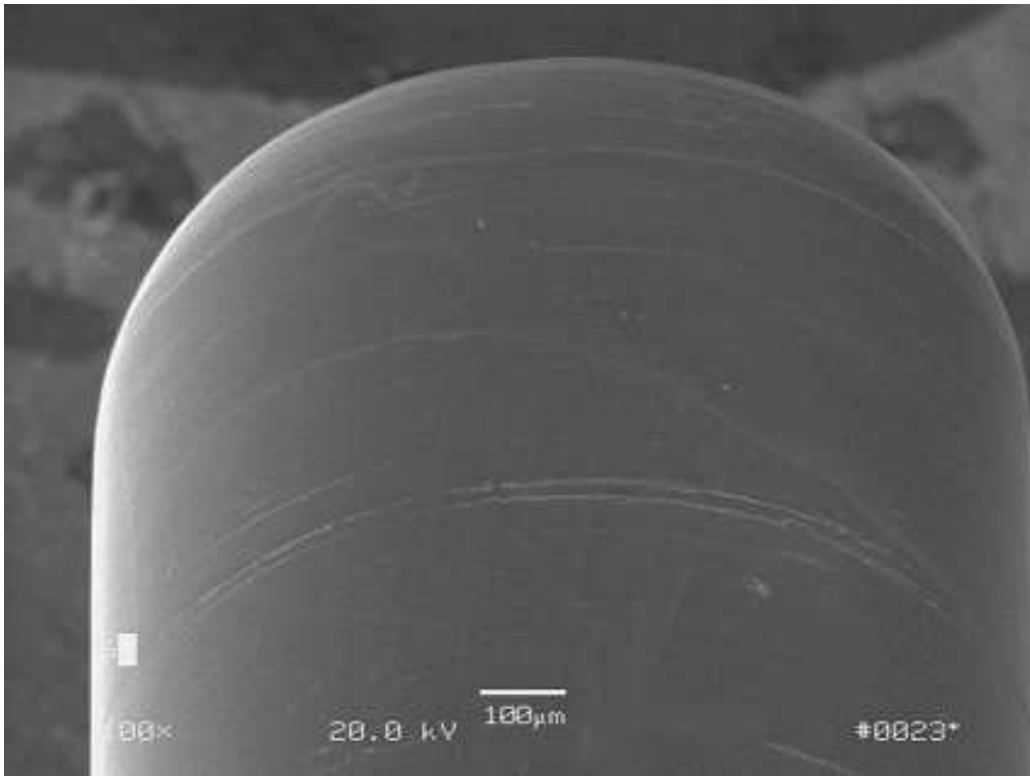
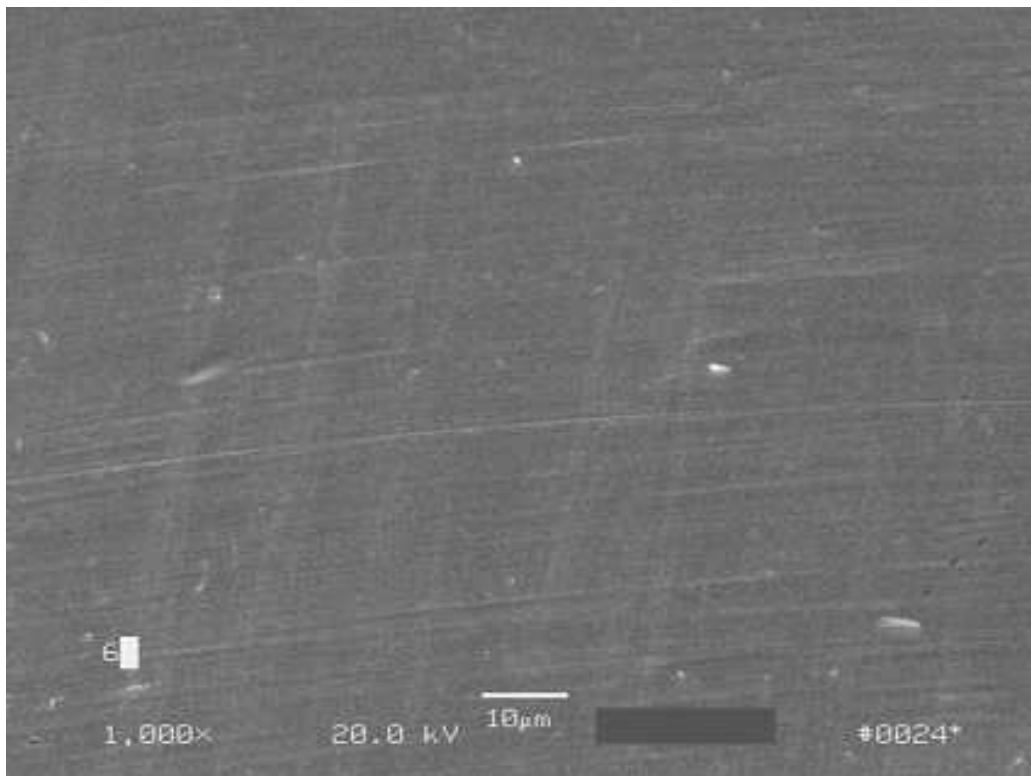
**Figure 32** – SEM Sample 6-3

**Figure 33** - SEM Sample 6-4

Even at the higher magnification the finish looks very good. Some scratches and marks are visible but their effects on the performance of a clock are left to further debates. The condition and cleanliness of the burnishing file and fixtures may also have an effect on the finish over the time that they may be in use.
