Holden Vectra

Triple Info Display

Instructions

Triple Info Display Removal

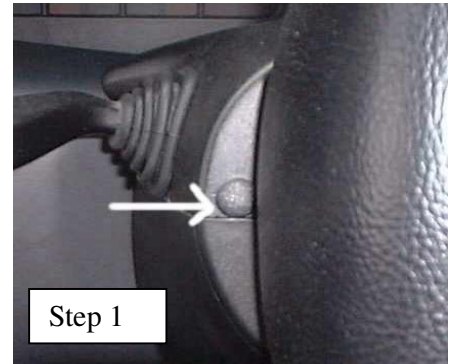
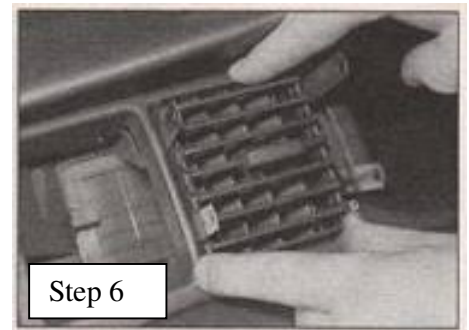
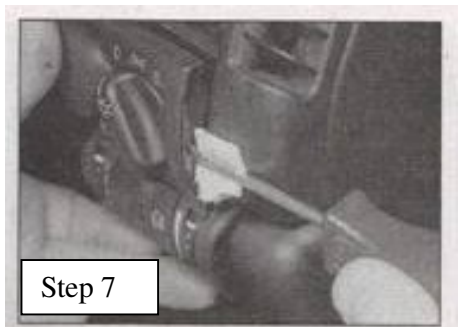
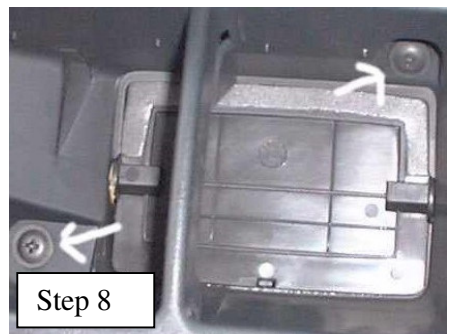
- 1) Turn the steering wheel to reveal the screw cover plugs. Remove these and the screw underneath. There are 2 for removal, one on either side of the steering wheel.

- 2) Remove the 3 screws securing the bottom half of the steering wheel shroud.
- 3) Ensure the ignition is off and remove the key. Open and close a door. Apply sticky tape over the ignition key entry.

- 4) Remove the top and bottom steering wheel shrouds.
- 5) Remove the wiper switch by releasing the top and bottom clips. Let it hang free. Repeat the same for the indicator switch.

- 6) Remove both the center vents and the vent on the driver's side by the following method described: *working one vent at a time insert each of the 4 feeler gauges down the sides of the vent to press and release the clips securing the vent in place. Remove the vent when the clips have released.*

- 7) Protect the sharp edges of the small screwdriver by applying sticky tape. Now carefully lever the light switch out from the dashboard and withdraw the switch assembly.

- 8) Remove the screws located inside the center vent. Remove the center vent surround.

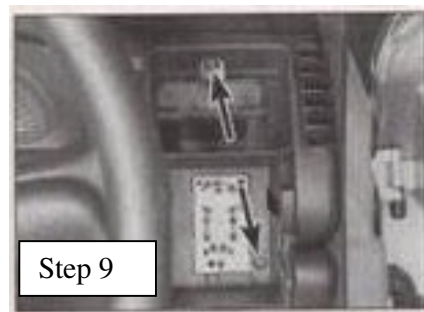
Step 9

9) Remove the screws located inside the driver's side vent and light switch. Remove the surrounds of the driver's side vent. Remove the screw that secures the right hand side of the instrument cluster (revealed after removal of vent surround.)

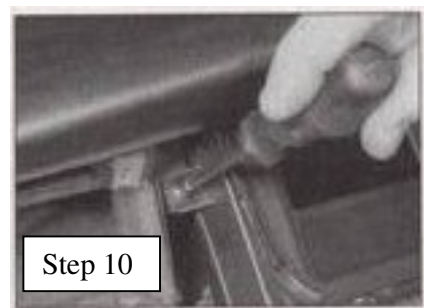
Step 10

10) Remove the screw (revealed after removal of center vent surround) that secures the left hand side of the instrument cluster.

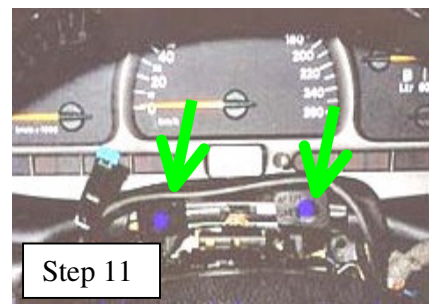
Step 11

11) Remove the two screws below the instrument cluster.

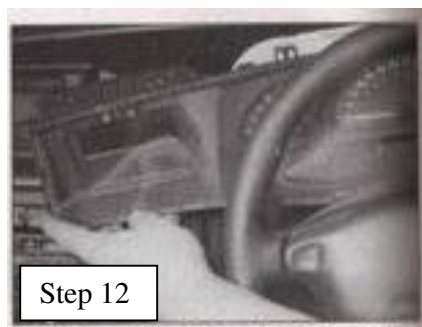
Step 12

12) The instrument cluster together with the Triple Info Display can now be removed from the dashboard a short distance. Reach behind and lift the black clip to allow the removal of the yellow connector from the rear of the Triple Info Display. The whole instrument cluster can now be completely removed.

Remove the clock adjustment buttons and the 2 screws that secure the Triple Info Display to the main instrument cluster. The Triple Info Display will now be free and looks like the picture below.

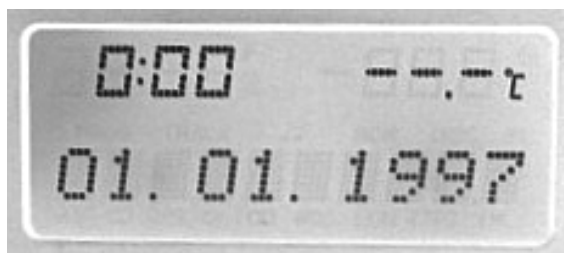
LCD Problem Areas

Please mark the areas or pixels that are currently defective on your display.
