Applies To: **2001 Civic 4-door** – From VIN 2HGES....1H615287 thru 2HGES....1H617435
2002 Civic 4-door – From VIN 2HGES....2H508286 thru 2HGES....2H510382

October 22, 2001

Safety Recall: Civic Air Cleaner Housing

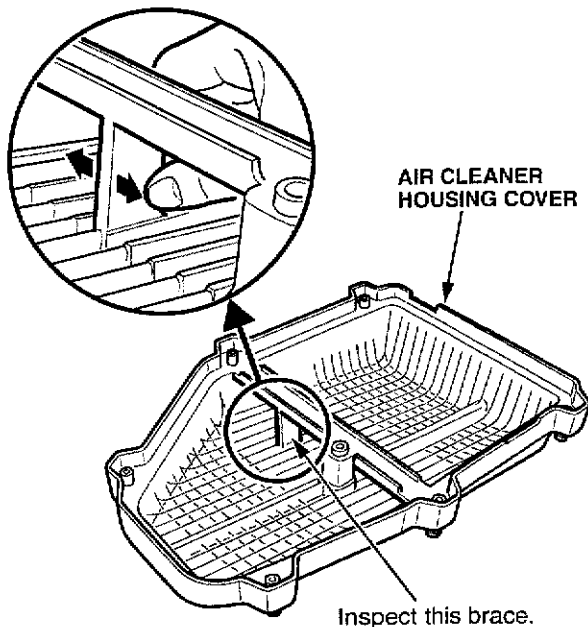
2. Inspect the plastic brace between the case and the crossbar. Try to flex it back and forth, and look for any cracks or missing pieces.

- If the brace is not damaged, reinstall the air cleaner housing cover, then go to step 14.
- If the brace is cracked or broken, but you find *all* of the missing pieces in the air cleaner housing, remove the pieces and install a new cover. Then go to step 14.
- If the brace is broken and you cannot locate *all* of the missing pieces, go to step 3.
