Applies To: **2001 Civic 2-Door** – ALL
2002 Civic 2-Door – From VIN 1HGEM2...2L000001 thru 1HGEM2...2L034290

April 2, 2002

Rattle From the High Mount Brake Light

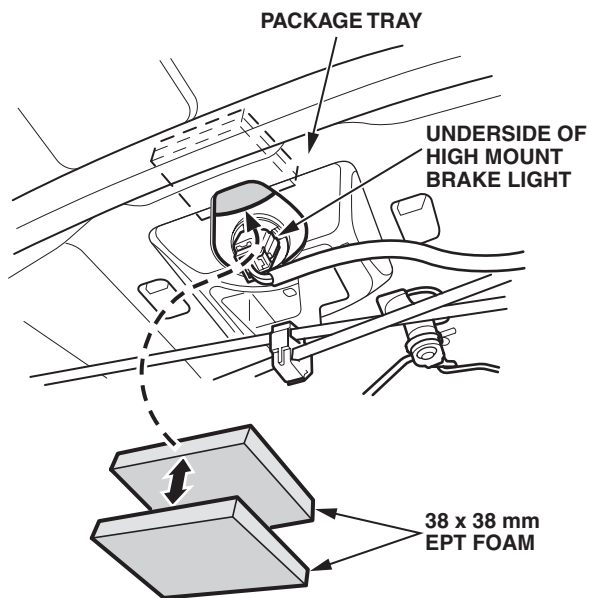
1. Cut two 38 x 38 mm pieces of 10T EPT foam.
2. Remove the backing and attach the two pieces of foam together, adhesive side to adhesive side.
3. Open the trunk.
4. Insert the foam between the package tray and the parcel shelf at the opening for the high mount brake light. Install the foam at the rear of the high mount brake light wiring opening. Push the foam into the rear of the opening toward the rear window.

5. Drive the vehicle to confirm that the rattle from the high mount brake light has been eliminated. If the rattle has not been eliminated, recheck your positioning of the foam. If the foam is properly installed, look for other causes.
